**Community Erosion Assessment
Kwigillingok, Alaska
27 January 2009**

1. Community: Kwigillingok, Alaska

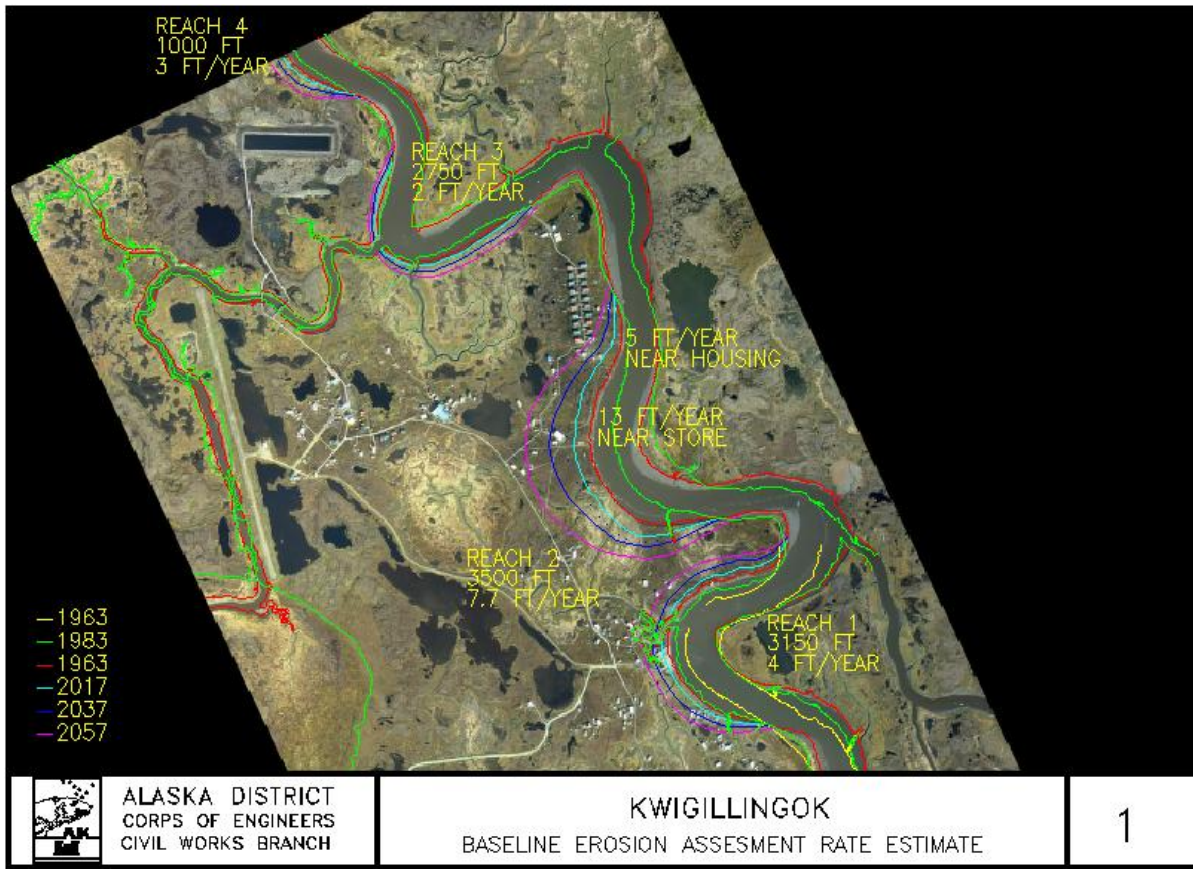
Figure 2. Kwigillingok Erosion Map

For this study the area was divided into four reaches. Reach 1 is a 3,150-foot portion of riverbank that fronts the community and is eroding at a rate of 4.0 feet per year. Reach 2 is a 3,500-foot portion of riverbank directly upstream (and north) of Reach 1 and is eroding at a rate of 7.7 feet per year. Reach 3 is a 2,750-foot portion of riverbank upstream of Reach 2 and is eroding at a rate of 2.0 feet per year. Reach 4 is a 1,000-foot portion of riverbank upstream of Reach 3 and is eroding at a rate of 3.0 feet per year. There is an area near the store that is eroding at a rate of 13 feet per year.

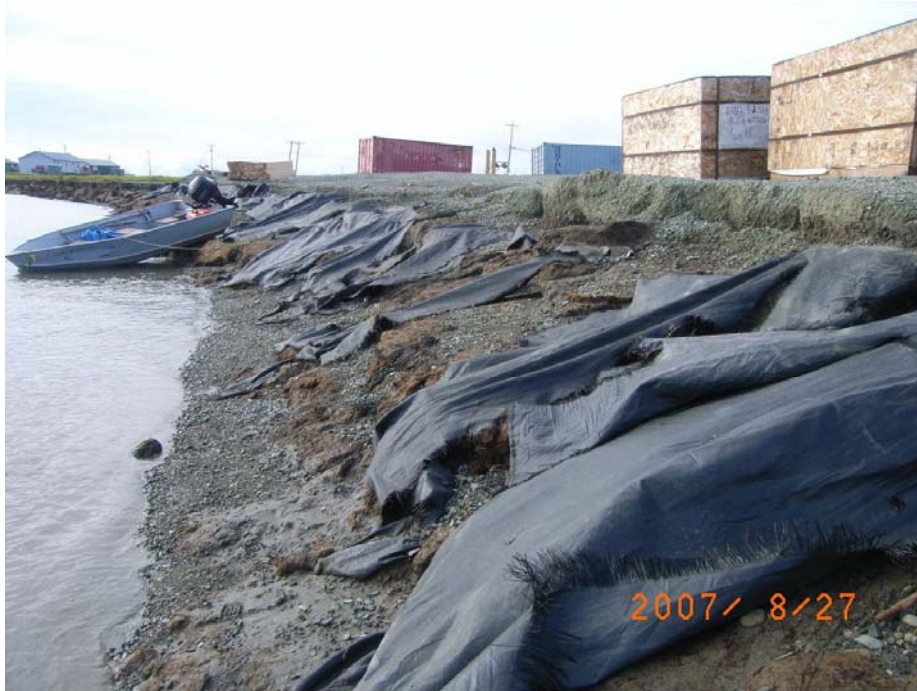
N 59° 52.244' W 163° 08.713'

Kwigillingok
Photo 1: Reach 1.

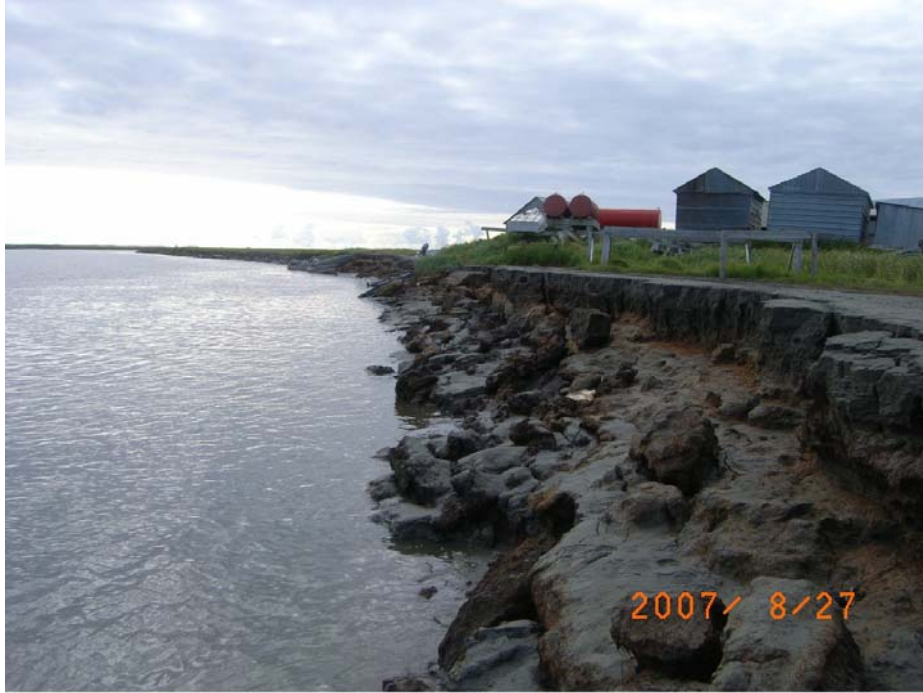
N 59° 52.173' W 163° 08.613'

Photo 2: Looking downstream at structures.
