**APPENDIX HW**  
**Hazardous Waste**

**USACE Haines-Fairbanks Pipeline No Department of Defense Action  
Indicated (NDAI) Final Determination (2014)**

Hazardous, Toxic, or Radioactive Waste  
Project # F10AK1016-01  
Haines-Fairbanks Pipeline  
Various Locations, Alaska

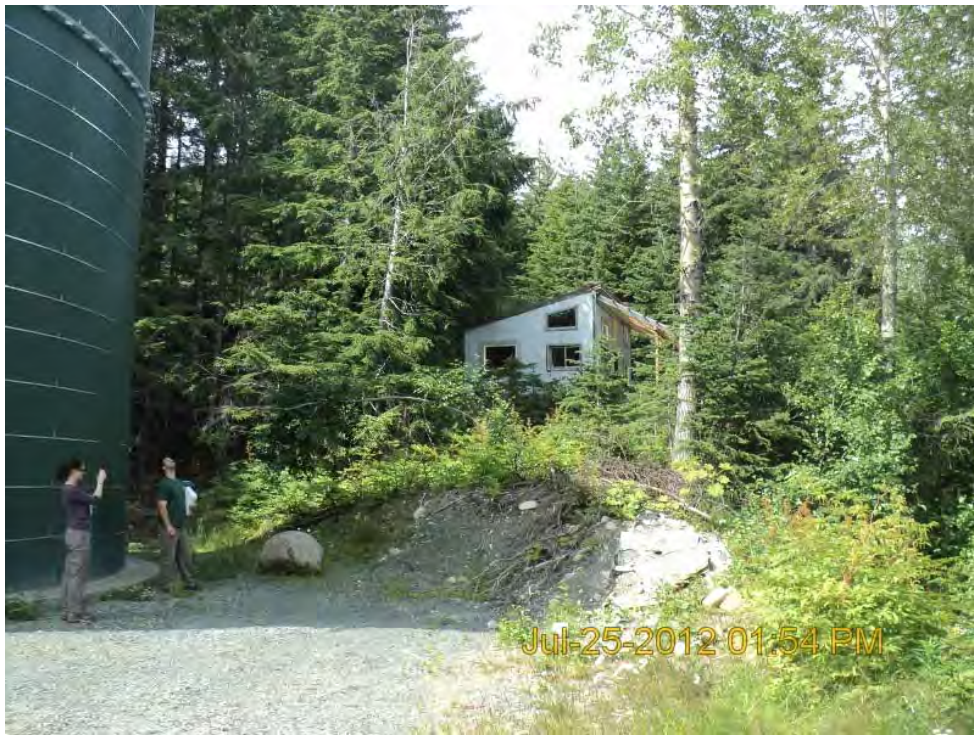
**PMP 1.9 (Young Road Site) –Water Tank and Adjacent Soil Berm with Remaining Soil Contamination**

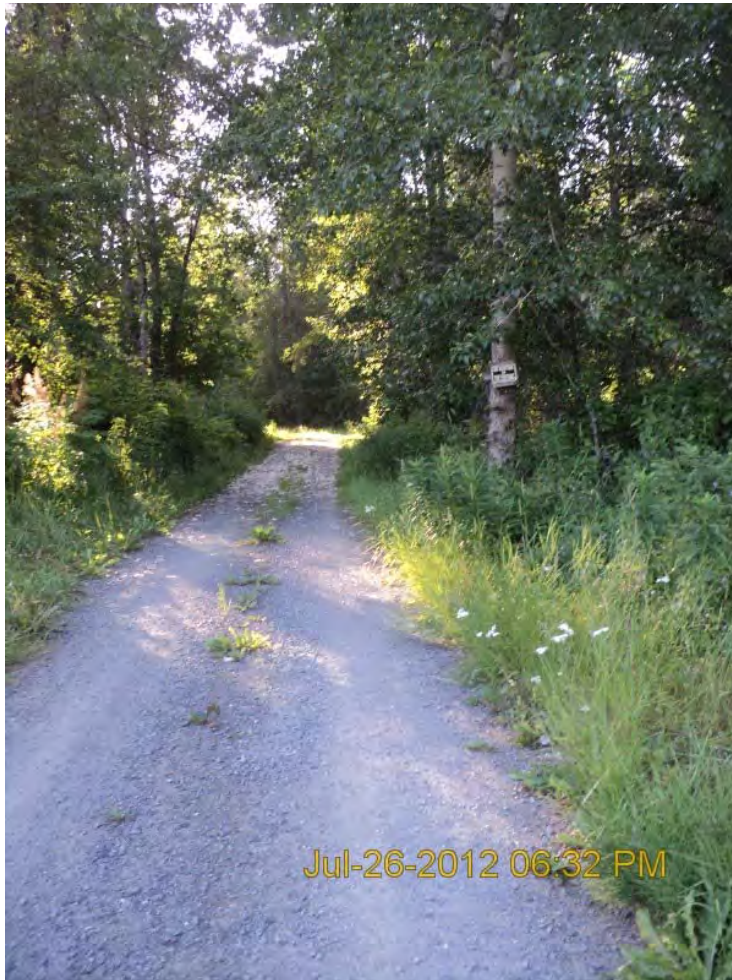
**PMP 19.5 – Private Road that HFP Intersects and where Release is Believed to have Occurred (Photo Looking Northwest)**

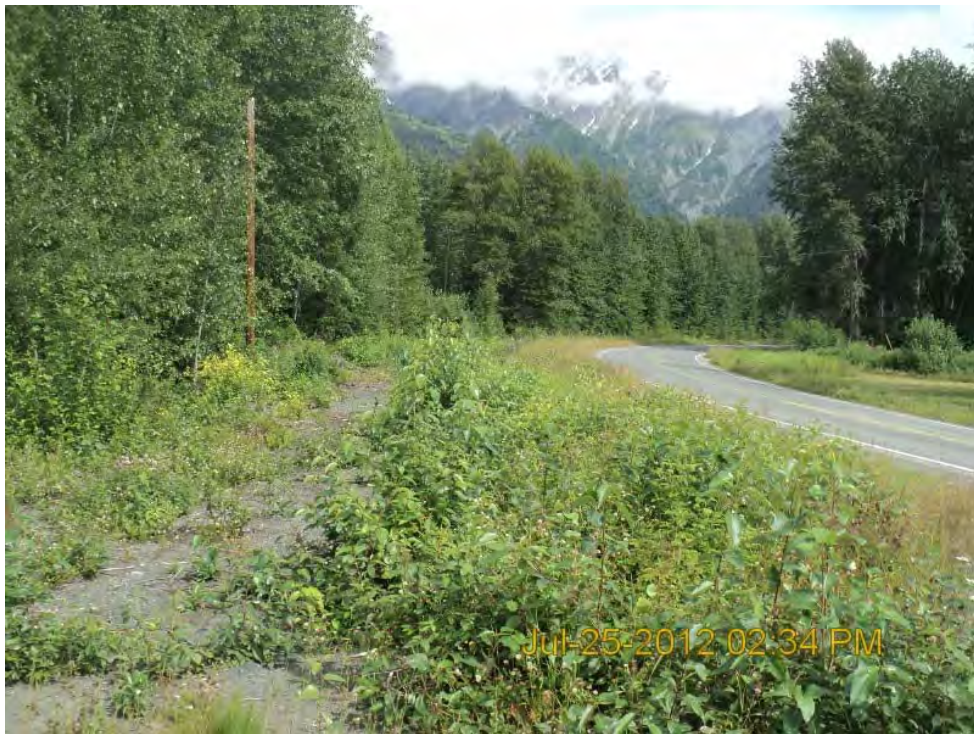
**PMP 25.5 - East of GV4 on North Side of Haines Highway (Looking East)**

PMP 25.5 (GV 4) – The proximity of an underground power line and the Haines Highway represent limitations to drilling at this site. However, a sampling approach can be developed that will enable a safe and adequate investigation of the GV4 area. Since highway construction activities in this area are planned for 2014, this site should receive priority.

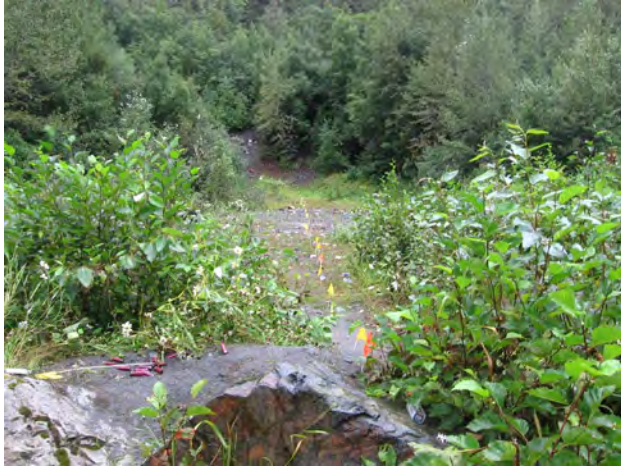
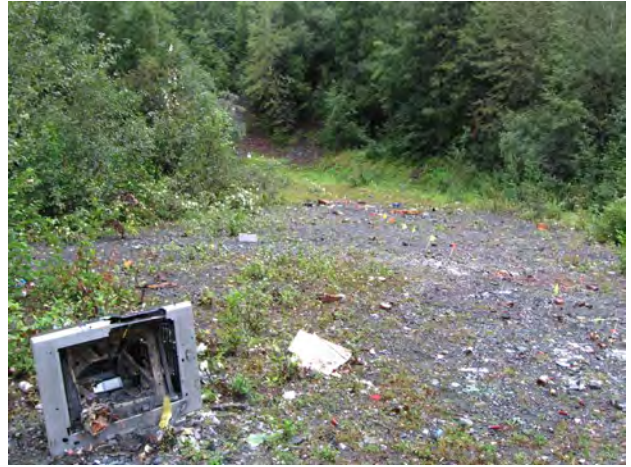
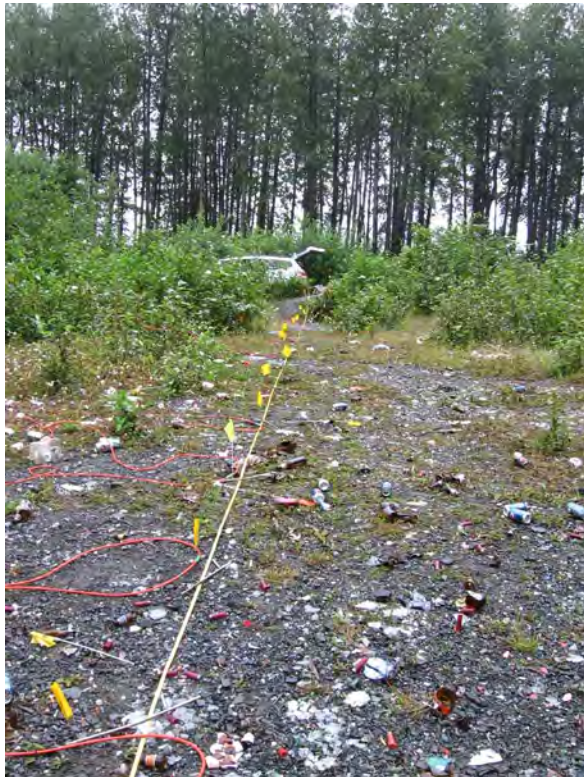
**Figure 3.** Photos showing the Haines 7-Mile Dump near Haines, Alaska. Photos taken looking (a) north along the direct-current resistivity line (indicated by pin flags) from the southern end of the dump area, (b) northeast from the middle of the dump area, and (c) south along the direct-current resistivity line from the middle of the dump area.

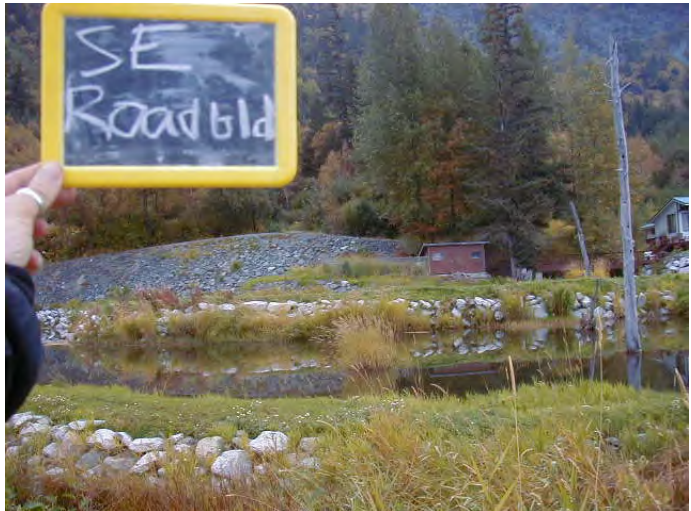
<p><b>Photograph No. 7</b></p> <p>Location: Site 3</p> <p>Direction: Facing west</p> <p>Comments: Squatters cabin</p>
