CADD	ECC	<b>TITLE</b> <b>GEOLOGIC HAZARD SUMMARY</b> <b>ARRANGED BY 2012 SEIS STATIONING</b> <b>LYNN CANAL HIGHWAY PHASE 2</b> <b>2012 SEIS ALIGNMENT HAZARD REVISIONS</b>		
	DATE	9/10/12			
	CHECK	RGD			
FILE No.	GEO_HAZ_SUMM.PPT	DATE	9/24/12	<b>HDR / 2012 SEIS JUNEAU ACCESS / AK</b>	<b>G-133</b>
PROJECT No.	113-95756	REV	1

TITLE  
**GEOLOGIC HAZARD SUMMARY**  
**ARRANGED BY 2012 SEIS STATIONING**  
**LYNN CANAL HIGHWAY PHASE 2**  
**2012 SEIS ALIGNMENT HAZARD REVISIONS**

HDR / 2012 SEIS JUNEAU ACCESS / AK

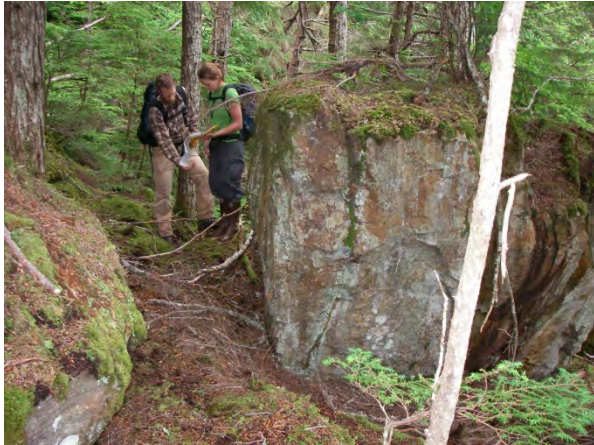
RF38. View south/down alignment at typical talus field within rockfall hazard.

Hazard ID #:	RF38
Hazard Type:	rockfall
HIN:	33
Rating:	B
2012 SEIS Alignment Location:	2481
Frequency (yrs):	5-25
Predictability:	high
Material Volume (CY):	<10
Clast Size (ft):	1-2
Source Elev. (ft):	100-500
Centerline Slope:	single_channel
Alignment Location:	deposition_zone
Impact Alignment:	yes
Alignment Exposure (ft):	50-200
Vegetation:	disturbed
Deciduous Trees:	yes
2012 SEIS Alignment South Margin:	2480+90
2012 SEIS Alignment North Margin:	2481+80
Photo #:	6092

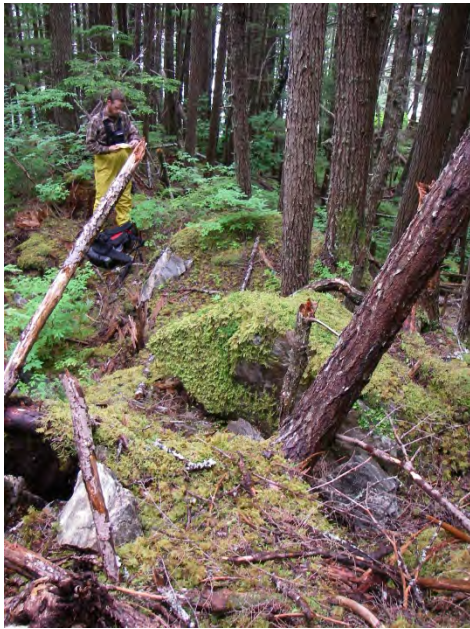
RF39. View south/down alignment at rockfall hazard.

Hazard ID #:	RF39
Hazard Type:	rockfall
HIN:	129
Rating:	B
2012 SEIS Alignment Location:	2488
Frequency (yrs):	1-5
Predictability:	unpredictable
Material Volume (CY):	<10
Clast Size (ft):	3-4
Source Elev. (ft):	100-500
Centerline Slope:	other
Alignment Location:	deposition_zone
Impact Alignment:	yes
Alignment Exposure (ft):	50-200
Vegetation:	disturbed
Deciduous Trees:	yes
2012 SEIS Alignment South Margin:	2488+00
2012 SEIS Alignment North Margin:	2489+00
Photo #:	6083, 6084

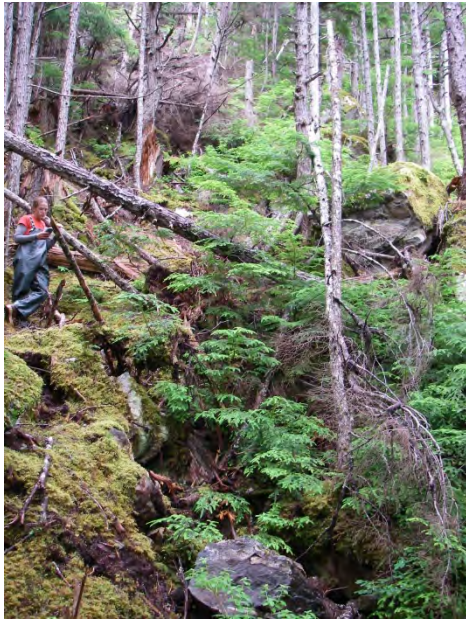
RF39. View east/upslope at rockfall.

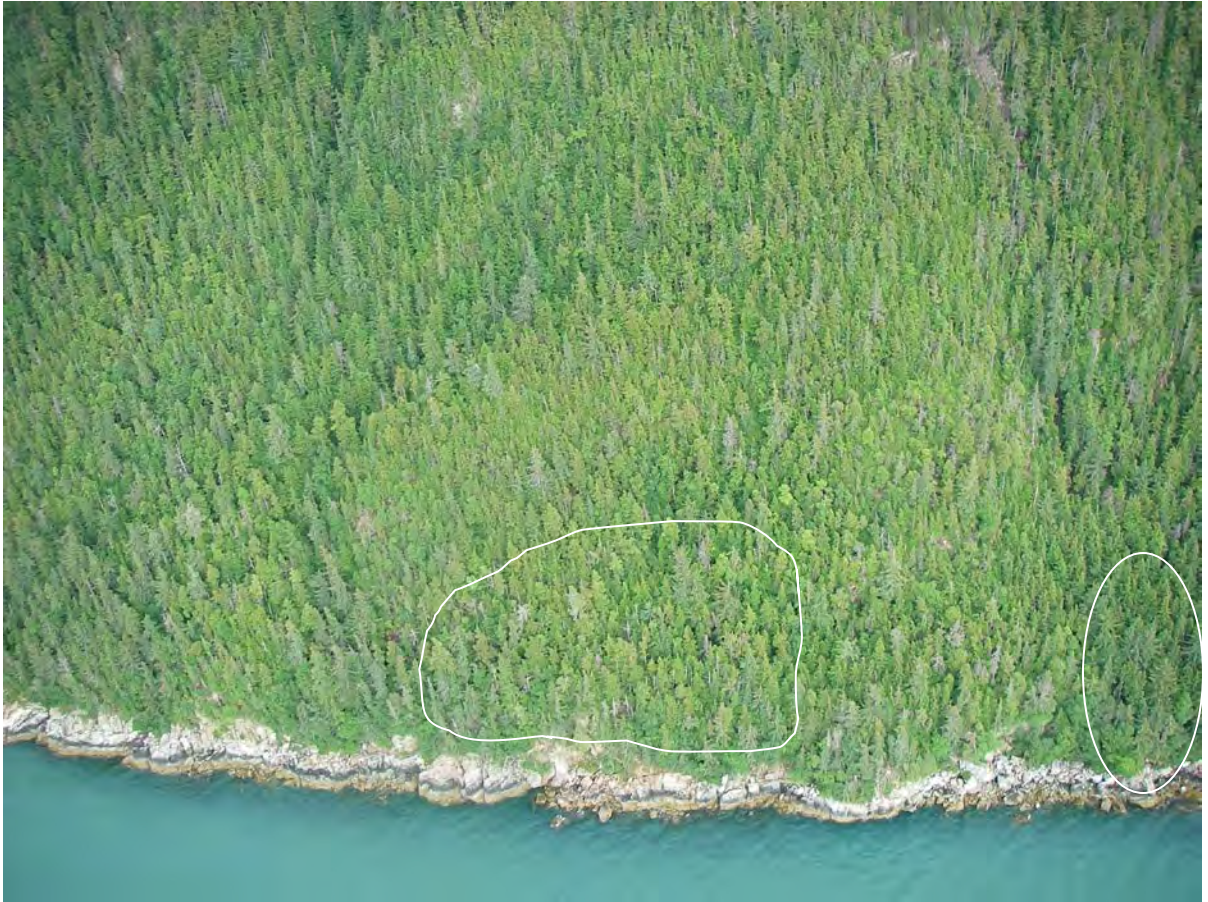
RF39 & RF40. View east/upslope at rockfall hazards RF39 (right) and RF40 (left).

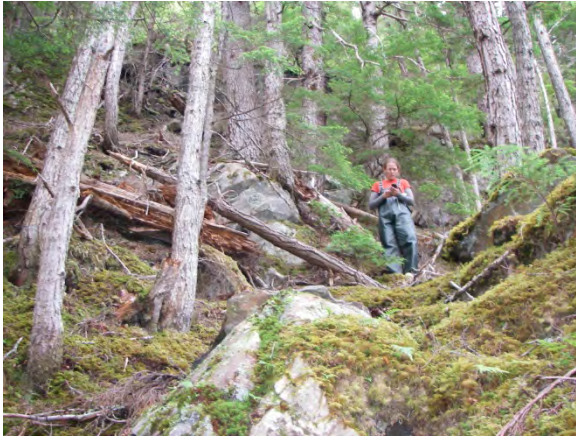
RF40. View west/upslope at rockfall hazard.

Hazard ID #:	RF40
Hazard Type:	rockfall
HIN:	147
Rating:	B
2012 SEIS Alignment Location:	2494
Frequency (yrs):	1-5
Predictability:	unpredictable
Material Volume (CY):	<10
Clast Size (ft):	3-4
Source Elev. (ft):	100-500
Centerline Slope:	-
Alignment Location:	deposition_zone
Impact Alignment:	yes
Alignment Exposure (ft):	200-500
Vegetation:	disturbed
Deciduous Trees:	no
2012 SEIS Alignment South Margin:	2491+60
2012 SEIS Alignment North Margin:	2496+20
Photo #:	5182, 5964, 6085

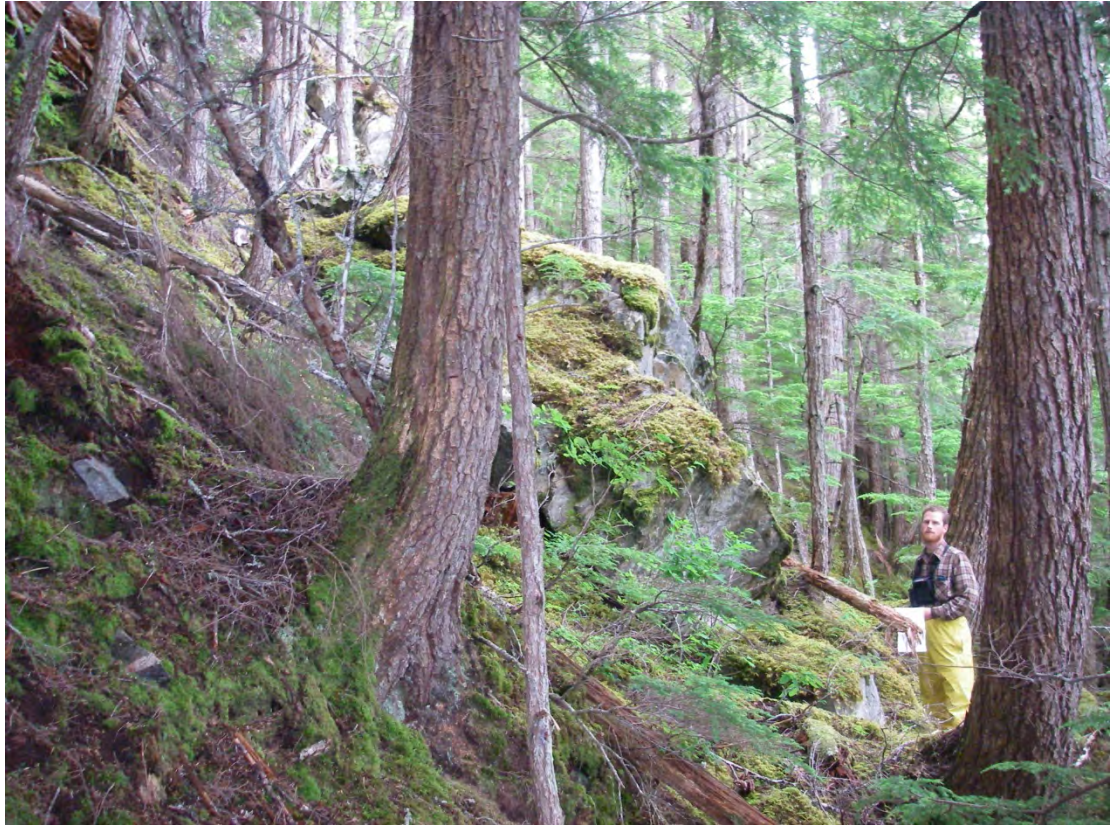
RF40. View south/down alignment at rockfall hazard.

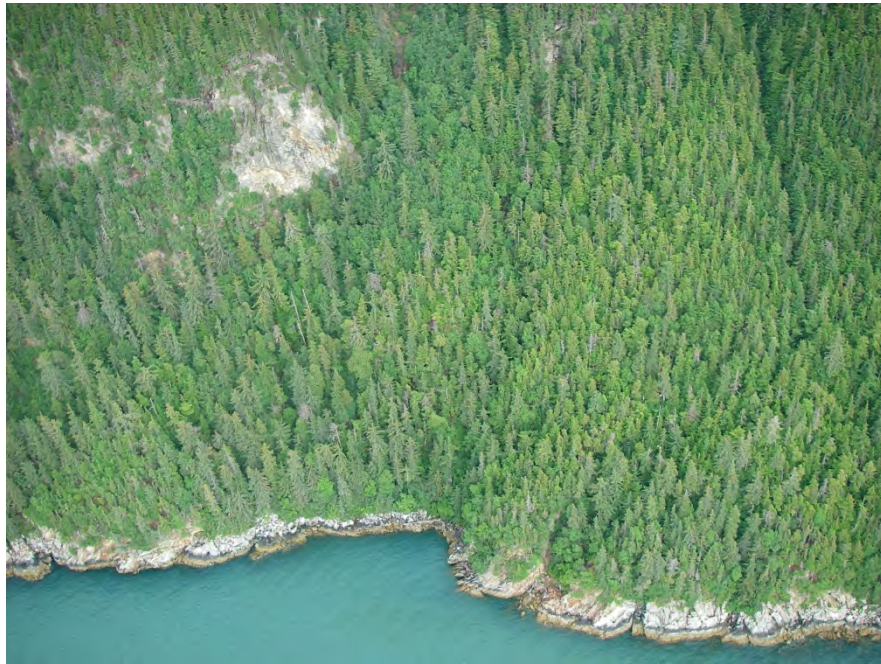
Hazard ID #:	DF42
Hazard Type:	debris_flow
HIN:	117
Rating:	B
2012 SEIS Alignment Location:	2498
Frequency (yrs):	5-25
Predictability:	moderate
Material Volume (CY):	10-100
Clast Size (ft):	1-2
Source Elev. (ft):	>1000
Centerline Slope:	single_channel
Alignment Location:	path
Impact Alignment:	yes
Alignment Exposure (ft):	50-200
Vegetation:	disturbed
Deciduous Trees:	yes
2012 SEIS Alignment South Margin:	2498+10
2012 SEIS Alignment North Margin:	2498+90
Photo #:	6086

DF42. View east/upslope at debris flow channel.

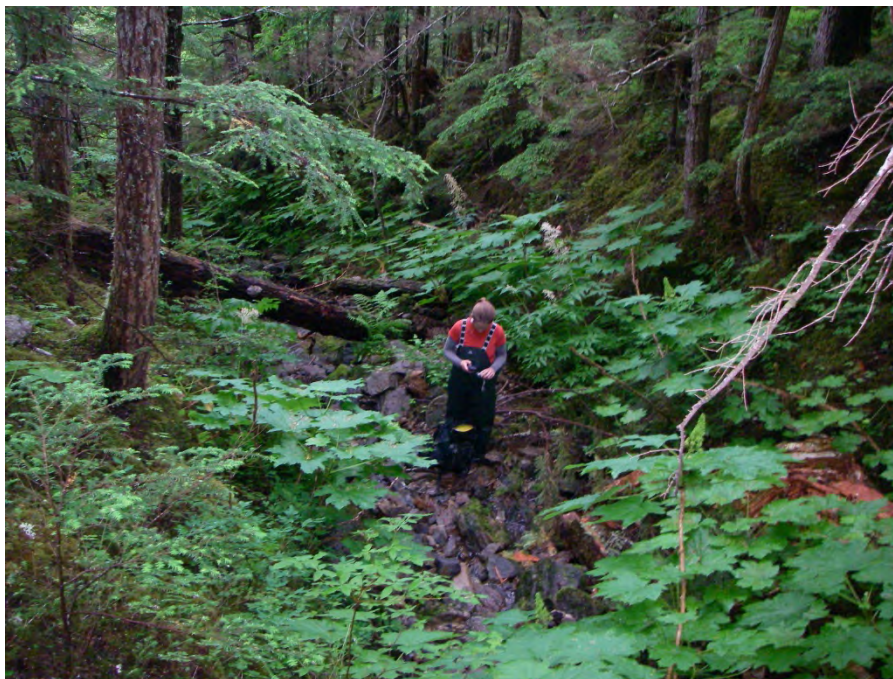
DF42. View west/downslope at debris flow channel.

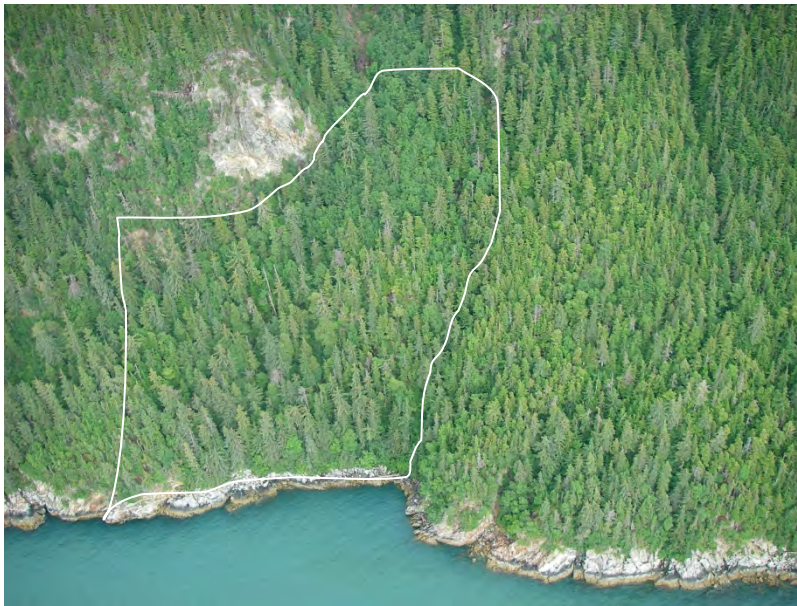
Hazard ID #:	RF41
Hazard Type:	rockfall
HIN:	93
Rating:	C
2012 SEIS Alignment Location:	2505
Frequency (yrs):	1-5
Predictability:	moderate
Material Volume (CY):	<10
Clast Size (ft):	2-3
Source Elev. (ft):	500-1000
Centerline Slope:	open_soil_slope
Alignment Location:	path
Impact Alignment:	yes
Alignment Exposure (ft):	200-500
Vegetation:	disturbed
Deciduous Trees:	yes
2012 SEIS Alignment South Margin:	2502+50
2012 SEIS Alignment North Margin:	2507+20
Photo #:	5965, 6094, 6095

RF41. View east/upslope at rockfall hazard.

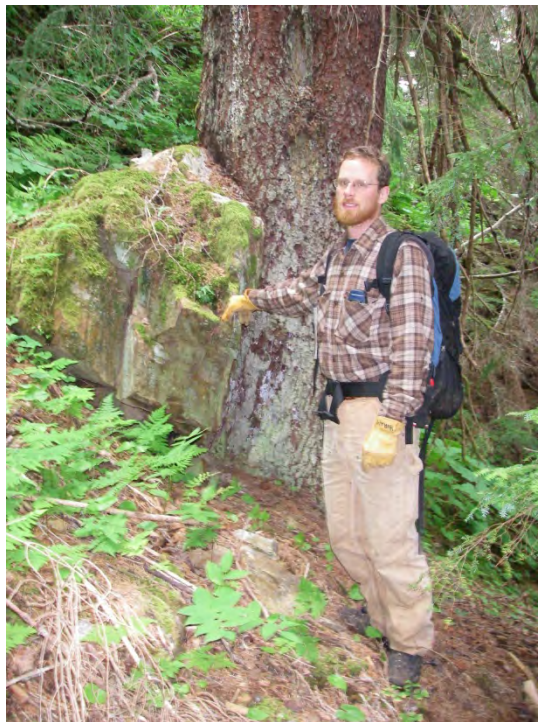
RF41. View south/down alignment at rockfall stopped by a spruce tree.

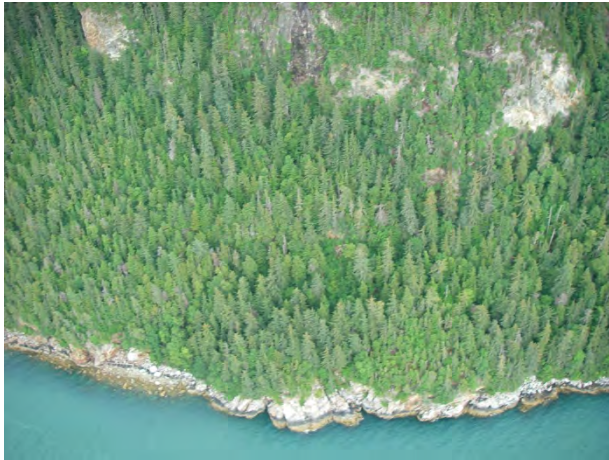
RF42. View east/upslope at rockfall hazard.

Hazard ID #:	RF42
Hazard Type:	rockfall
HIN:	111
Rating:	B
2012 SEIS Alignment Location:	2507
Frequency (yrs):	unknown (5-25?)
Predictability:	moderate
Material Volume (CY):	<10
Clast Size (ft):	0-1
Source Elev. (ft):	100-500
Centerline Slope:	deciduous_trees
Alignment Location:	path
Impact Alignment:	yes
Alignment Exposure (ft):	500+
Vegetation:	denuded
Deciduous Trees:	yes
2012 SEIS Alignment South Margin:	2502+50
2012 SEIS Alignment North Margin:	2512+40
Photo #:	6094, 6095

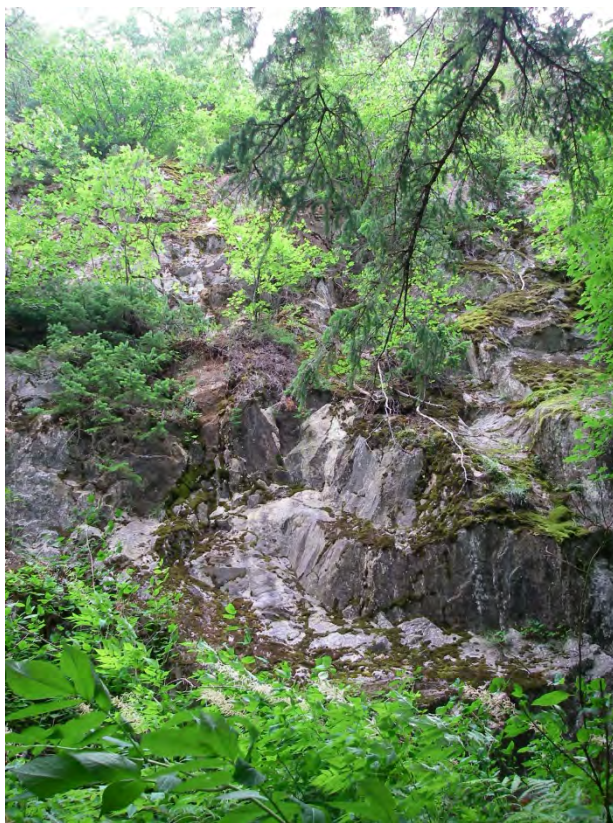
RF42. View east/upslope at rockfall hazard.

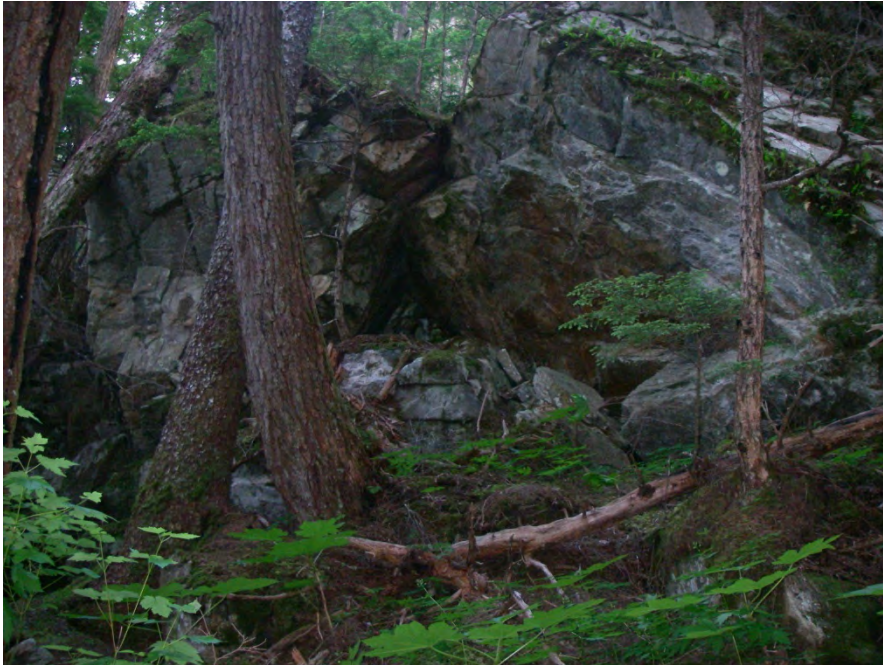
Hazard ID #:	HR03
Hazard Type:	hazard_rocks
HIN:	105
Rating:	C
2012 SEIS Alignment Location:	2525
Frequency (yrs):	unknown (>25?)
Predictability:	unpredictable
Material Volume (CY):	<10
Clast Size (ft):	4+
Source Elev. (ft):	100-500
Centerline Slope:	-
Alignment Location:	below_deposition_zone
Impact Alignment:	yes
Alignment Exposure (ft):	50-200
Vegetation:	-
Deciduous Trees:	no
2012 SEIS Alignment South Margin:	2524+45
2012 SEIS Alignment North Margin:	2525+10
Photo #:	5311, 5312

HR03. View east/upslope at hazard rock.

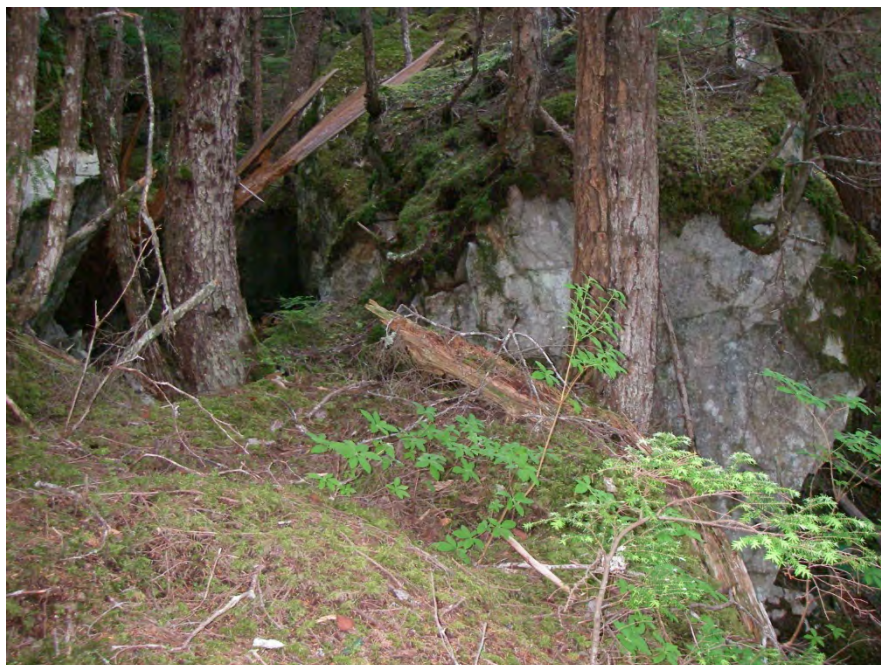
Hazard ID #:	HR04
Hazard Type:	hazard_rocks
HIN:	105
Rating:	C
2012 SEIS Alignment Location:	2533
Frequency (yrs):	unknown (>25?)
Predictability:	unpredictable
Material Volume (CY):	<10
Clast Size (ft):	4+
Source Elev. (ft):	100-500
Centerline Slope:	-
Alignment Location:	below_deposition_zone
Impact Alignment:	yes
Alignment Exposure (ft):	50-200
Vegetation:	-
Deciduous Trees:	no
2012 SEIS Alignment South Margin:	2533+00
2012 SEIS Alignment North Margin:	2533+70
Photo #:	5318

HR04. View south/down alignment at hazard rock.

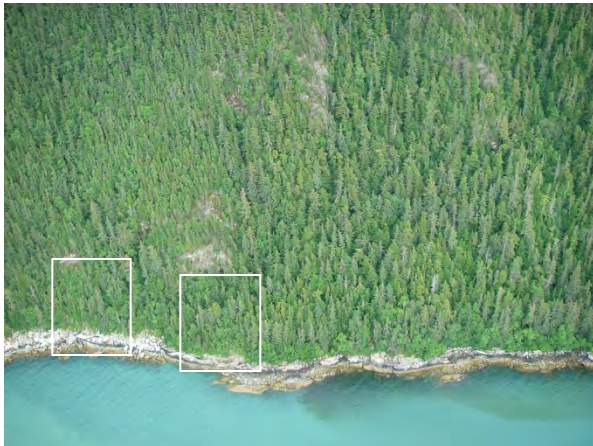
RF43 & RF44. View east/upslope at rockfall areas RF43 (right) and RF44 (left).

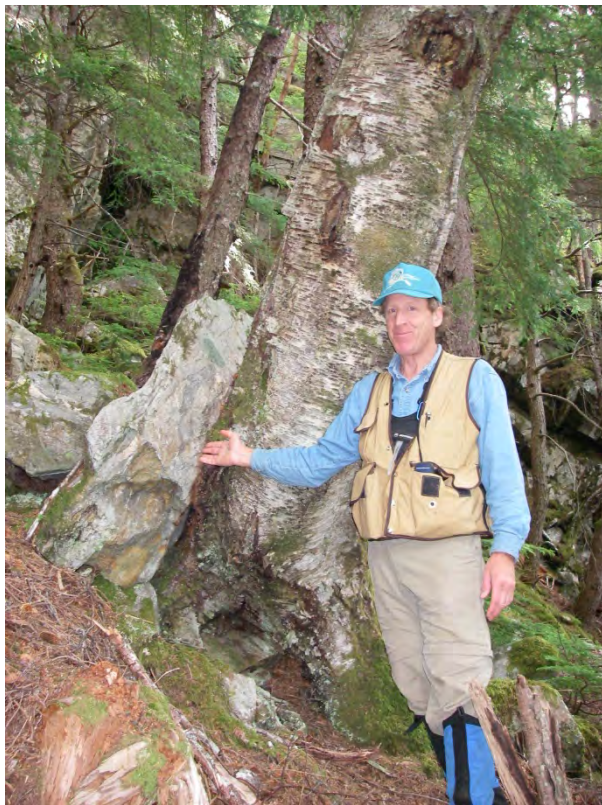
RF43. View south/down alignment at rockfall hazard, recently deposited boulder embedded into 2 ft diameter birch tree.

Hazard ID #:	RF43
Hazard Type:	rockfall
HIN:	129
Rating:	A
2012 SEIS Alignment Location:	2536
Frequency (yrs):	1-5
Predictability:	unpredictable
Material Volume (CY):	<10
Clast Size (ft):	2-3
Source Elev. (ft):	100-500
Centerline Slope:	open_soil_slope
Alignment Location:	below_deposition_zone
Impact Alignment:	no
Alignment Exposure (ft):	50-200
Vegetation:	disturbed
Deciduous Trees:	yes
2012 SEIS Alignment South Margin:	2535+20
IRP 2006 North Margin:	2537+20
Photo #:	3648, 5969

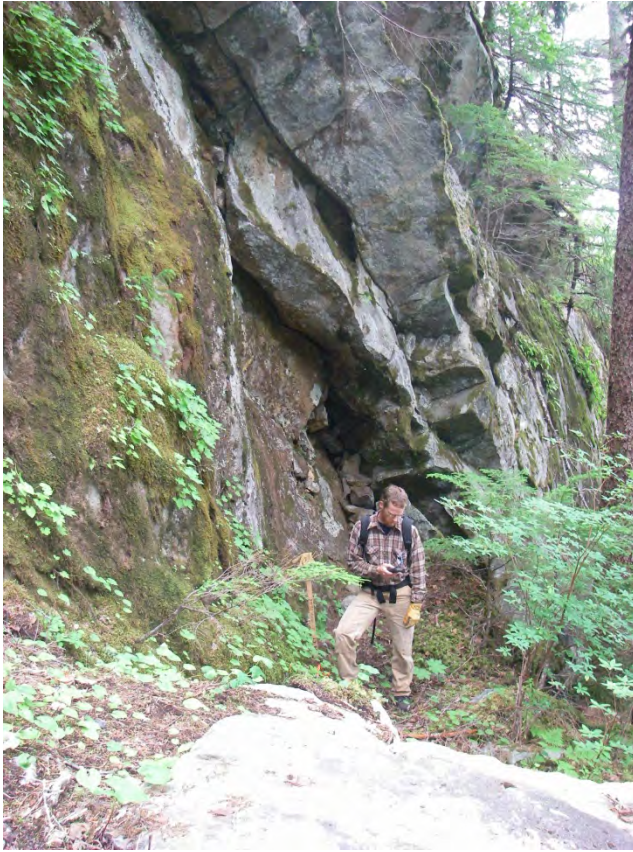
RF44. View south/down alignment at rockfall hazard.

Hazard ID #:	RF44
Hazard Type:	rockfall
HIN:	147
Rating:	B
2012 SEIS Alignment Location:	2540
Frequency (yrs):	1-5
Predictability:	unpredictable
Material Volume (CY):	<10
Clast Size (ft):	1-2
Source Elev. (ft):	100-500
Centerline Slope:	open_soil_slope
Alignment Location:	deposition_zone
Impact Alignment:	yes
Alignment Exposure (ft):	200-500
Vegetation:	disturbed
Deciduous Trees:	no
2012 SEIS Alignment South Margin:	2538+40
2012 SEIS Alignment North Margin:	2540+70
Photo #:	1565, 5326, 5327

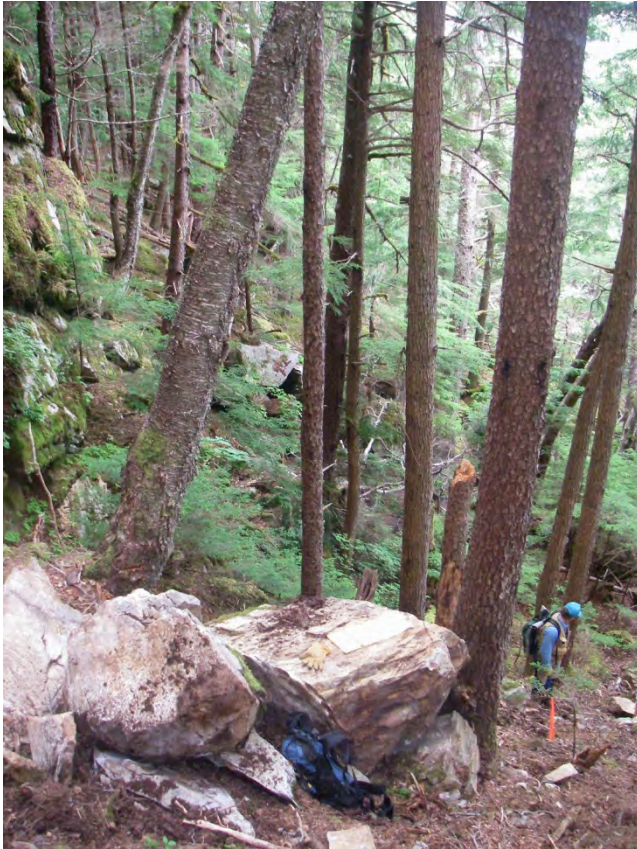
RF45. View west/downslope at rockfall with fresh rockfall stopped by spruce trees.

Hazard ID #:	RF45
Hazard Type:	rockfall
HIN:	129
Rating:	B
2012 SEIS Alignment Location:	2544
Frequency (yrs):	1-5
Predictability:	unpredictable
Material Volume (CY):	<10
Clast Size (ft):	1-2
Source Elev. (ft):	100-500
Centerline Slope:	-
Alignment Location:	below_deposition _zone
Impact Alignment:	no
Alignment Exposure (ft):	50-200
Vegetation:	-
Deciduous Trees:	no
2012 SEIS Alignment South Margin:	2543+00
2012 SEIS Alignment North Margin:	2545+00
Photo #:	6098, 6099

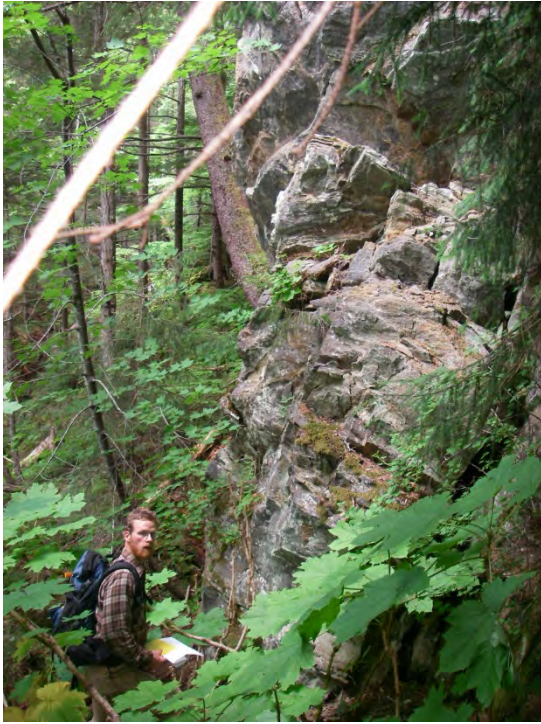
RF46. View north/up alignment at rockfall hazard cliffs.

Hazard ID #:	RF46
Hazard Type:	rockfall
HIN:	111
Rating:	B
2012 SEIS Alignment Location:	2556
Frequency (yrs):	5-25
Predictability:	unpredictable
Material Volume (CY):	<10
Clast Size (ft):	2-3
Source Elev. (ft):	100-500
Centerline Slope:	open_soil_slope
Alignment Location:	below_deposition_zone
Impact Alignment:	no
Alignment Exposure (ft):	50-200
Vegetation:	disturbed
Deciduous Trees:	yes
2012 SEIS Alignment South Margin:	2555+50
2012 SEIS Alignment North Margin:	2557+10
Photo #:	5338, 5339

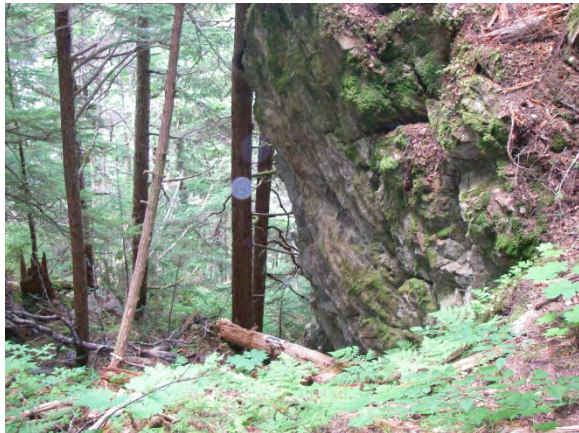
RF46. View northwest (up alignment and downslope) at rockfall hazard area.

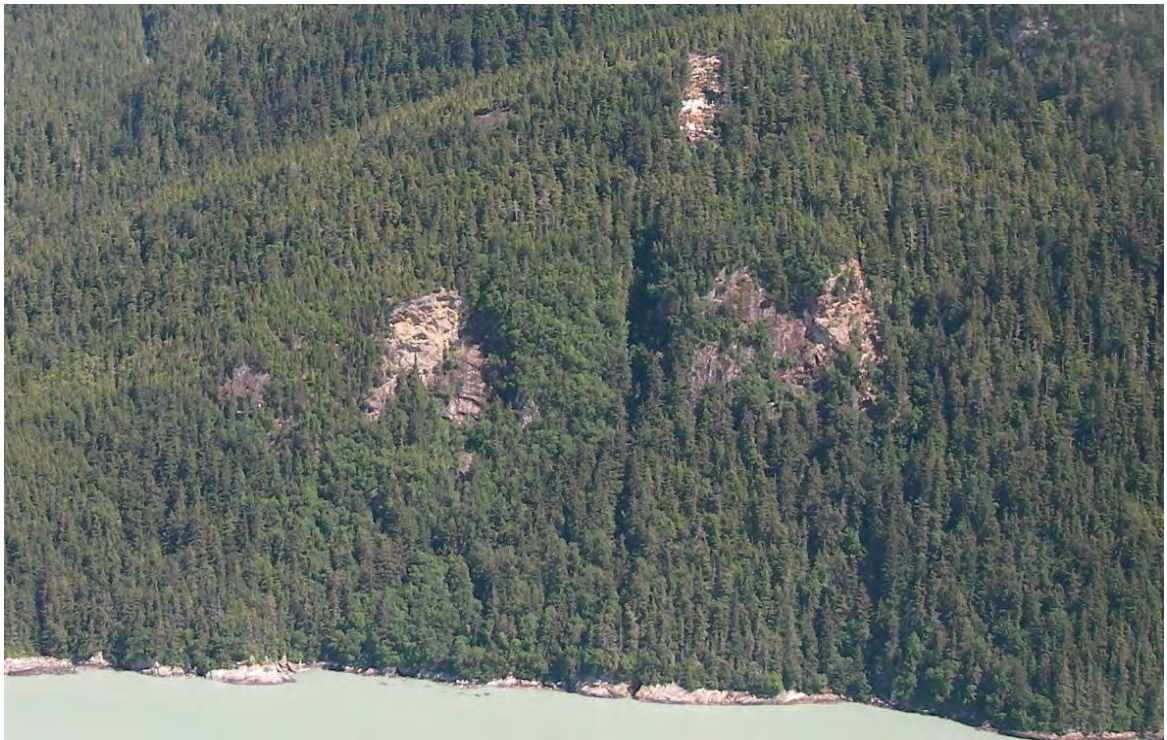
Regional photo, view east/upslope, at hazards listed below. Local photos and details for individual hazards follow.

- RF47
- LS06
- HR05
- RF49
- RF50
- RF51
- LS07
- DF43
- RF52

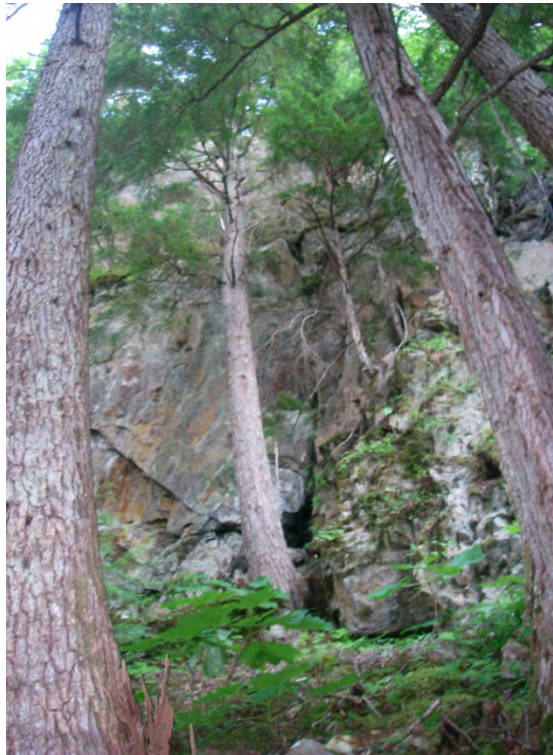
Hazard ID #:	RF47
Hazard Type:	rockfall
HIN:	183
Rating:	B
2012 SEIS Alignment Location:	2561
Frequency (yrs):	5-25
Predictability:	unpredictable
Material Volume (CY):	<10
Clast Size (ft):	2-3
Source Elevation (ft):	100-500
Centerline Slope:	open_soil_slope
Alignment Location:	below_deposition _zone
Impact Alignment:	no
Alignment Exposure (ft):	500+
Vegetation:	disturbed
Deciduous Trees:	yes
2012 SEIS Alignment South Margin:	2558+50
2012 SEIS Alignment North Margin:	2565+00
Photo #:	3660

RF47. View east/upslope at rockfall.

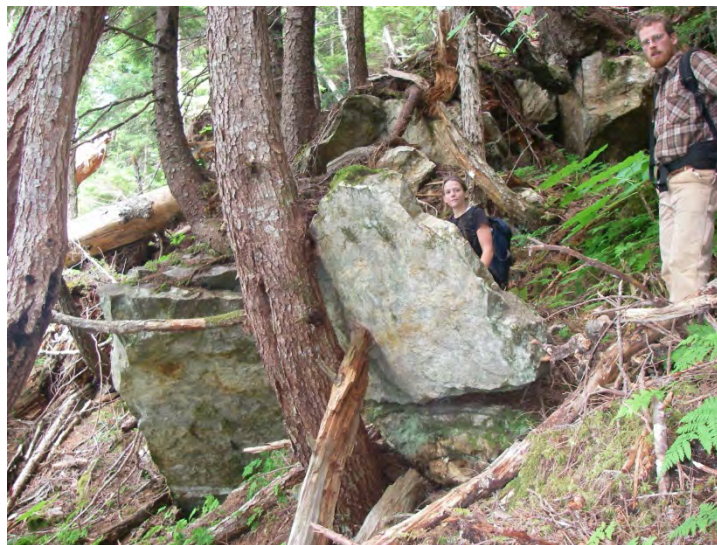
RF47. View north/up alignment at rockfall stopped by tree trunk.

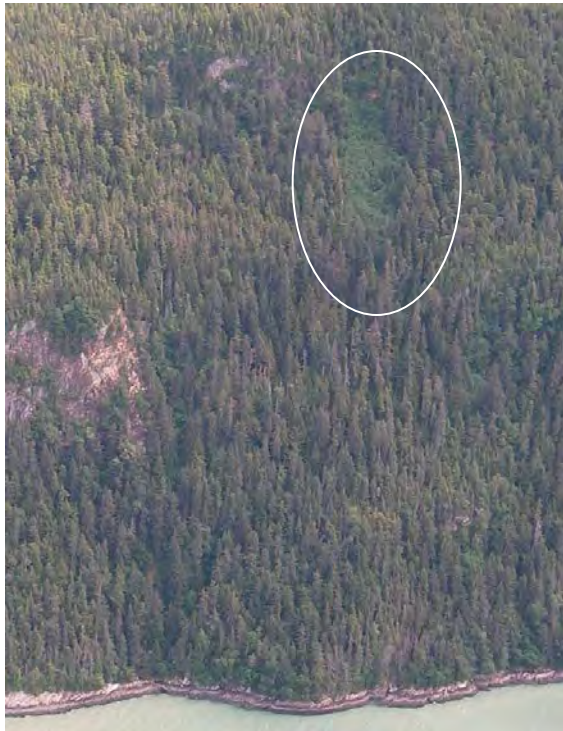
LS06. View east/upslope at landslide area (green patch of disturbed vegetation in upper right photo).

Hazard ID #:	LS06
Hazard Type:	landslide
HIN:	183
Rating:	C
2012 SEIS Alignment Location:	2562
Frequency (yrs):	unknown (>25?)
Predictability:	unpredictable
Material Volume (CY):	10-100
Clast Size (ft):	-
Source Elevation (ft):	>1000
Centerline Slope:	open_soil_slope
Alignment Location:	below_deposition_zone
Impact Alignment:	no
Alignment Exposure (ft):	50-200
Vegetation:	disturbed
Deciduous Trees:	no
2012 SEIS Alignment South Margin:	2561+60
2012 SEIS Alignment North Margin:	2562+80
Photo #:	5185, 5341, 5342

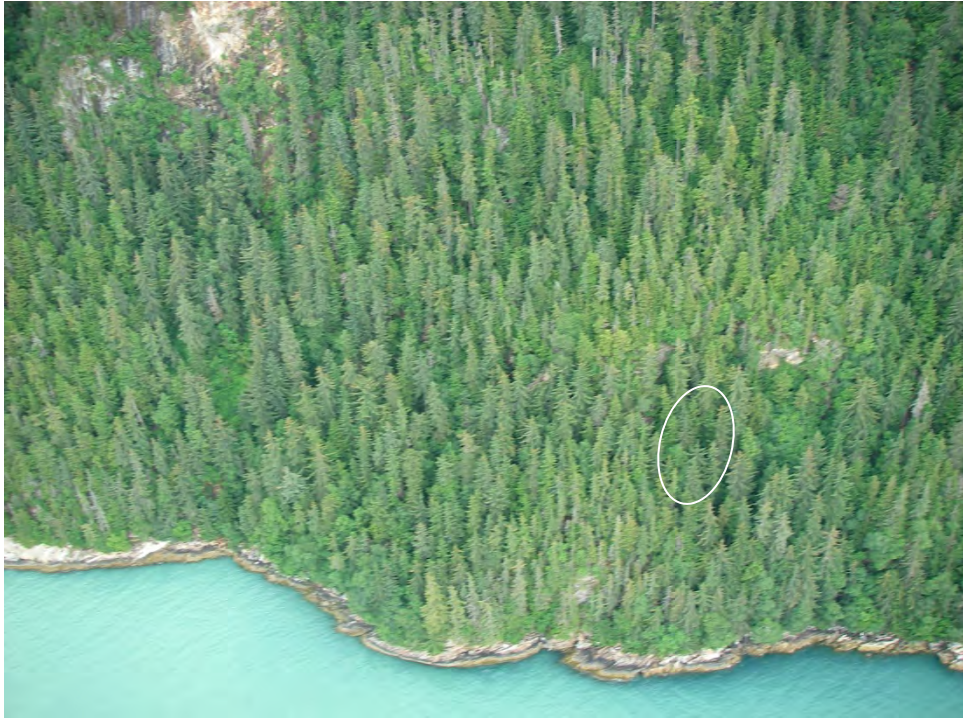
Hazard ID #:	HR05
Hazard Type:	hazard_rocks
HIN:	105
Rating:	C
2012 SEIS Alignment Location:	2562
Frequency (yrs):	unknown (>25?)
Predictability:	unpredictable
Material Volume (CY):	<10
Clast Size (ft):	4+
Source Elevation (ft):	100-500
Centerline Slope:	open_soil_slope
Alignment Location:	below_deposition _zone
Impact Alignment:	yes
Alignment Exposure (ft):	50-200
Vegetation:	-
Deciduous Trees:	no
2012 SEIS Alignment South Margin:	2562+20
2012 SEIS Alignment North Margin:	2562+80
Photo #:	5362, 5363

HR05. View east/upslope at hazard rock location.

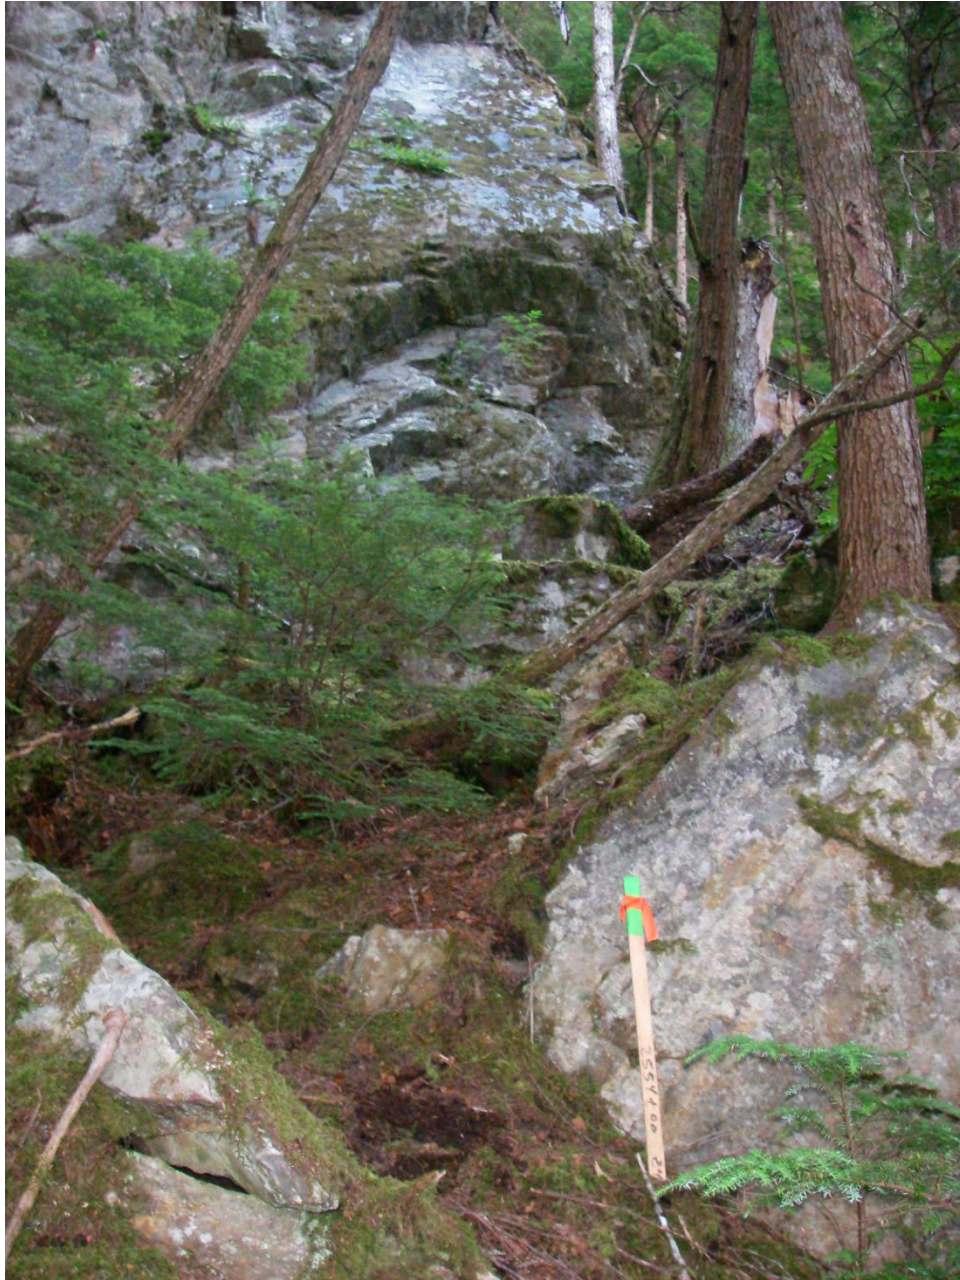
HR05. View east/upslope at hazard rock. Survey lath represents previous IRP 2006 alignment.

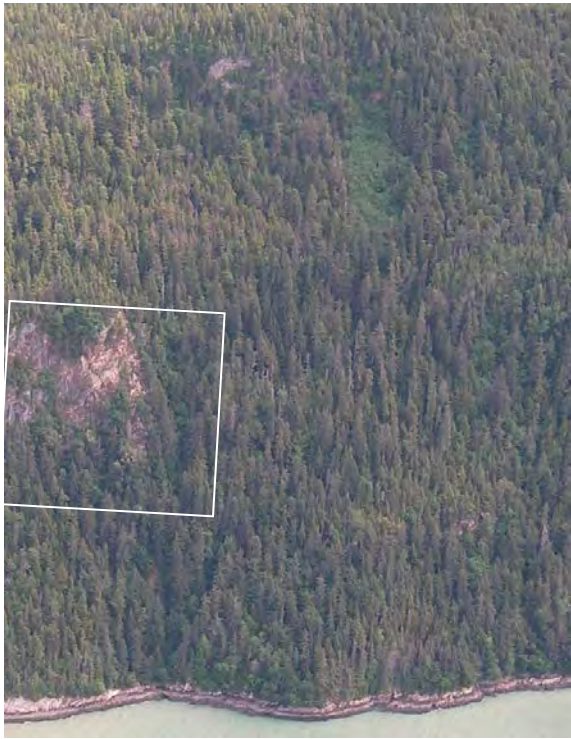
RF49. View east/upslope at rockfall hazard below cliffs.

Hazard ID #:	RF49
Hazard Type:	rockfall
HIN:	201
Rating:	C
2012 SEIS Alignment Location:	2566
Frequency (yrs):	1-5
Predictability:	unpredictable
Material Volume (CY):	<10
Clast Size (ft):	2-3
Source Elevation (ft):	100-500
Centerline Slope:	open_soil_slope
Alignment Location:	below_deposition_zone
Impact Alignment:	no
Alignment Exposure (ft):	500+
Vegetation:	disturbed
Deciduous Trees:	yes
2012 SEIS Alignment South Margin:	2565+00
2012 SEIS Alignment North Margin:	2571+00
Photo #:	3661, 3662, 3664

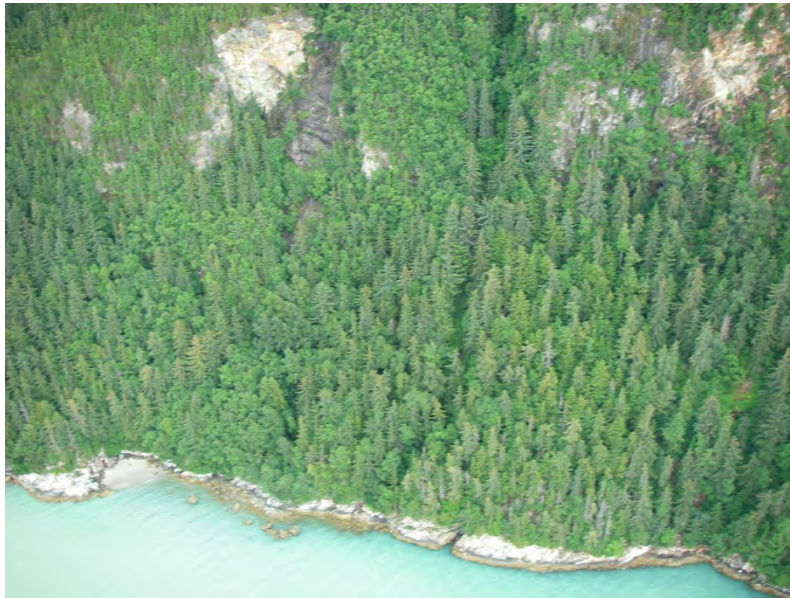
RF49. View east/upslope at the north half of rockfall area.

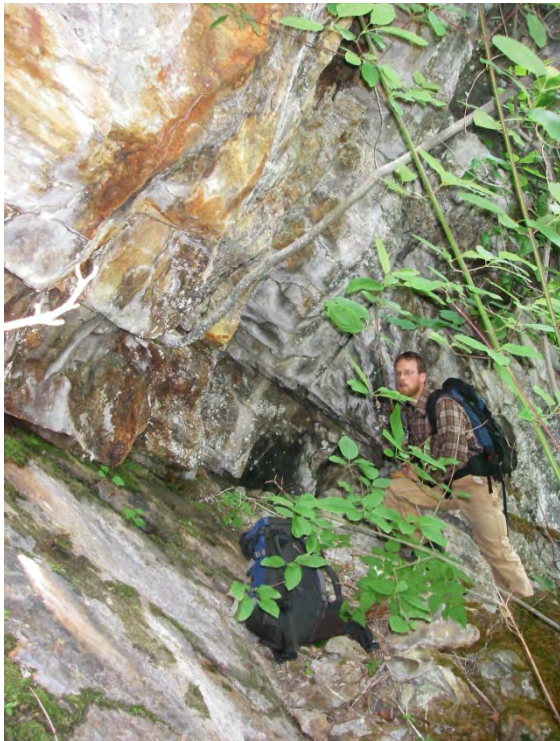
RF49. View south/down alignment across rockfall hazard.

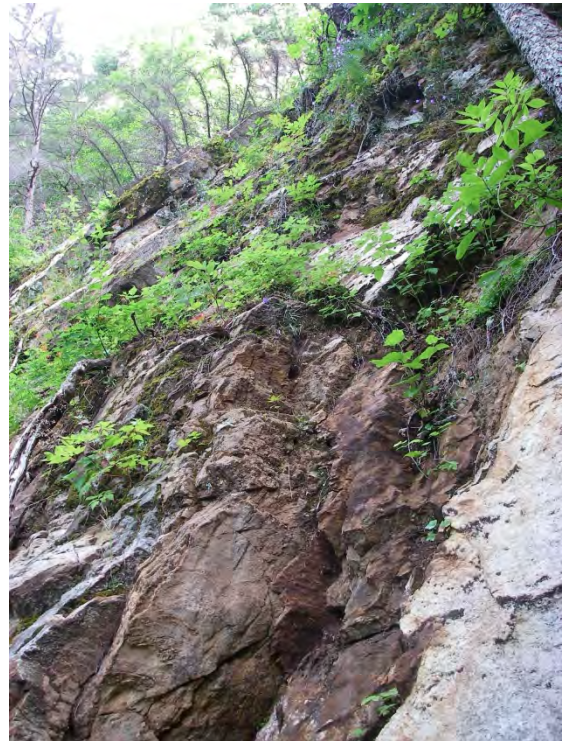
RF49. View north/up alignment across rockfall hazard.

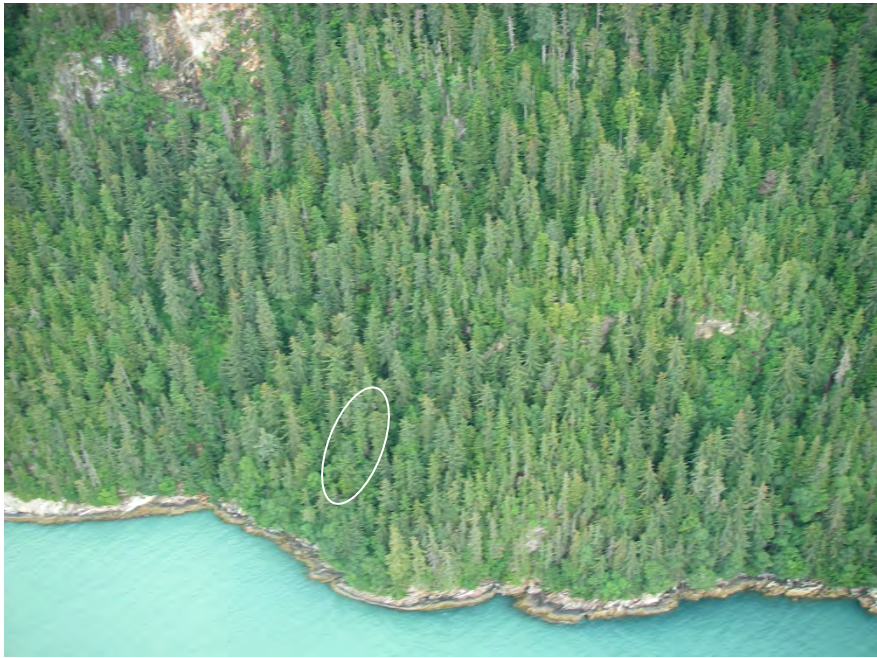
Hazard ID #:	RF50
Hazard Type:	rockfall
HIN:	129
Rating:	B
2012 SEIS Alignment Location:	2567
Frequency (yrs):	1-5
Predictability:	unpredictable
Material Volume (CY):	<10
Clast Size (ft):	2-3
Source Elevation (ft):	100-500
Centerline Slope:	open_soil_slope
Alignment Location:	below_deposition_ zone
Impact Alignment:	no
Alignment Exposure (ft):	50-200
Vegetation:	disturbed
Deciduous Trees:	yes
2012 SEIS Alignment South Margin:	2566+70
2012 SEIS Alignment North Margin:	2567+30
Photo #:	3661, 3662, 3664

RF50. View east/upslope at rockfall area.

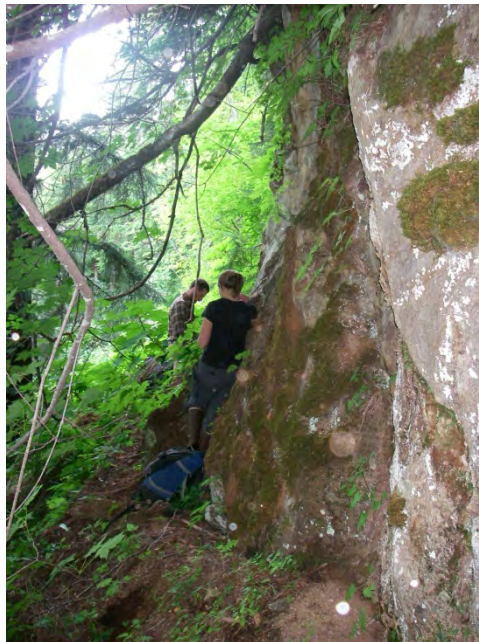
RF50. View north/up alignment at margin of rockfall hazard.

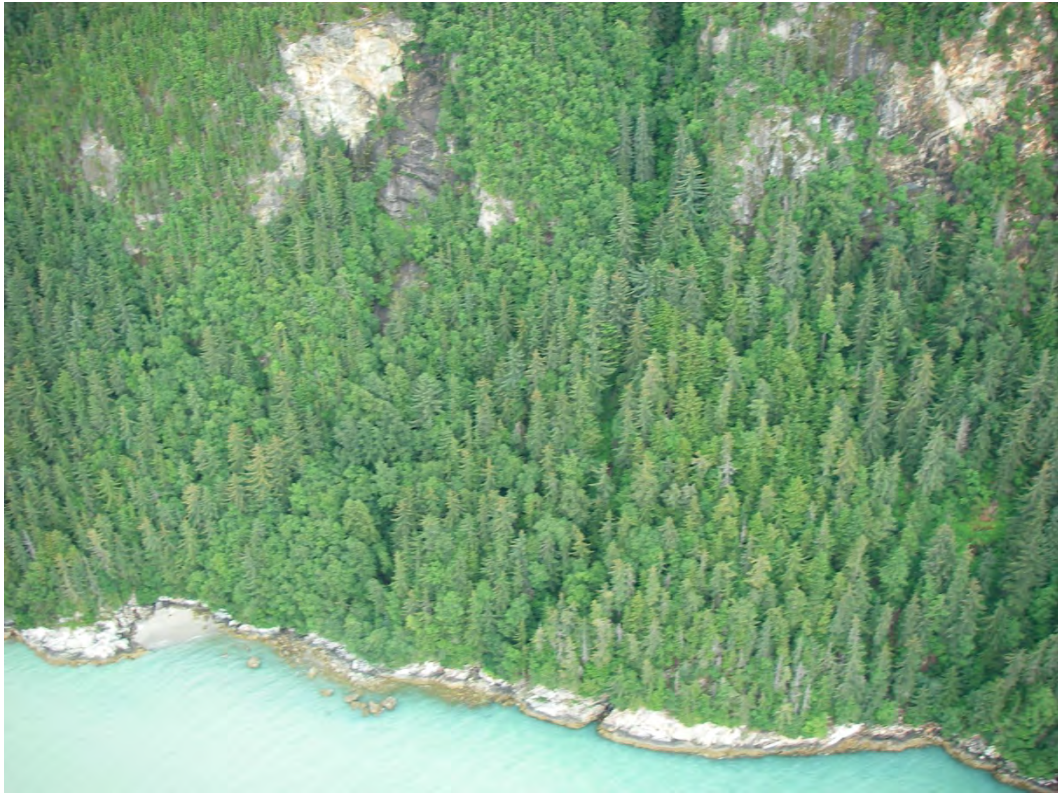
Hazard ID #:	RF51
Hazard Type:	rockfall
HIN:	201
Rating:	B
2012 SEIS Alignment Location:	2568
Frequency (yrs):	1-5
Predictability:	unpredictable
Material Volume (CY):	<10
Clast Size (ft):	2-3
Source Elevation (ft):	>1000
Centerline Slope:	open_soil_slope
Alignment Location:	path
Impact Alignment:	no
Alignment Exposure (ft):	50-200
Vegetation:	disturbed
Deciduous Trees:	yes
2012 SEIS Alignment South Margin:	2568+00
2012 SEIS Alignment North Margin:	2569+20
Photo #:	3661, 3662, 3664

RF51. View east/upslope at rockfall hazard.

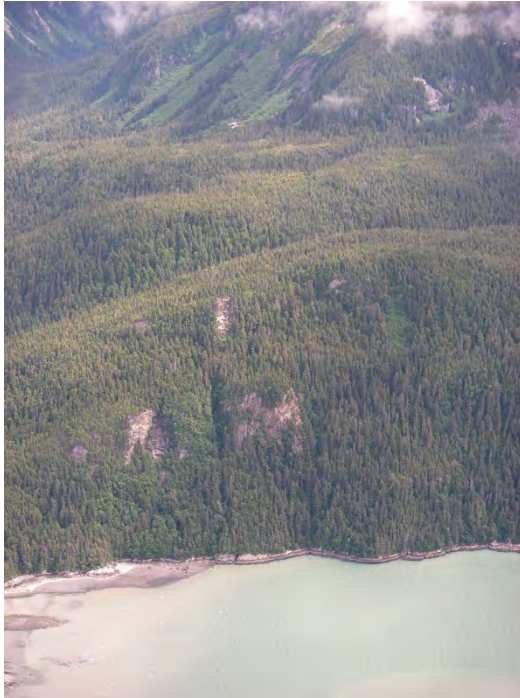
LS07. View east/upslope at landslide.

Hazard ID #:	LS07
Hazard Type:	landslide
HIN:	183
Rating:	C
2012 SEIS Alignment Location:	2571
Frequency (yrs):	unknown (>25?)
Predictability:	unpredictable
Material Volume (CY):	10-100
Clast Size (ft):	-
Source Elevation (ft):	>1000
Centerline Slope:	open_soil_slope
Alignment Location:	below_deposition_zone
Impact Alignment:	no
Alignment Exposure (ft):	50-200
Vegetation:	disturbed
Deciduous Trees:	no
2012 SEIS Alignment South Margin:	2571+00
2012 SEIS Alignment North Margin:	2572+00
Photo #:	5024

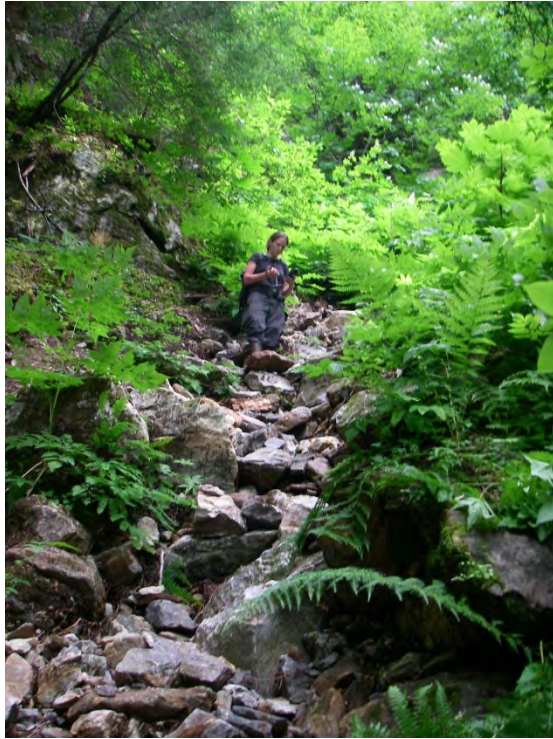
DF43. View north/upslope at debris flow channel.

Hazard ID #:	DF43
Hazard Type:	debris_flow
HIN:	117
Rating:	A
2012 SEIS Alignment Location:	2573
Frequency (yrs):	5-25
Predictability:	moderate
Material Volume (CY):	10-100
Clast Size (ft):	1-2
Source Elevation (ft):	>1000
Centerline Slope:	single_channel
Alignment Location:	below_deposition_zone
Impact Alignment:	no
Alignment Exposure (ft):	50-200
Vegetation:	denuded
Deciduous Trees:	yes
2012 SEIS Alignment South Margin:	2572+50
2012 SEIS Alignment North Margin:	2573+50
Photo #:	5356

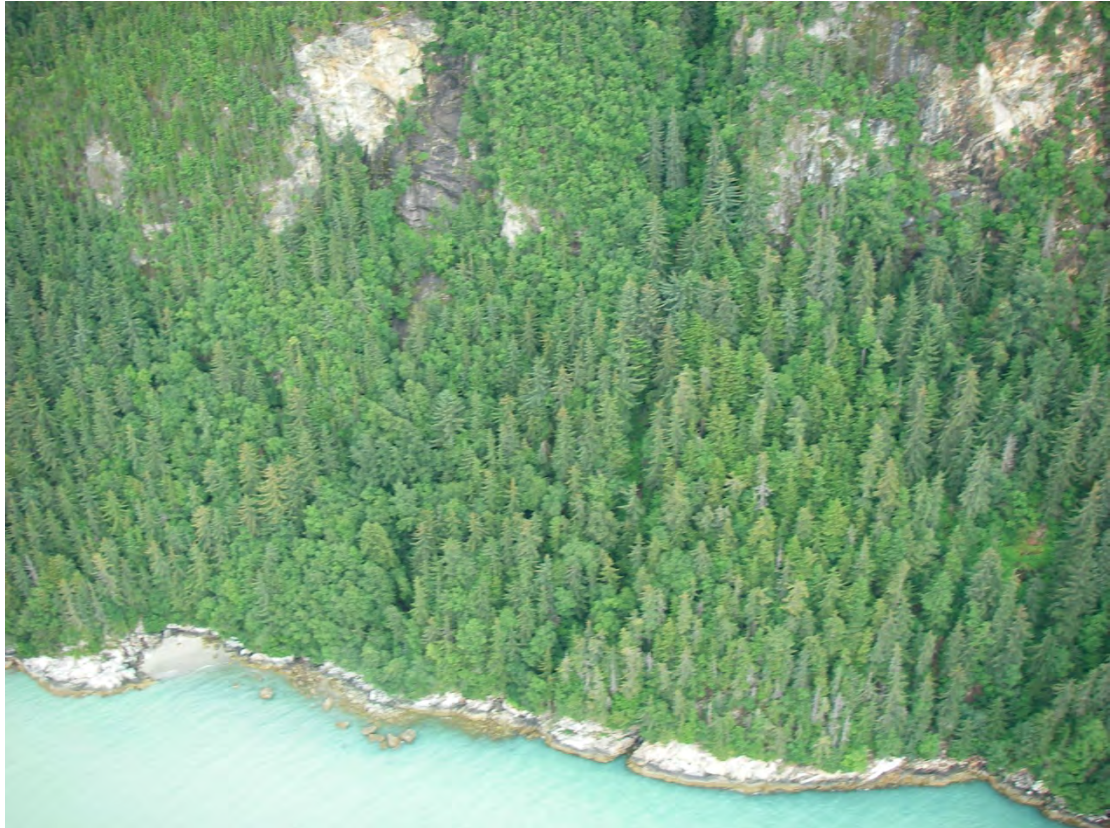
Hazard ID #:	RF52
Hazard Type:	rockfall
HIN:	123
Rating:	B
2012 SEIS Alignment Location:	2574
Frequency (yrs):	1-5
Predictability:	high
Material Volume (CY):	<10
Clast Size (ft):	4+
Source Elevation (ft):	100-500
Centerline Slope:	open_soil_slope
Alignment Location:	path
Impact Alignment:	yes
Alignment Exposure (ft):	500+
Vegetation:	disturbed
Deciduous Trees:	yes
2012 SEIS Alignment South Margin:	2573+80
2012 SEIS Alignment North Margin:	2578+80
Photo #:	6105, 6106

RF52. View east/upslope at rockfall hazard.
