CADD	ECC	<b>TITLE</b> <b>GEOLOGIC HAZARD SUMMARY</b> <b>ARRANGED BY 2012 SEIS STATIONING</b> <b>LYNN CANAL HIGHWAY PHASE 2</b> <b>2012 SEIS ALIGNMENT HAZARD REVISIONS</b>		
	DATE	9/10/12			
	CHECK	RGD			
FILE No.	GEO_HAZ_SUMM.PPT	DATE	9/24/12	<b>HDR / 2012 SEIS JUNEAU ACCESS / AK</b>	<b>G-133</b>
PROJECT No.	113-95756	REV	1

TITLE  
**GEOLOGIC HAZARD SUMMARY**  
**ARRANGED BY 2012 SEIS STATIONING**  
**LYNN CANAL HIGHWAY PHASE 2**  
**2012 SEIS ALIGNMENT HAZARD REVISIONS**

HDR / 2012 SEIS JUNEAU ACCESS / AK

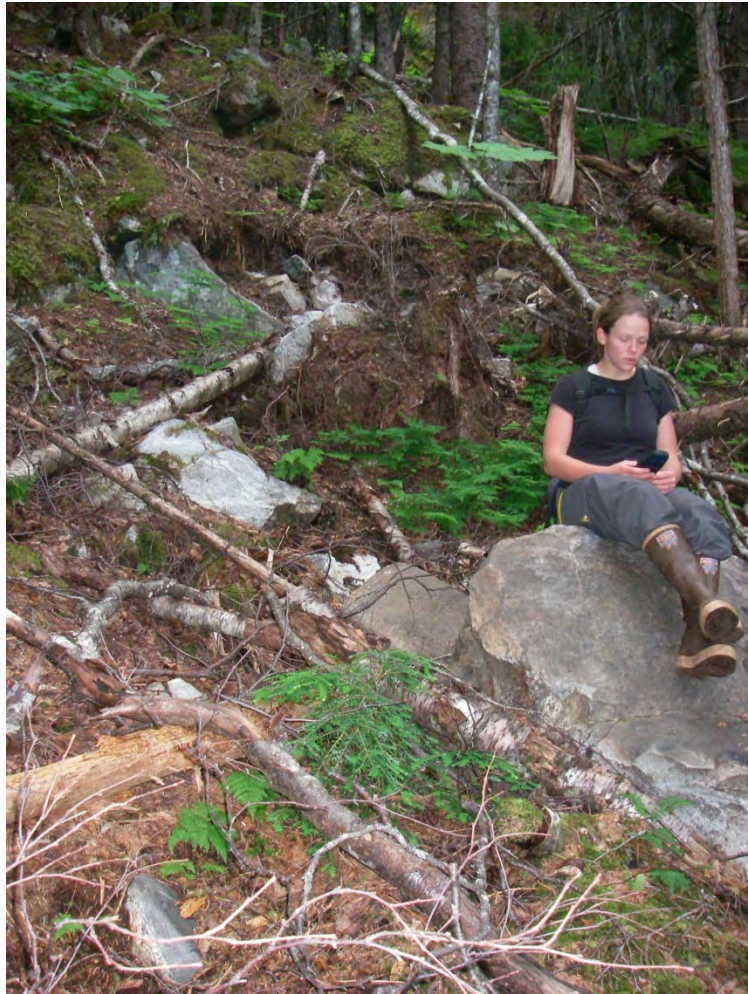
Hazard ID #:	RF52
Hazard Type:	rockfall
HIN:	123
Rating:	B
2012 SEIS Alignment Location:	2574
Frequency (yrs):	1-5
Predictability:	high
Material Volume (CY):	<10
Clast Size (ft):	4+
Source Elevation (ft):	100-500
Centerline Slope:	open_soil_slope
Alignment Location:	path
Impact Alignment:	yes
Alignment Exposure (ft):	500+
Vegetation:	disturbed
Deciduous Trees:	yes
2012 SEIS Alignment South Margin:	2573+80
2012 SEIS Alignment North Margin:	2578+80
Photo #:	6105, 6106

RF52. View south/down alignment at recent rockfall.

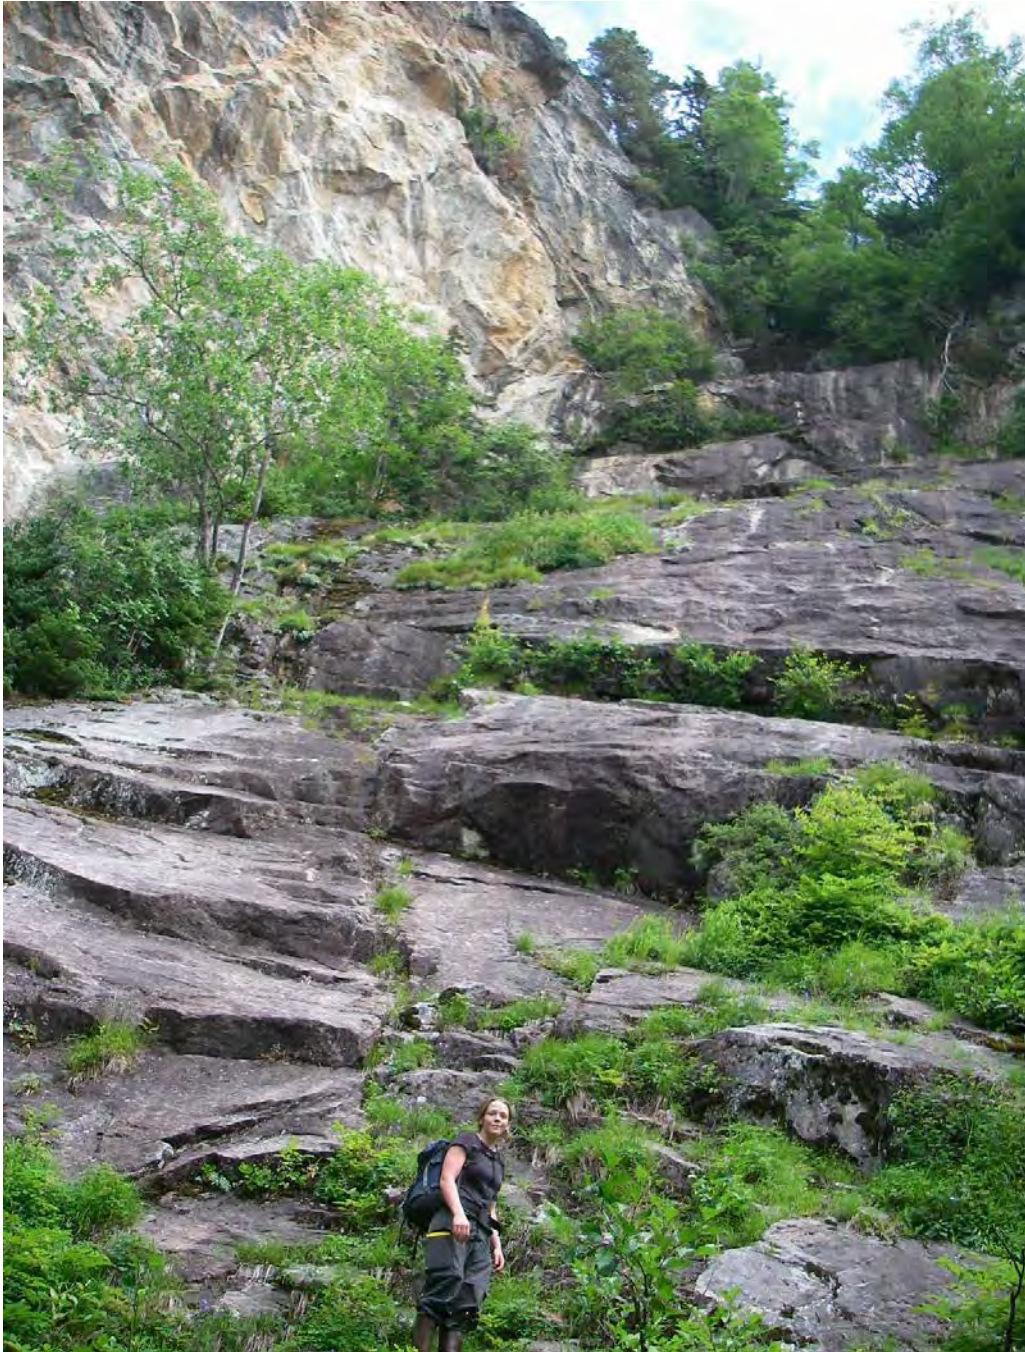
RF52. View east/upslope at source for rockfall hazard. Slope-parallel joints promote planar failure.

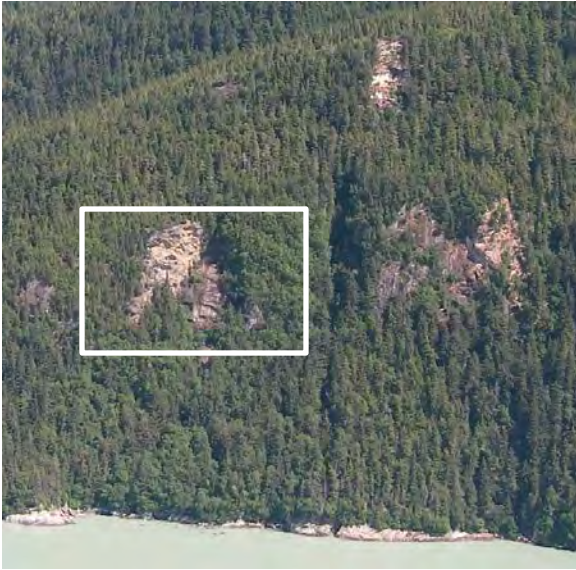
RF53. View east/upslope at rockfall hazard outlined in photo. Hazard characteristics based on RF49 characteristics.

Hazard ID #:	RF53
Hazard Type:	rockfall
HIN:	147
Rating:	C
2012 SEIS Alignment Location:	2575
Frequency (yrs):	1-5
Predictability:	unpredictable
Material Volume (CY):	<10
Clast Size (ft):	2-3
Source Elevation (ft):	100-500
Centerline Slope:	open_soil_slope
Alignment Location:	below_deposition_zone
Impact Alignment:	-
Alignment Exposure (ft):	200-500
Vegetation:	disturbed
Deciduous Trees:	-
2012 SEIS Alignment South Margin:	2572+90
2012 SEIS Alignment North Margin:	2577+00
Photo #:	-

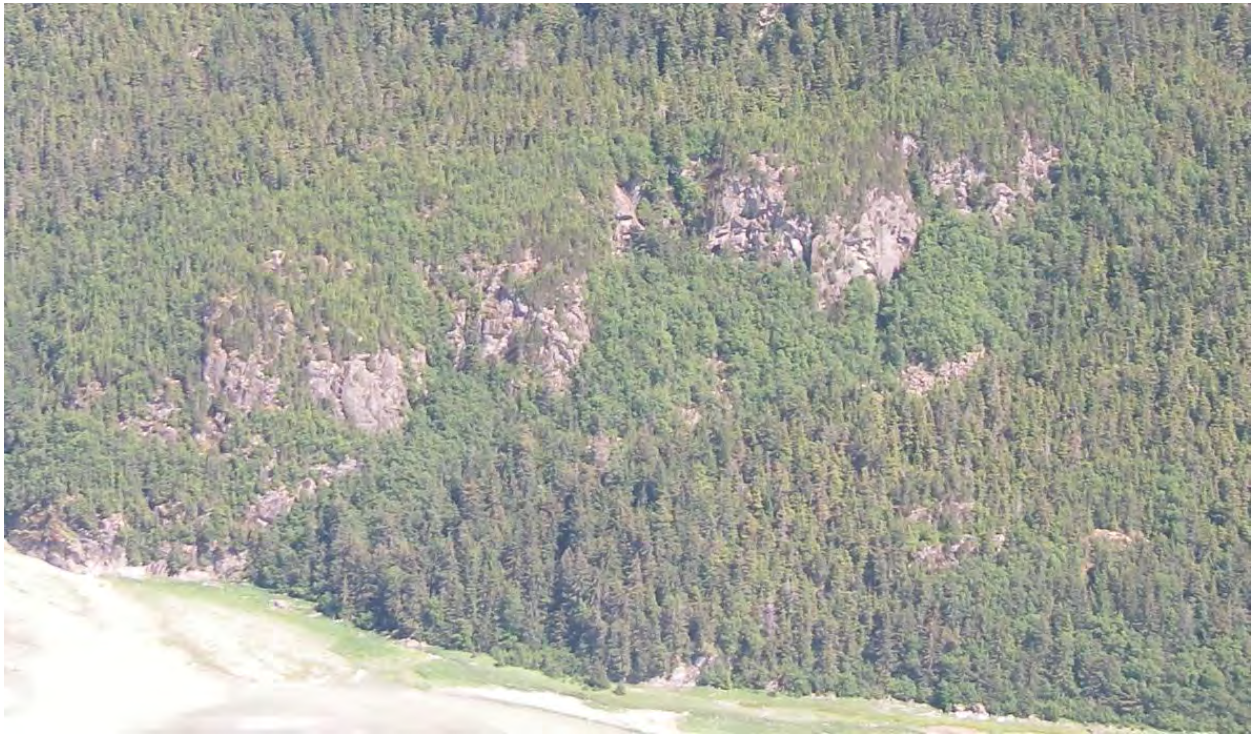
Hazard ID #:	RF54
Hazard Type:	rockfall
HIN:	147
Rating:	A
2012 SEIS Alignment Location:	2629
Frequency (yrs):	25+
Predictability:	unpredictable
Material Volume (CY):	100-1000
Clast Size (ft):	4+
Source Elevation (ft):	100-500
Centerline Slope:	fan
Alignment Location:	deposition_zone
Impact Alignment:	yes
Alignment Exposure (ft):	200-500
Vegetation:	disturbed
Deciduous Trees:	yes
2012 SEIS Alignment South Margin:	2627+40
2012 SEIS Alignment North Margin:	2631+00
Photo #:	3683, 3684

RF54. View east/upslope at rockfall hazard.
