**Community Erosion Assessment
Kwigillingok, Alaska
27 January 2009**

1. Community: Kwigillingok, Alaska

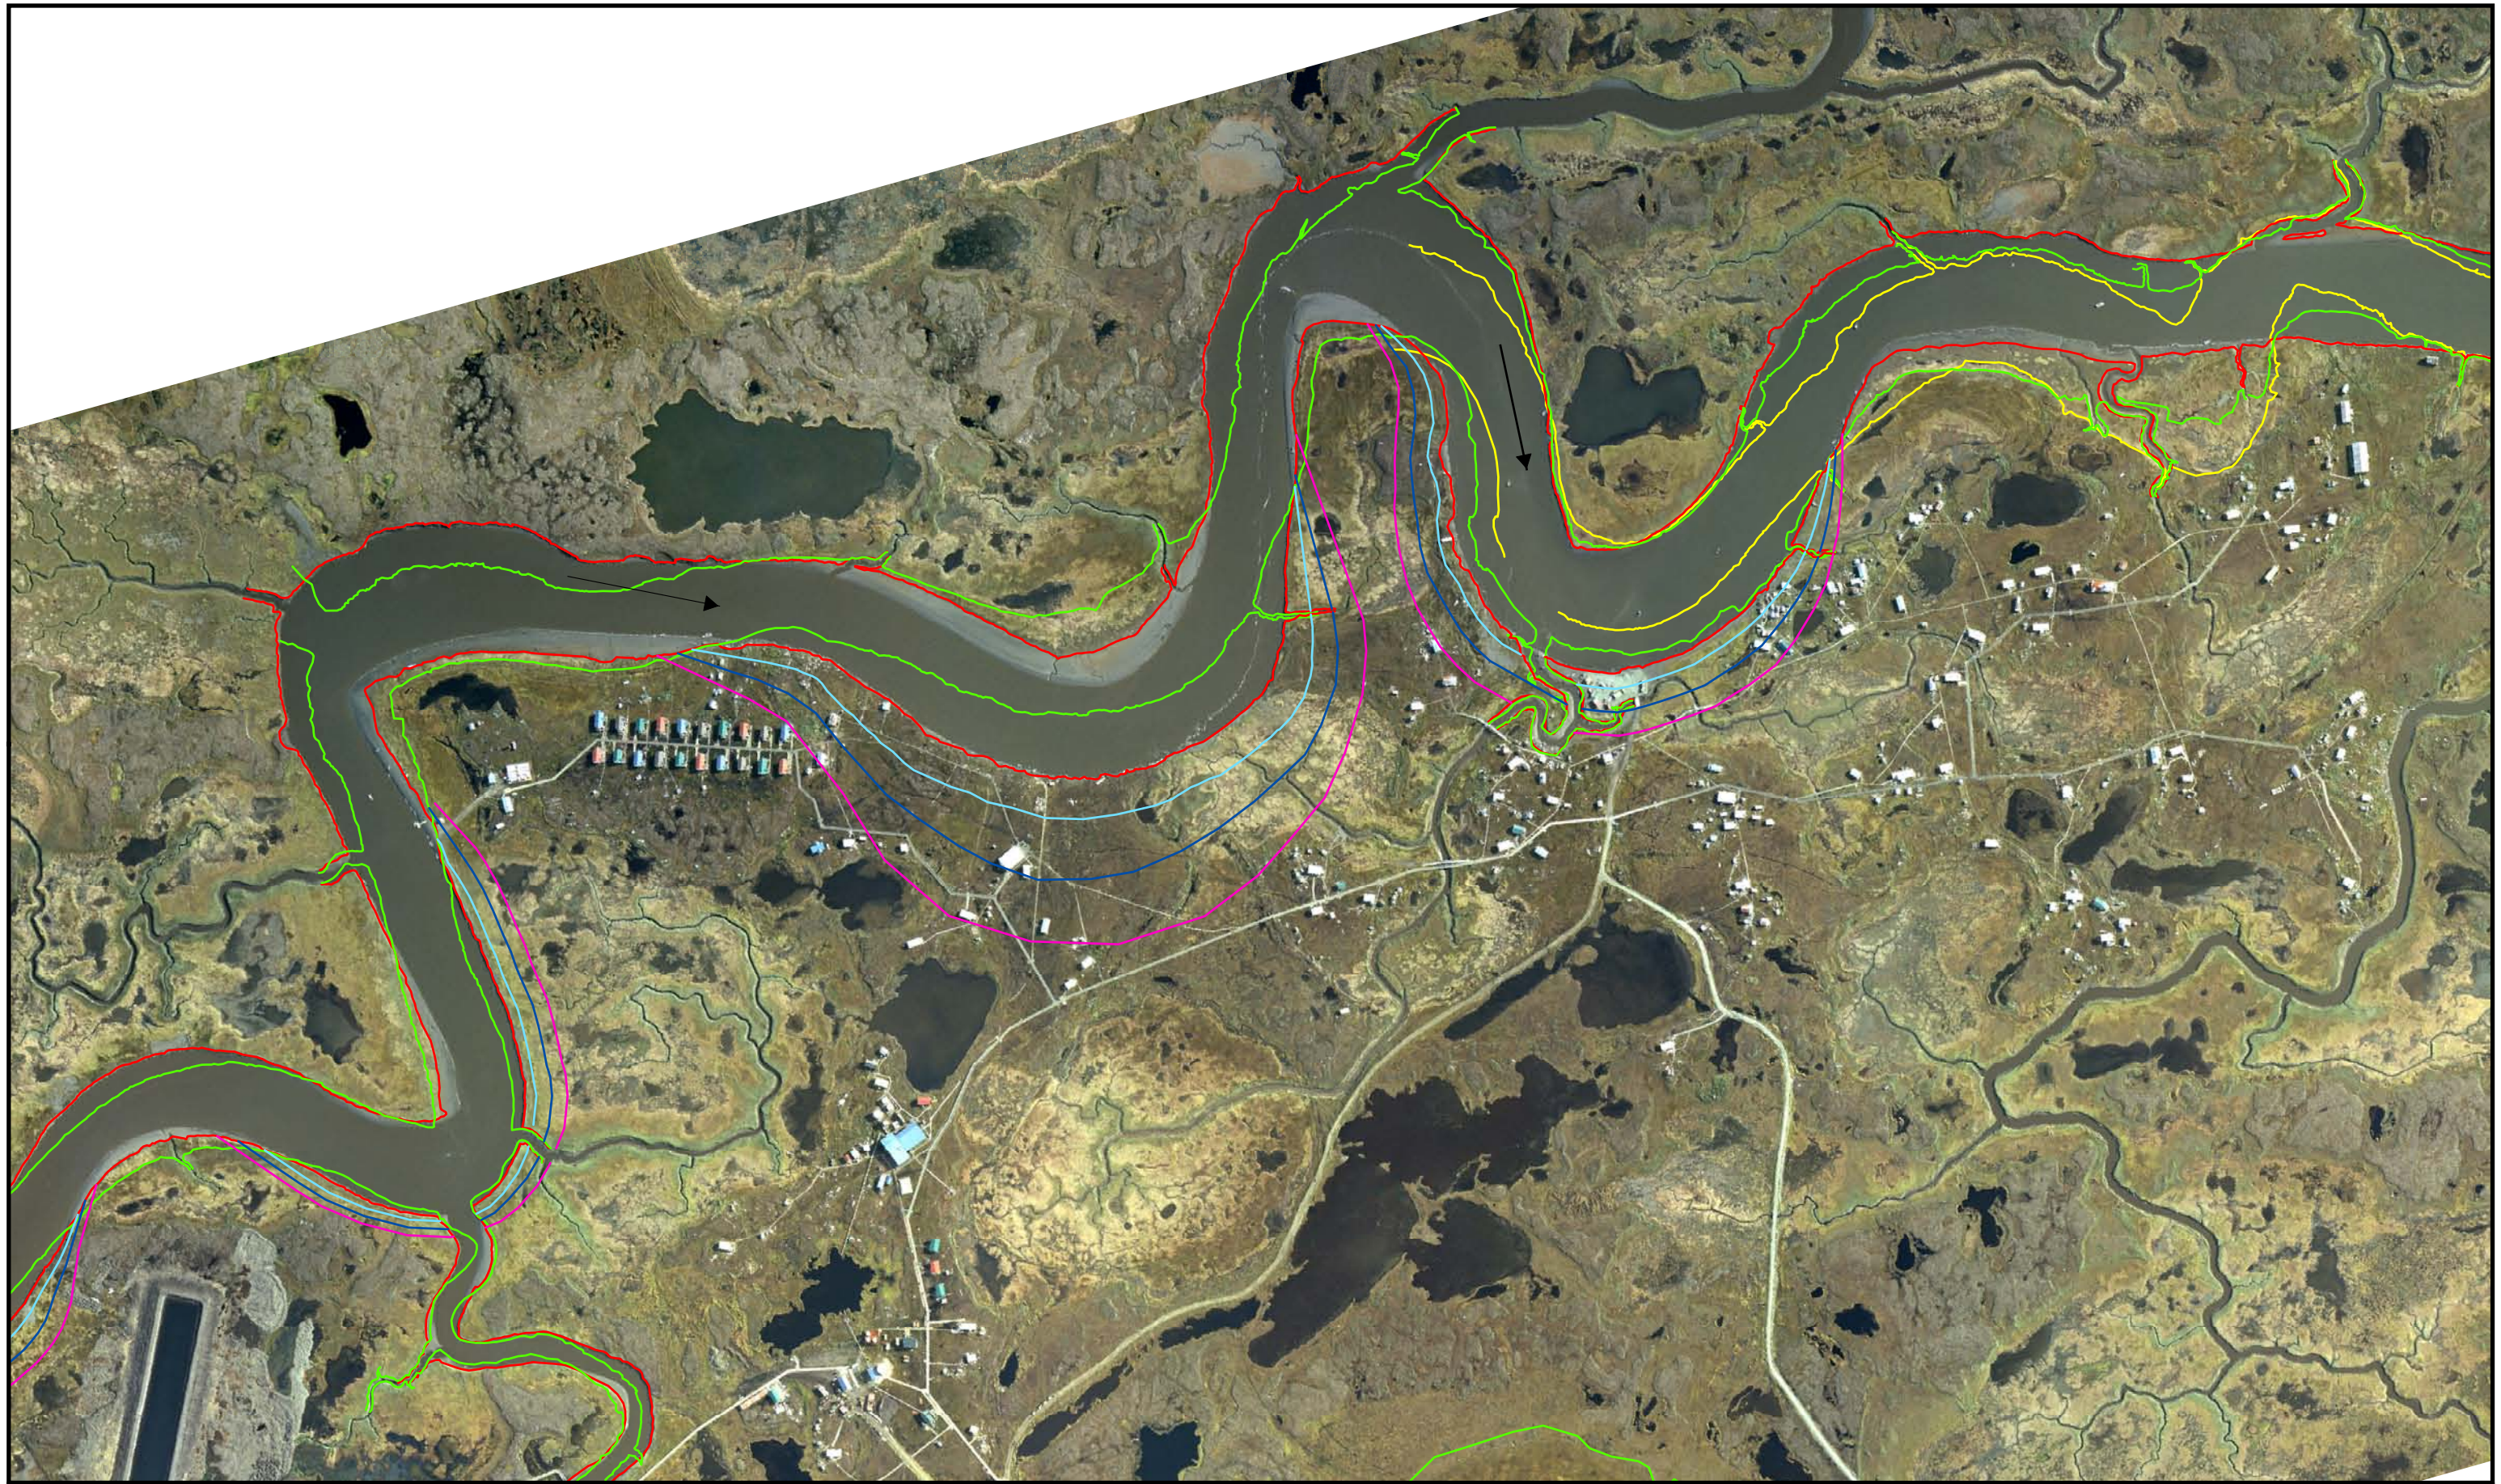
For this study the area was divided into four reaches. Reach 1 is a 3,150-foot portion of riverbank that fronts the community and is eroding at a rate of 4.0 feet per year. Reach 2 is a 3,500-foot portion of riverbank directly upstream (and north) of Reach 1 and is eroding at a rate of 7.7 feet per year. Reach 3 is a 2,750-foot portion of riverbank upstream of Reach 2 and is eroding at a rate of 2.0 feet per year. Reach 4 is a 1,000-foot portion of riverbank upstream of Reach 3 and is eroding at a rate of 3.0 feet per year. There is an area near the store that is eroding at a rate of 13 feet per year.
