**APPENDIX HW**  
**Hazardous Waste**

**USACE Haines-Fairbanks Pipeline No Department of Defense Action  
Indicated (NDAI) Final Determination (2014)**

Hazardous, Toxic, or Radioactive Waste  
Project # F10AK1016-01  
Haines-Fairbanks Pipeline  
Various Locations, Alaska

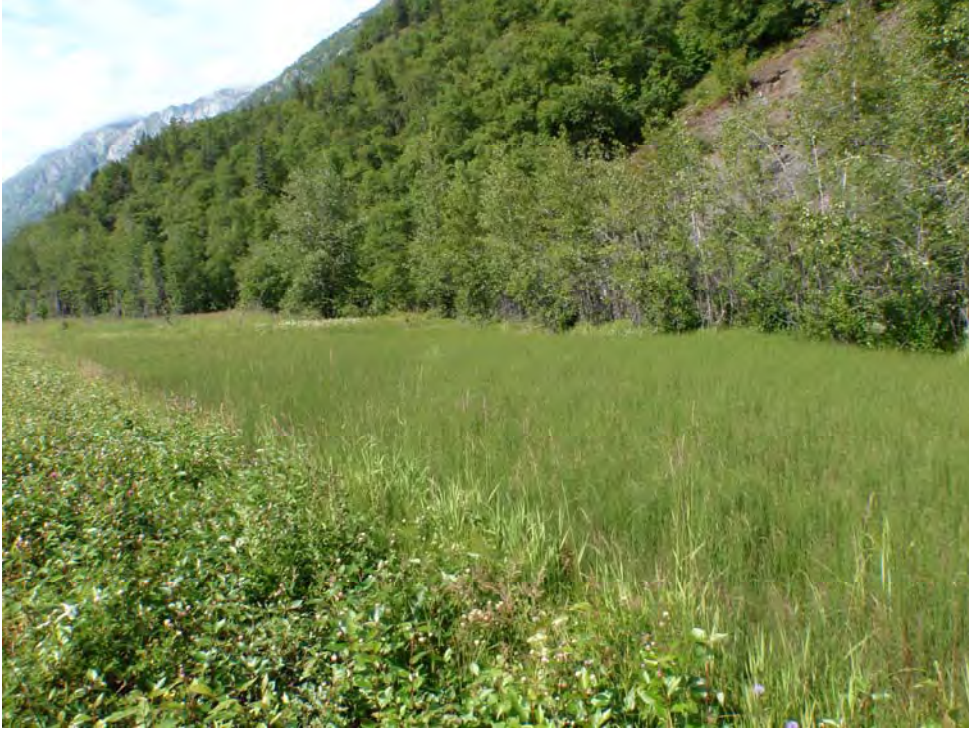
**PMP 17.7 – Wetland on East Side of Highway  
(Photo taken from Haines Highway Looking North)**

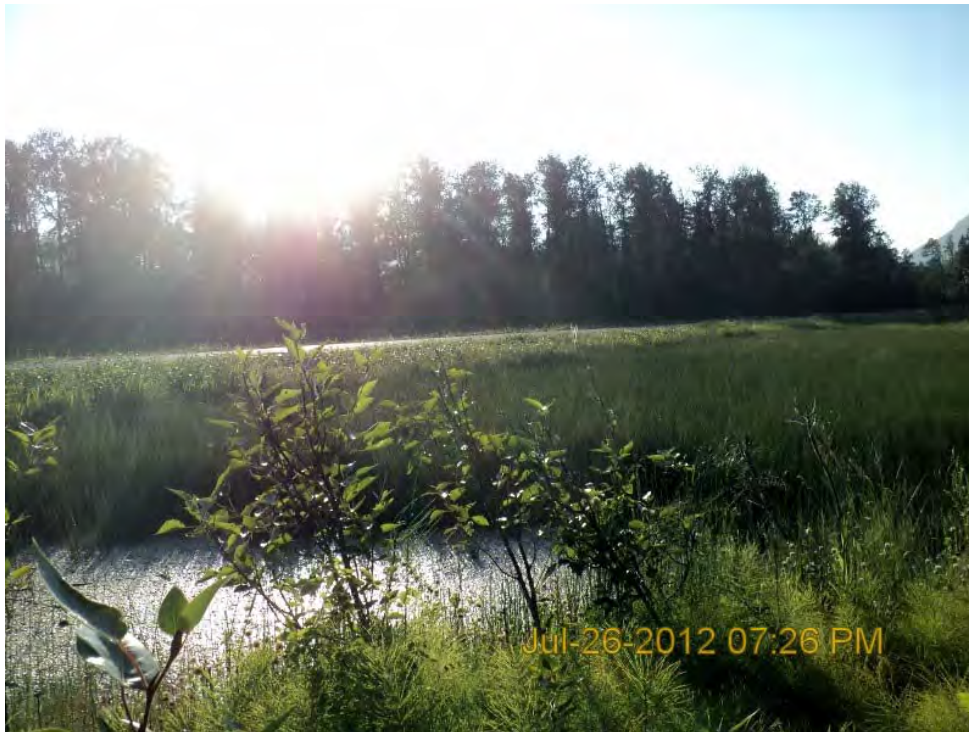
**PMP 17.7 – Wetland on East Side of Highway  
(Photo taken from Pipeline Trench Mound - Looking Northwest)**

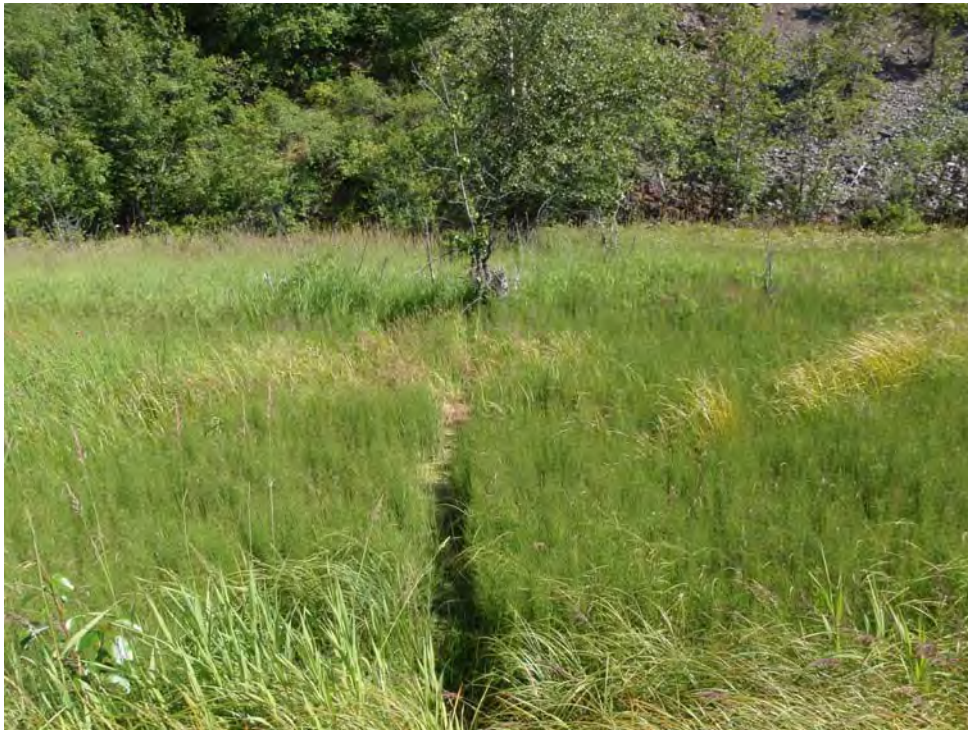
**PMP 17.7 – Wetland on East Side of Highway in Vicinity of Burn Box  
(Photo taken from Haines Highway - Looking Northeast)**

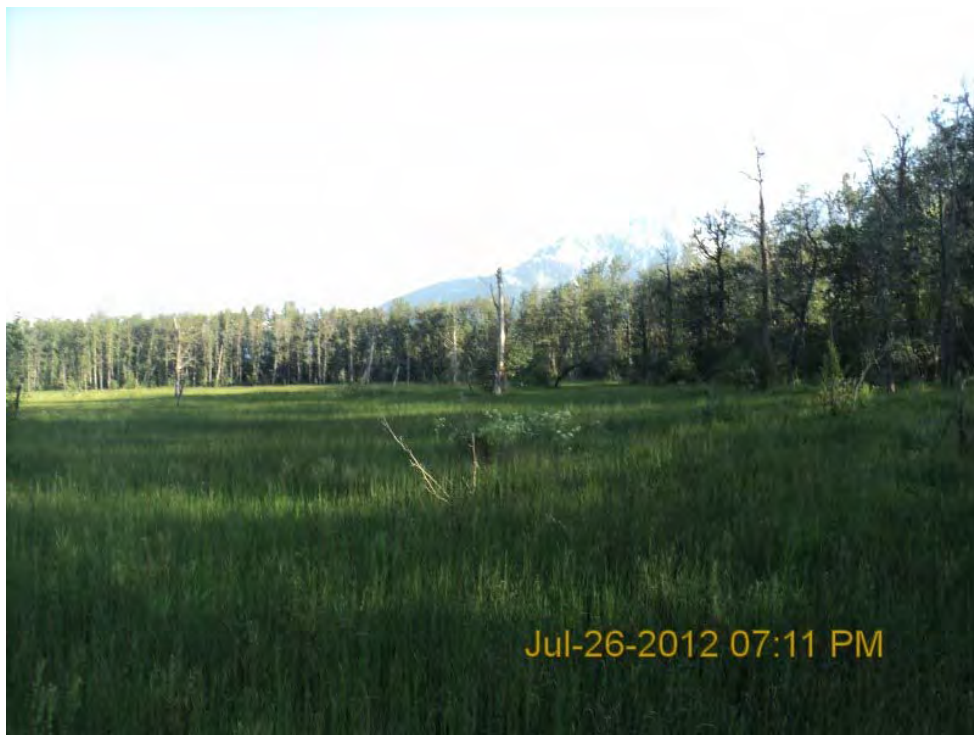
**PMP 17.7 – Wetland on West Side of Haines Highway  
(Photo Taken from Haines Highway – Looking Southwest)**

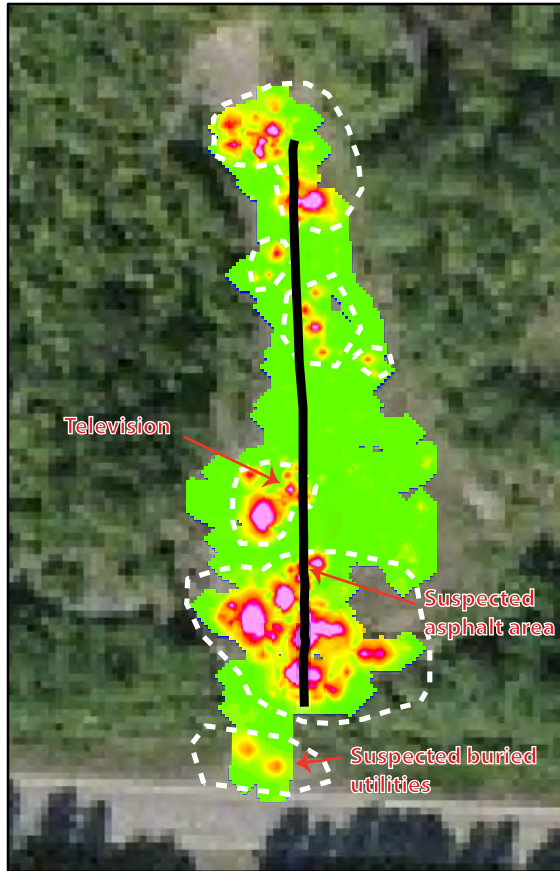
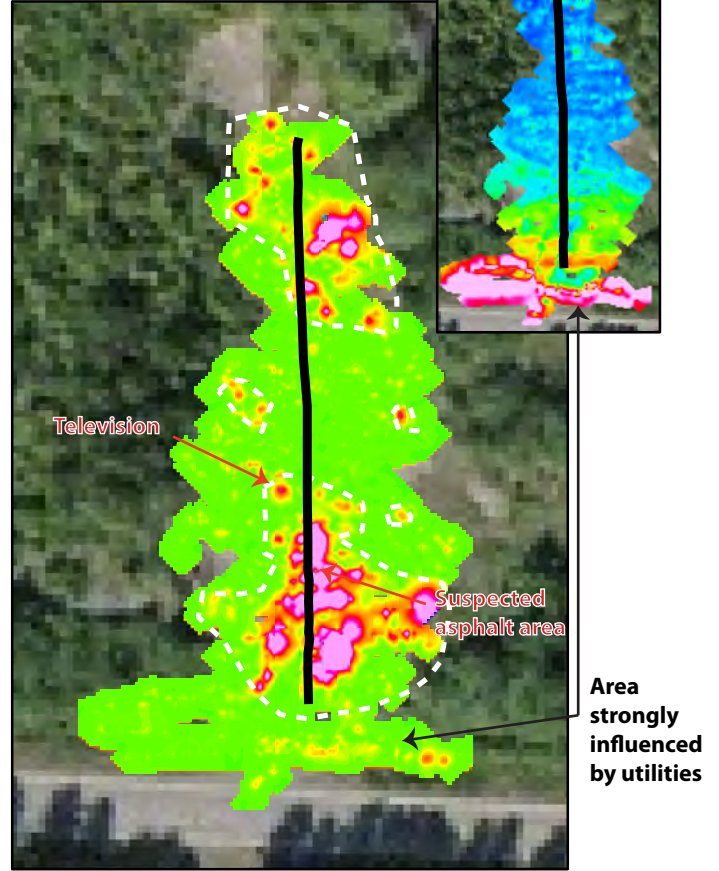
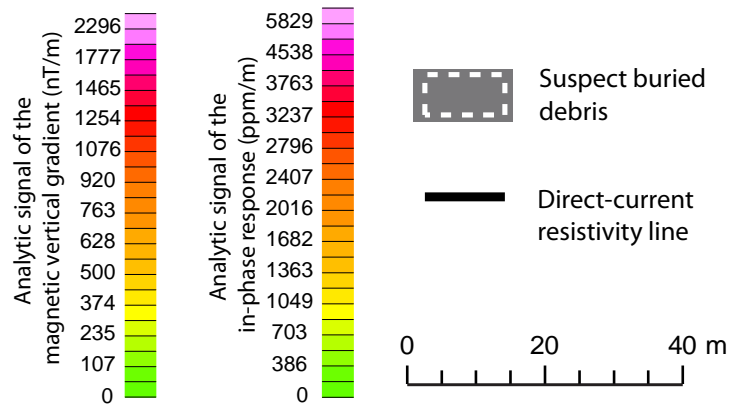
The EM and magnetic data show fairly consistent anomaly regions (fig. 1). The southernmost anomaly area identified in the magnetic data (fig. 1a) is likely the result of buried utilities running along the highway, as indicated by the strong response in the 60-Hz powerline monitoring frequency of the EM data (pink and red areas in the inset of fig. 1b). These utilities also have a strong influence on the nearby EM data; consequently, the EM data south of the DC line may not reliably detect conductive metals here. The most prominent anomaly region is present along the southern portion of the DC line and extends both east and west across the accessible areas. The anomalies extend into the heavy shrubs, where old concrete pilings and other surface debris were also noted at the surface. Few major anomalies were identified with EM or magnetic methods in the central part of the dump area (fig. 1), likely indicating a general absence of large buried metallic debris; this area was also noted to be particularly sparse of vegetative ground cover (fig. 3). A couple of small, individual anomalies were seen in the EM data (fig. 1b) that are mostly beyond the region surveyed with magnetics. These are isolated, relatively low amplitude signals, but are still distinctive from the background signals and have therefore been highlighted in fig. 1. DC resistivity data show a shallow, strongly resistive layer that partly coincides with this low-anomaly region and is also well correlated with the sparse ground cover (red area in fig. 2c). The northern anomaly region contains more dispersed anomalies, particularly focused in the eastern side of the survey area. GPS-reception was not as strong in this northern part of the site, likely the result of the limited open sky created by the close tree canopy and the steep topography. The northern anomalies are therefore not as precisely positioned as those mapped in the southern half of the survey area. However, both EM and mag results clearly indicate the presence of significant anomalies in this northern area. These anomalies coincide with the northern portion of the high-resistivity area in the DC resistivity results (red area in fig. 2c).

**Figure 1.** Results from surface geophysical surveys at the Haines 7-Mile Dump near Haines, Alaska. Maps show anomalies identified in the (a) magnetic vertical gradient and (b) electromagnetic in-phase response at 23 kHz with associated powerline monitoring data. Areas suspected to contain buried debris (white dashed lines) are summarized in (c).

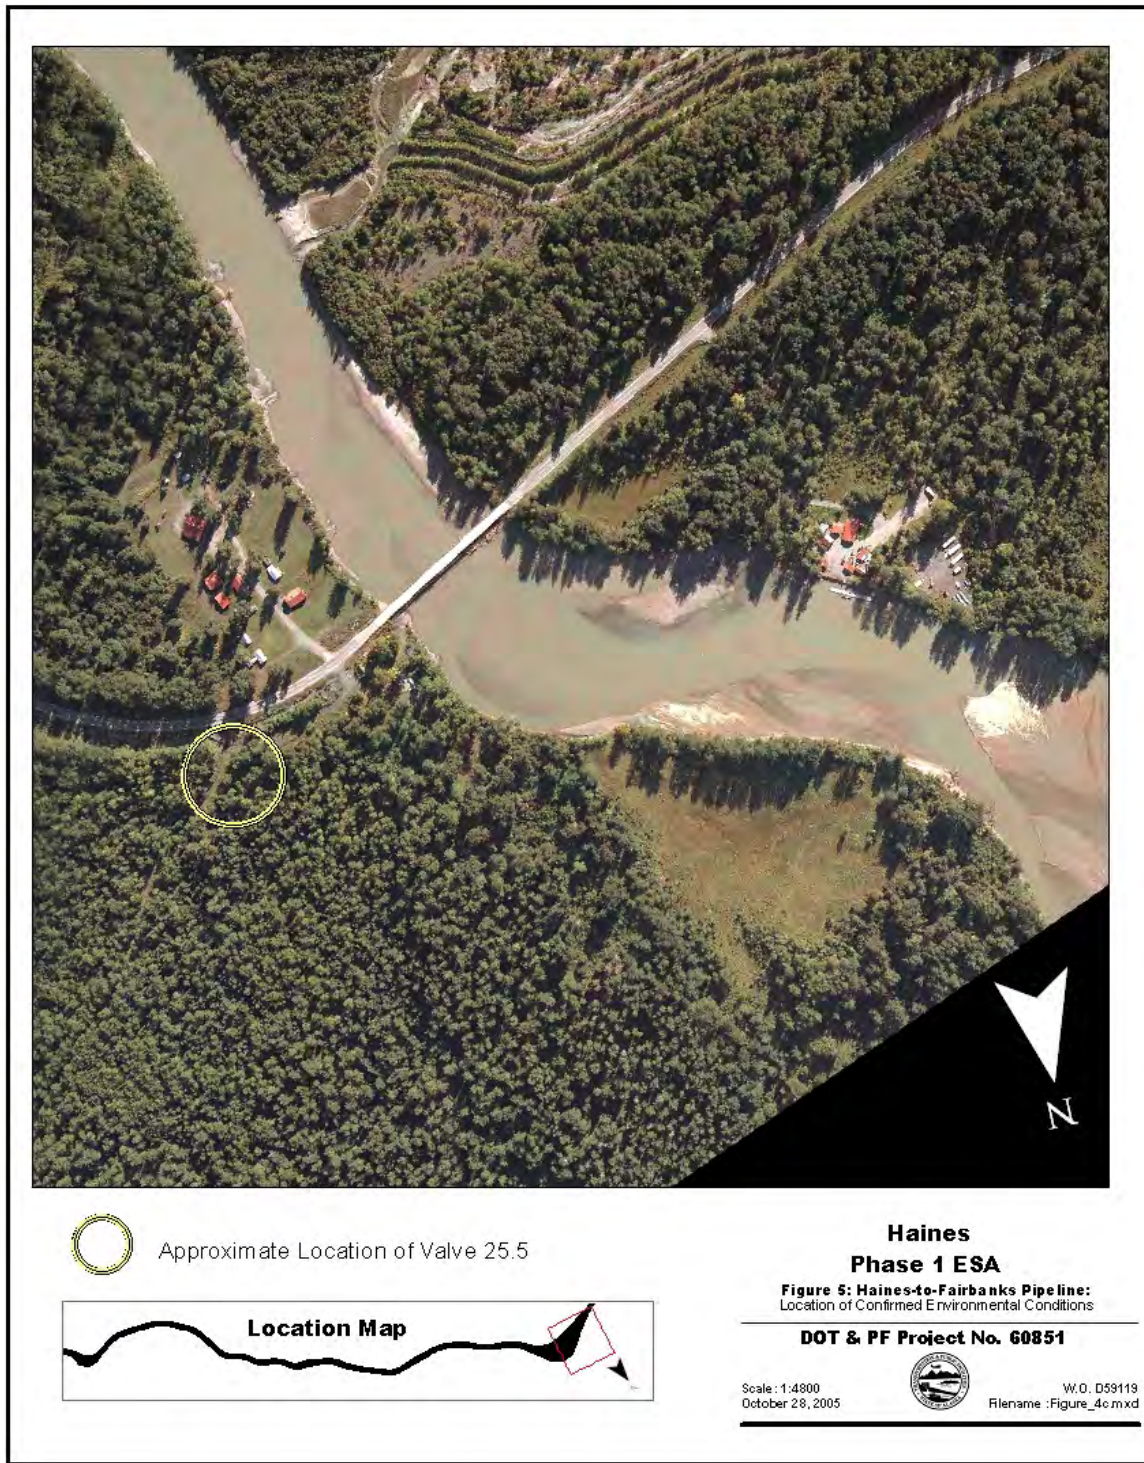
Several locations along the highway where the Haines-to-Fairbanks pipeline ran are currently being investigated for the presence of hydrocarbons. The investigation is being operated under the FUDS Program and ADEC will provide oversight. The USACE administers the investigation and performed hydrocarbon sampling in November 2005, which will resume in May or June of 2006 (see Table 2). The November sampling included two locations within the vicinity of the study area, referred to as Release 19.5 and Valve 25.5. During the investigation, hydrocarbon contamination was found at Valve 25.5, near the Wells Bridge (see Figure 5). The second site is located around MP 17.5 and hydrocarbon product was detected, but not at ADEC action levels.

**Figure 5: Haines-to-Fairbanks Pipeline: Location of Confirmed Environmental Conditions**

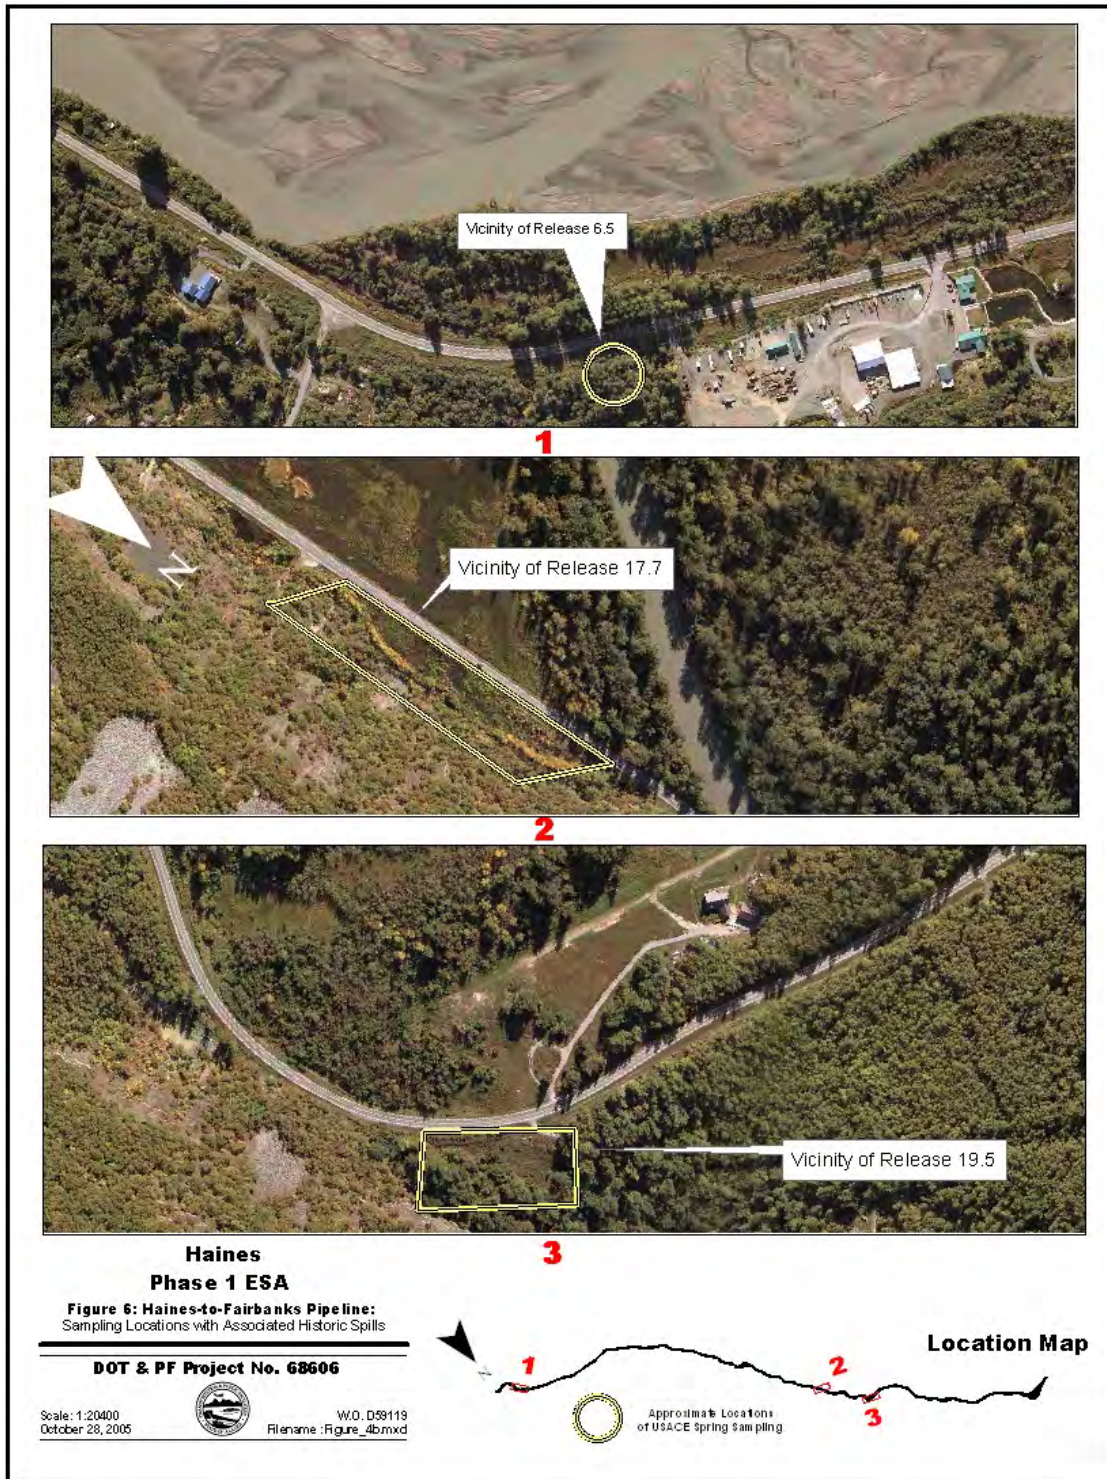
In spring 2006, the USACE will sample two additional locations, Release 6.5 and Release 17.7, that have associated historic spills (see Figure 6). The USACE will also revisit Release 19.5 to determine if additional product is present, as this site also has a historic spill associated with it.

**Figure 6: Haines-to-Fairbanks Pipeline: Sampling Locations with Associated Historic Spills**

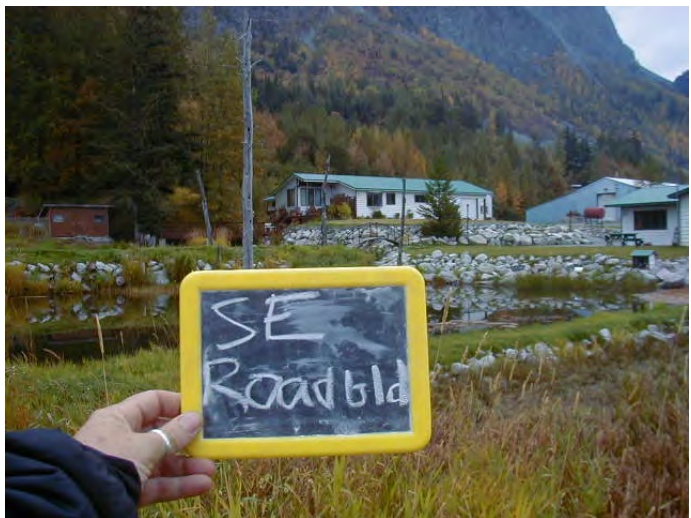
<p><b>Photograph No. 6</b></p> <p>Location: N/A</p> <p>Direction: Facing east</p> <p>Comments: Photo of pond on property</p>

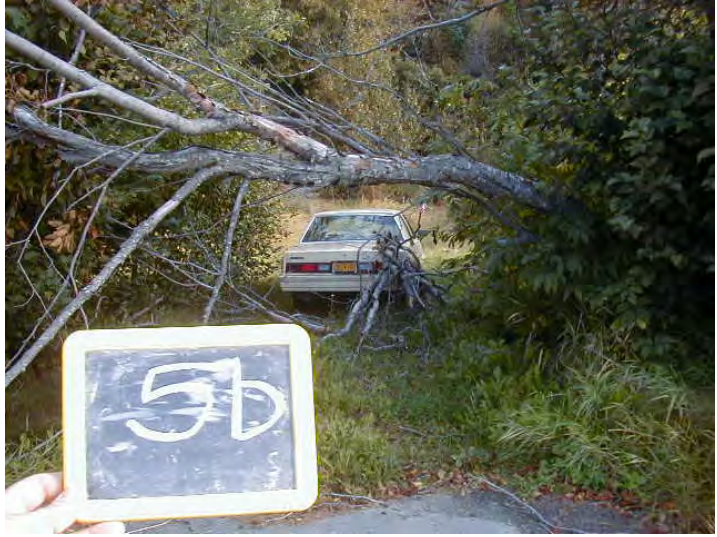
<p><b>Photograph No. 22</b> Location: Site 7 Direction: Facing east Comments:</p>

- Site 6: On the shoulder between the highway and the river is a recently used firepit and old trailer.
- Site 7: A large area that contains a dilapidated old home site was found between the road and the mountains. Associated debris included one drum, a partially collapsed house, car, and shed with one old drum. A smaller building was also observed up the hill.

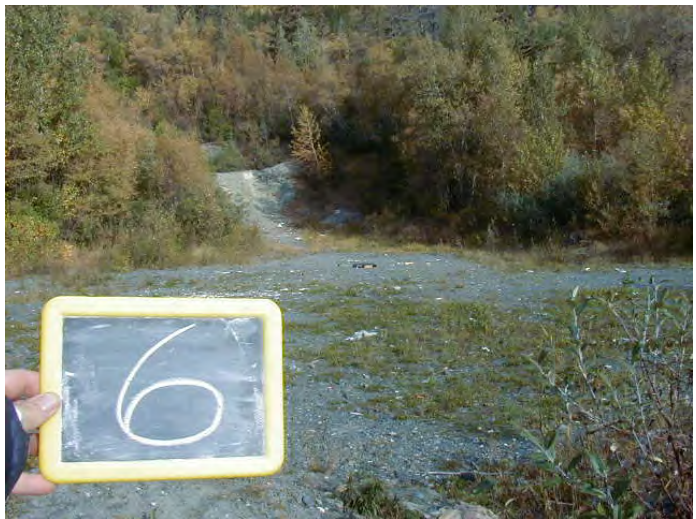
<p><b>Photograph No. 27</b> Location: Site 8 Direction: Facing east Comments:</p>

- Site 8: An illegal shooting range was observed on the mountainside of the highway.
- Site 9: Between the highway and the river is a large parking area with signs of illegal loitering, which included a burn pile approximately 15x10x5 feet large, a used trailer and associated machinery, and a pit that appears to be an old outhouse site.

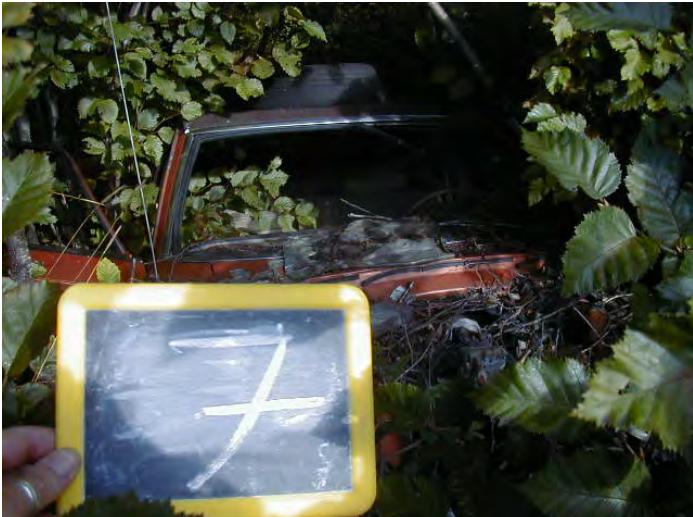
<p><b>Photograph No. 38</b> Location: Site 10 Direction: Facing east Comments:</p>

Site 10: An abandoned car was observed in the heavily wooded area between the highway and the mountains.

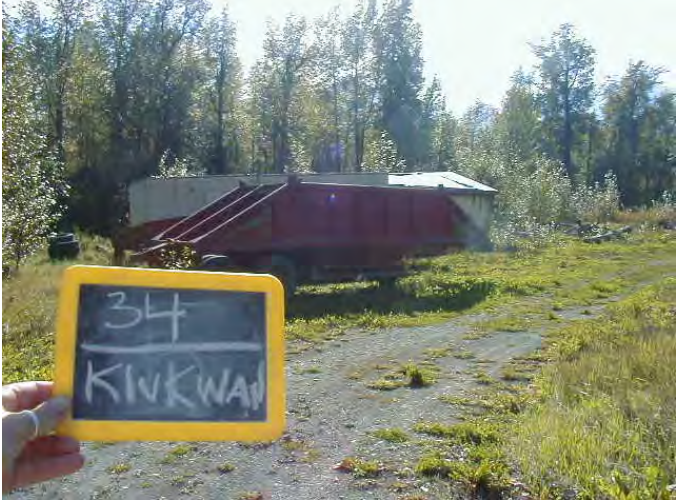
<p><b>Photograph No. 40</b></p> <p>Location: Site 12</p> <p>Direction: Facing west</p> <p>Comments:</p>

Site 12: At the Klukwan turnoff, an area was observed that contained multiple vehicles, oil buckets, and associated debris.
