SEWARD AIRPORT MASTER PLAN

JULY 2008

STATE PROJECT NO. 56525

DOWL Engineers
4041 B Street
Anchorage, Alaska 99503

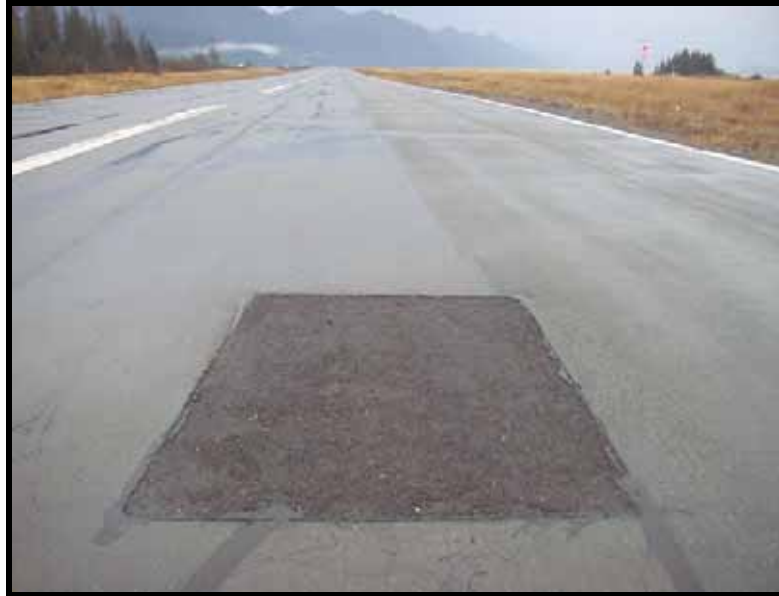
Figure 3: A Recent Patch on Runway 12-30

A pavement inspection in 2002 reported that the runway pavement is generally in good condition, but that the condition varies from poor to excellent. There are stumps and pieces of wood protruding through the pavement on both runways and on adjacent taxiways. Rutting has begun on Runway 12-30, Taxiway B and the apron. Various other pavement problems, including cracking, raveling, depressions, corrugations, and rough patching, also exist at the Airport.

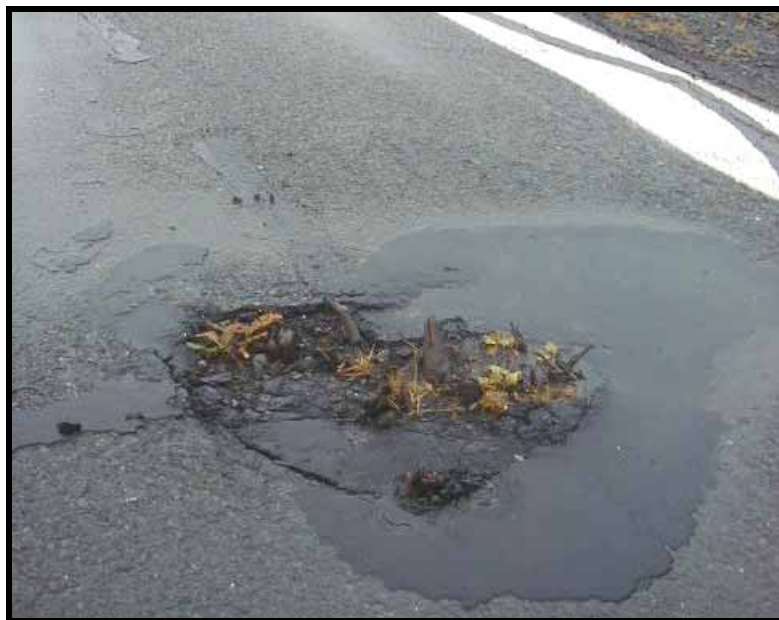
Figure 4: Pothole in Runway 15-33

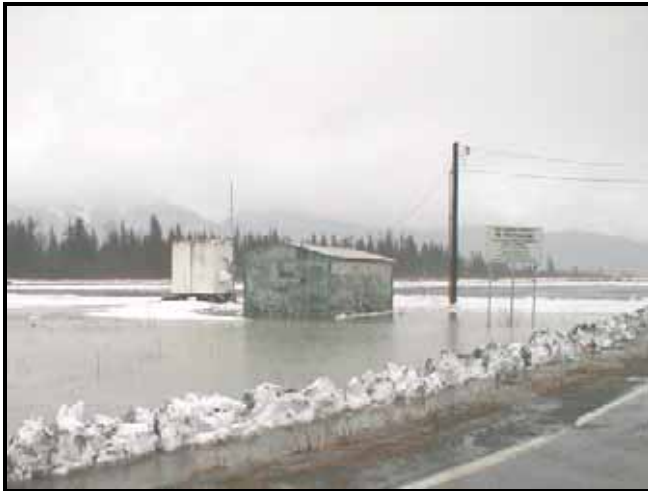
Figure 6: Flooded Lighting Building

The Airport has Medium-Intensity Runway Edge Lights (MIRL) on Runway 12-30. This lighting system is in poor condition and requires significant maintenance. Light cans routinely “float” up out of the ground and many of the runway lights lean to the side significantly. The lighting control building is in poor condition and is located in a low-lying area. In May 2008, replacing and elevating the building scored highly in an evaluation of Airport Improvement building and Equipment projects. In the near future, flooding of the lighting building should no longer be a problem.

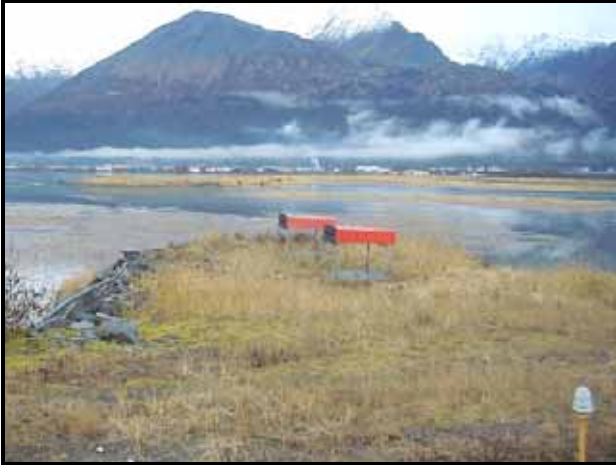
Figure 8: VASI on Runway 30

There is a Visual Approach Slope Indicator system (VASI) on Runway 30. The VASI is pilot controlled and its alignment is offset five degree five degrees clockwise from the runway centerline. The VASI is unusable beyond four miles. There is a rotating beacon located near the midpoint of Taxiway A between the runways. There is also a segmented circle and a windsock located between the runways near the intersection of the two runways.

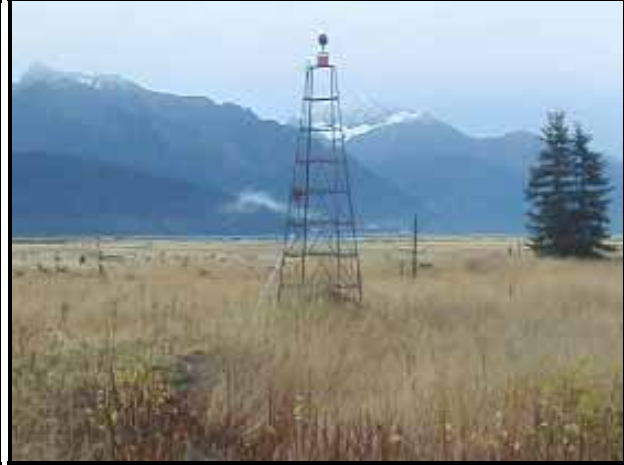
Figure 9: Rotating Beacon

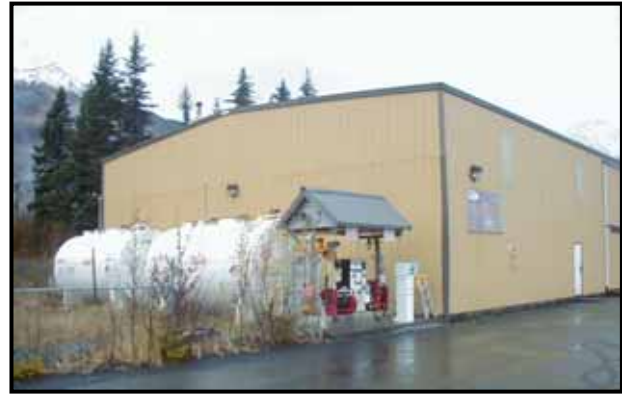
Figure 14: Short Final Air, LLC Hangar

South of the office is the Short Final Air, LLC maintenance hangar. The hangar is a pre-engineered steel building used for the purpose of private aircraft storage. Short Final Air, LLC

also has two fuel tanks and a pump station located on the south side of the hangar adjacent to the apron. One of the tanks holds 5,000 gallons of Jet A fuel, while the other holds 5,000 gallons of 100 LL AvGas. Shoreside Petroleum provides both types of fuel, which are sold to the public.

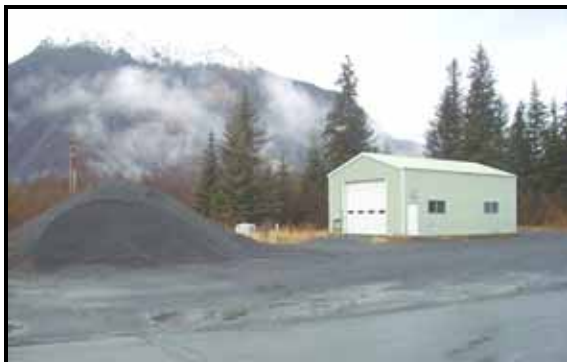
Figure 15: DOT&PF Maintenance Building

The DOT&PF maintenance facilities South of Short Final Air, LLC are located on Block 200, Lot 3. The main building is a pre-engineered steel structure and is used to store and maintain a loader, which is used for snow removal and airport maintenance. A small office is located in the maintenance building for DOT&PF staff. A sand storage building is also on this lot and is located between the maintenance building and the parking apron. The building also has a small aboveground tank used to store heating oil.

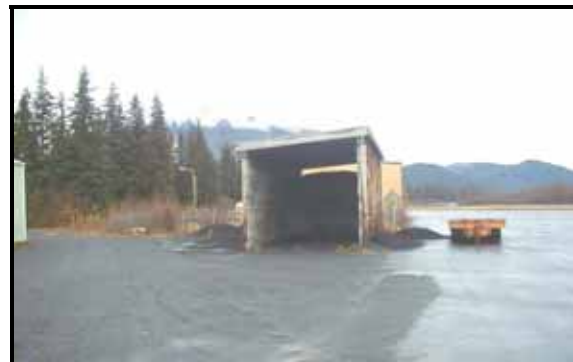
Figure 16: Sand Storage Building

A sand storage building is located at the Seward Airport and is situated between the maintenance building and the parking apron. The sand storage building is constructed of wood and consists of two walls, a roof and is 18 feet wide by 42 feet long. The sand building is in generally poor condition.

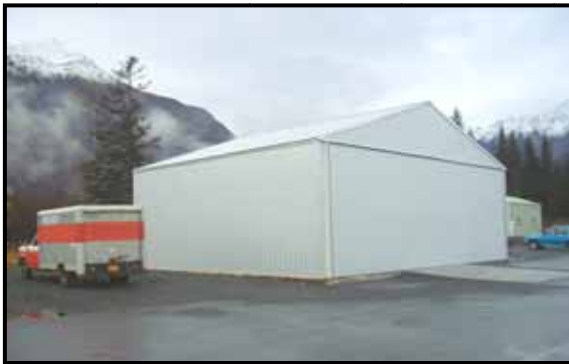
Figure 17: CAP Hangar

South of the DOT&PF maintenance facility is the hangar of the Seward Composite Squadron of the Alaska Wing of the CAP. This is a new pre-engineered steel building that was completed in the spring of 2002 and is used to store and maintain the squadron's C-172 as well as other CAP aircraft used during search and rescue missions. The building is also used for training and
