**GENERAL LAYOUT
KING COVE**

King Cove Dock

Terminal Description: The M/V Tustumena docks at the Aleutians East Borough facility in King Cove on its east/west passage through the Aleutian Chain. The King Cove facility consists of a sheet pile cell structure with a face approximately 125' long, and 4 steel pile mooring dolphins (two on each side of the dock) connected to the dock by steel catwalks. Access to the dock is via an embankment and paved roadway. There is a breach in the embankment at about its midpoint to permit juvenile fish migration. A steel girder/concrete deck bridge spans the breach; open sheet pile cells protect the abutments. The facility is a multi-purpose facility and could be in use by other vessels when the ferry arrives. AMHS is not in control of operation or maintenance of this facility. The past 10 years of total passenger and vehicle traffic at King Cove is shown below. The M/V Tustumena was out of service most of 2013, causing a steep dropoff in traffic at the terminal.

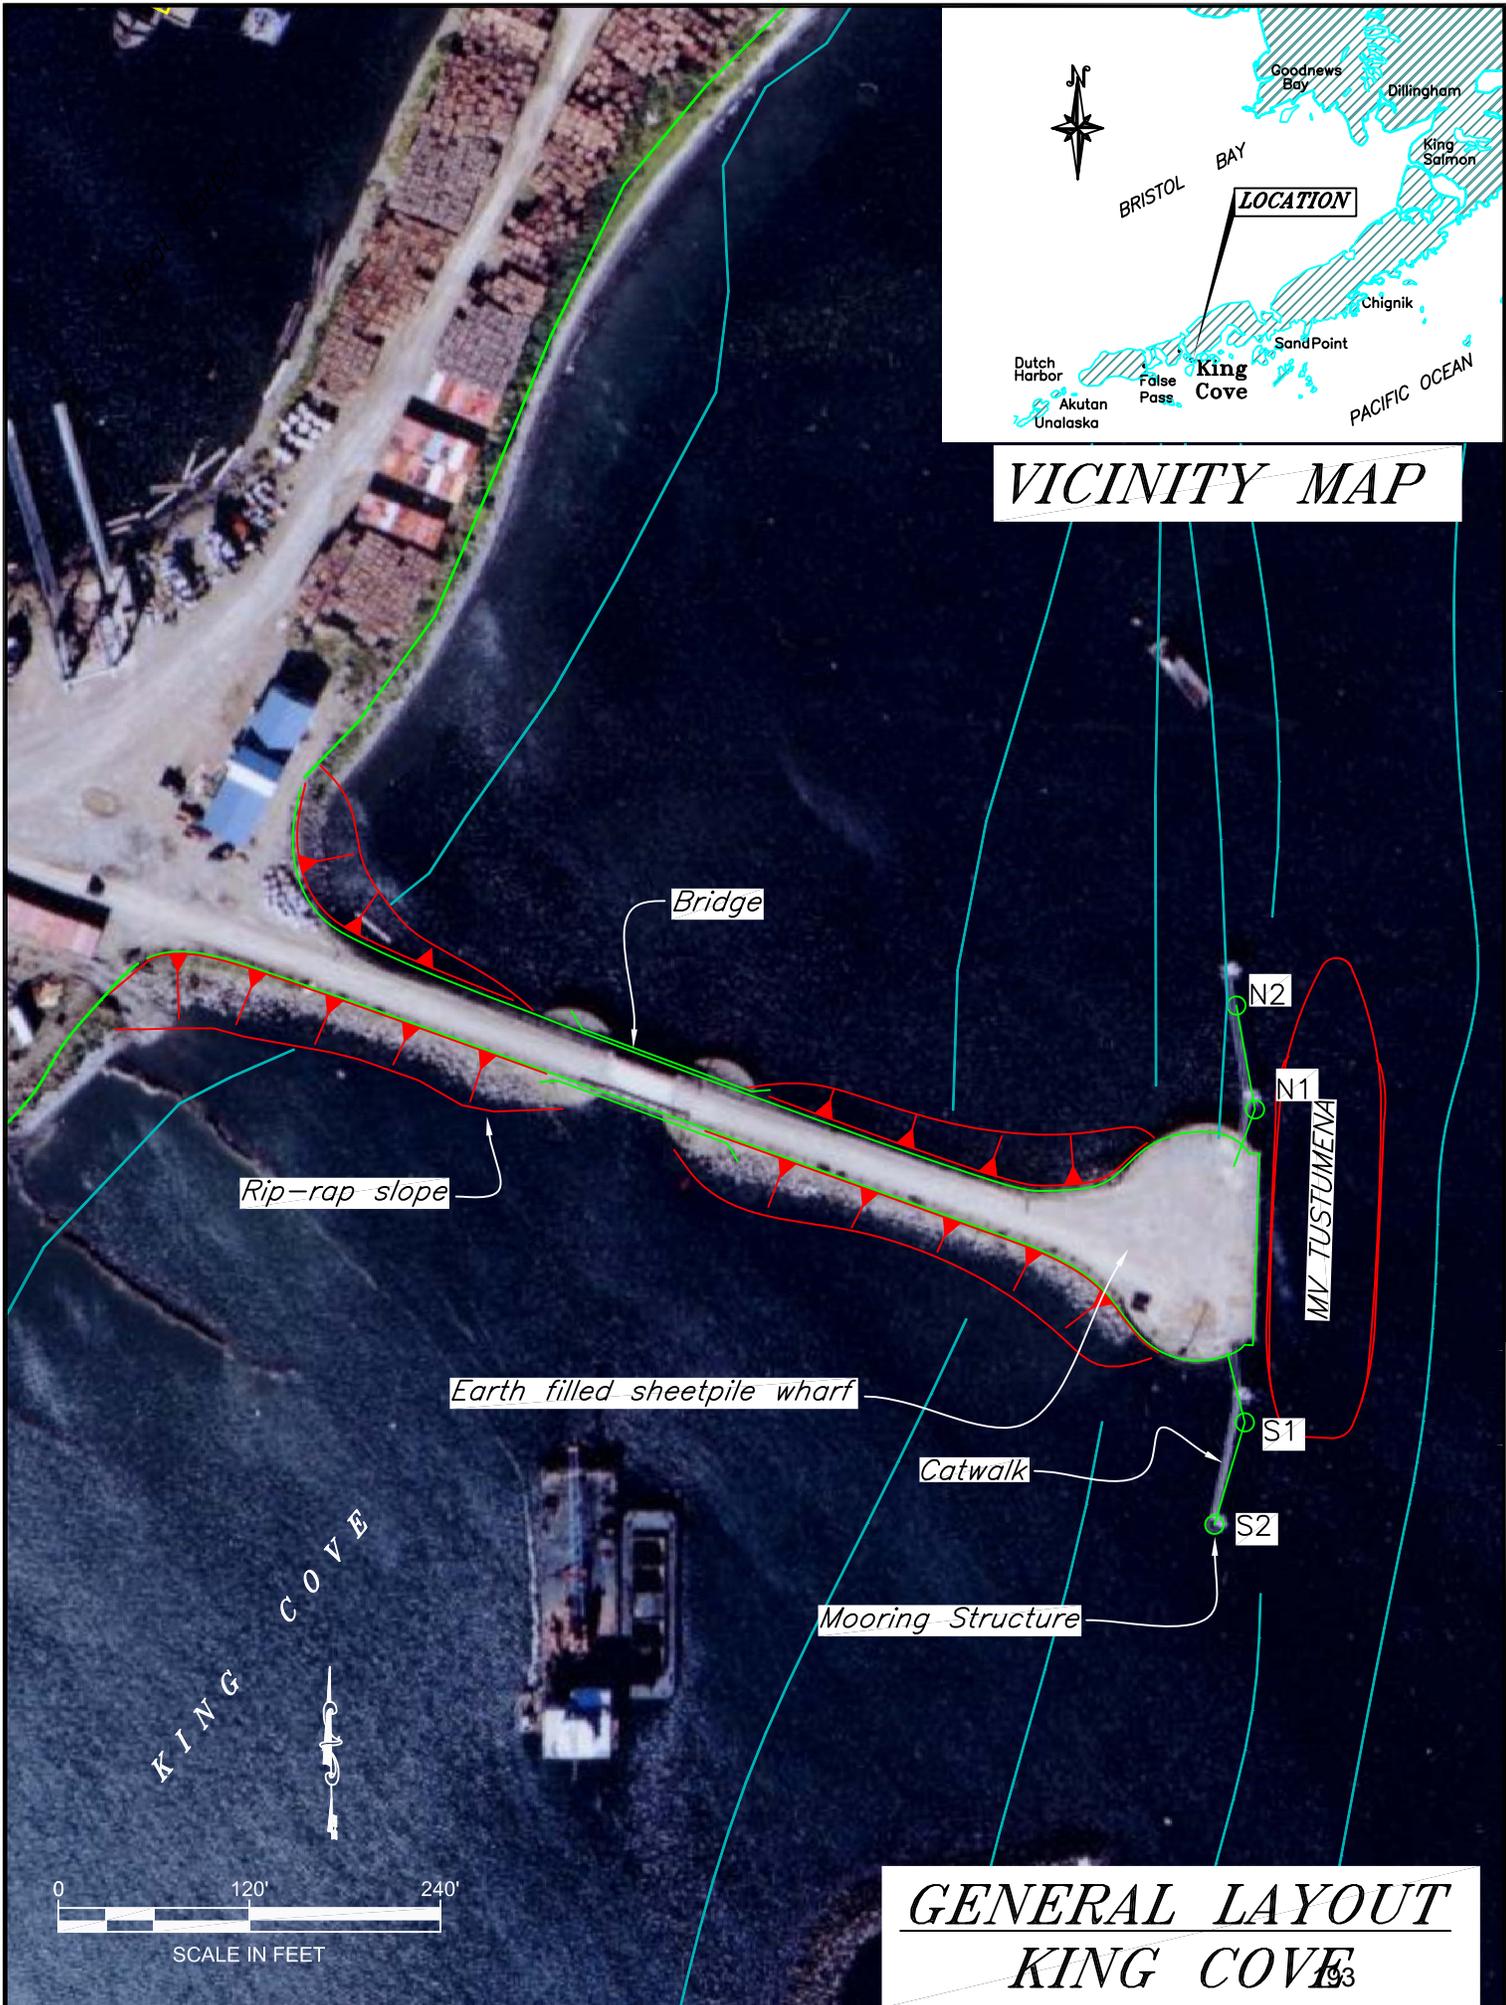
Bridge

Rip-rap slope

Earth filled sheetpile wharf

Catwalk

Mooring Structure

N2

N1

S1

S2

3. Line loads on dolphins N1 and S1 appear to have exceeded their capacities. Dolphin N1 was pulled to the southeast and the dolphin leans to the south. Dolphin S1 was pulled to the northeast and leans to the northwest. Dolphin S1 does not appear to have leaned further north or northwest since the 2006 inspection based on catwalk misalignments. Displacing these dolphins caused failure of the bolts securing the catwalks to the dolphin caps and the catwalks no longer bear equally on the caps. The catwalk to dolphin S2 is chained to the bollard and bears on only 8” of the cap. The gratings on the

4. The catwalk between dolphins N1 & N2 has been impacted on the seaward side. The entire catwalk has been bent horizontally shoreward slightly. No members or their connections were observed to show signs of cracking.
