GENERAL LAYOUT KODIAK

Kodiak City Dock (Pier 1)

Terminal Description: The M/V Tustumena docks at the Kodiak City Dock (also called Pier 1) on its east/west passage between Homer and the Aleutian Chain. The Kodiak City Dock structure is supported by steel pipe piles, with concrete pier caps, p/c concrete channel beams (approach), & p/c concrete haunched deck panels (main dock). The fender system consists of five pin-pile supported fender panels. The facility is a U-shaped concrete structure with a main dock section approximately 230' x 25', and two 103' approach trestles, one at each end of the dock. The dock is currently used for transfer of general cargo and fuel, in addition to ferry operations. The paved area between the street and the terminal building has a shared use for parking and vehicle staging. Embarking vehicles line up on the adjacent city street, in the paved area and along the 75'-wide north approach trestle. The contractor operated ticket office is located in a city owned building, on shore, between the two approach trestles. The wharf is crowded between a marine fuel service depot to the north and a shore based seafood processor to the south. Vessels moored at th

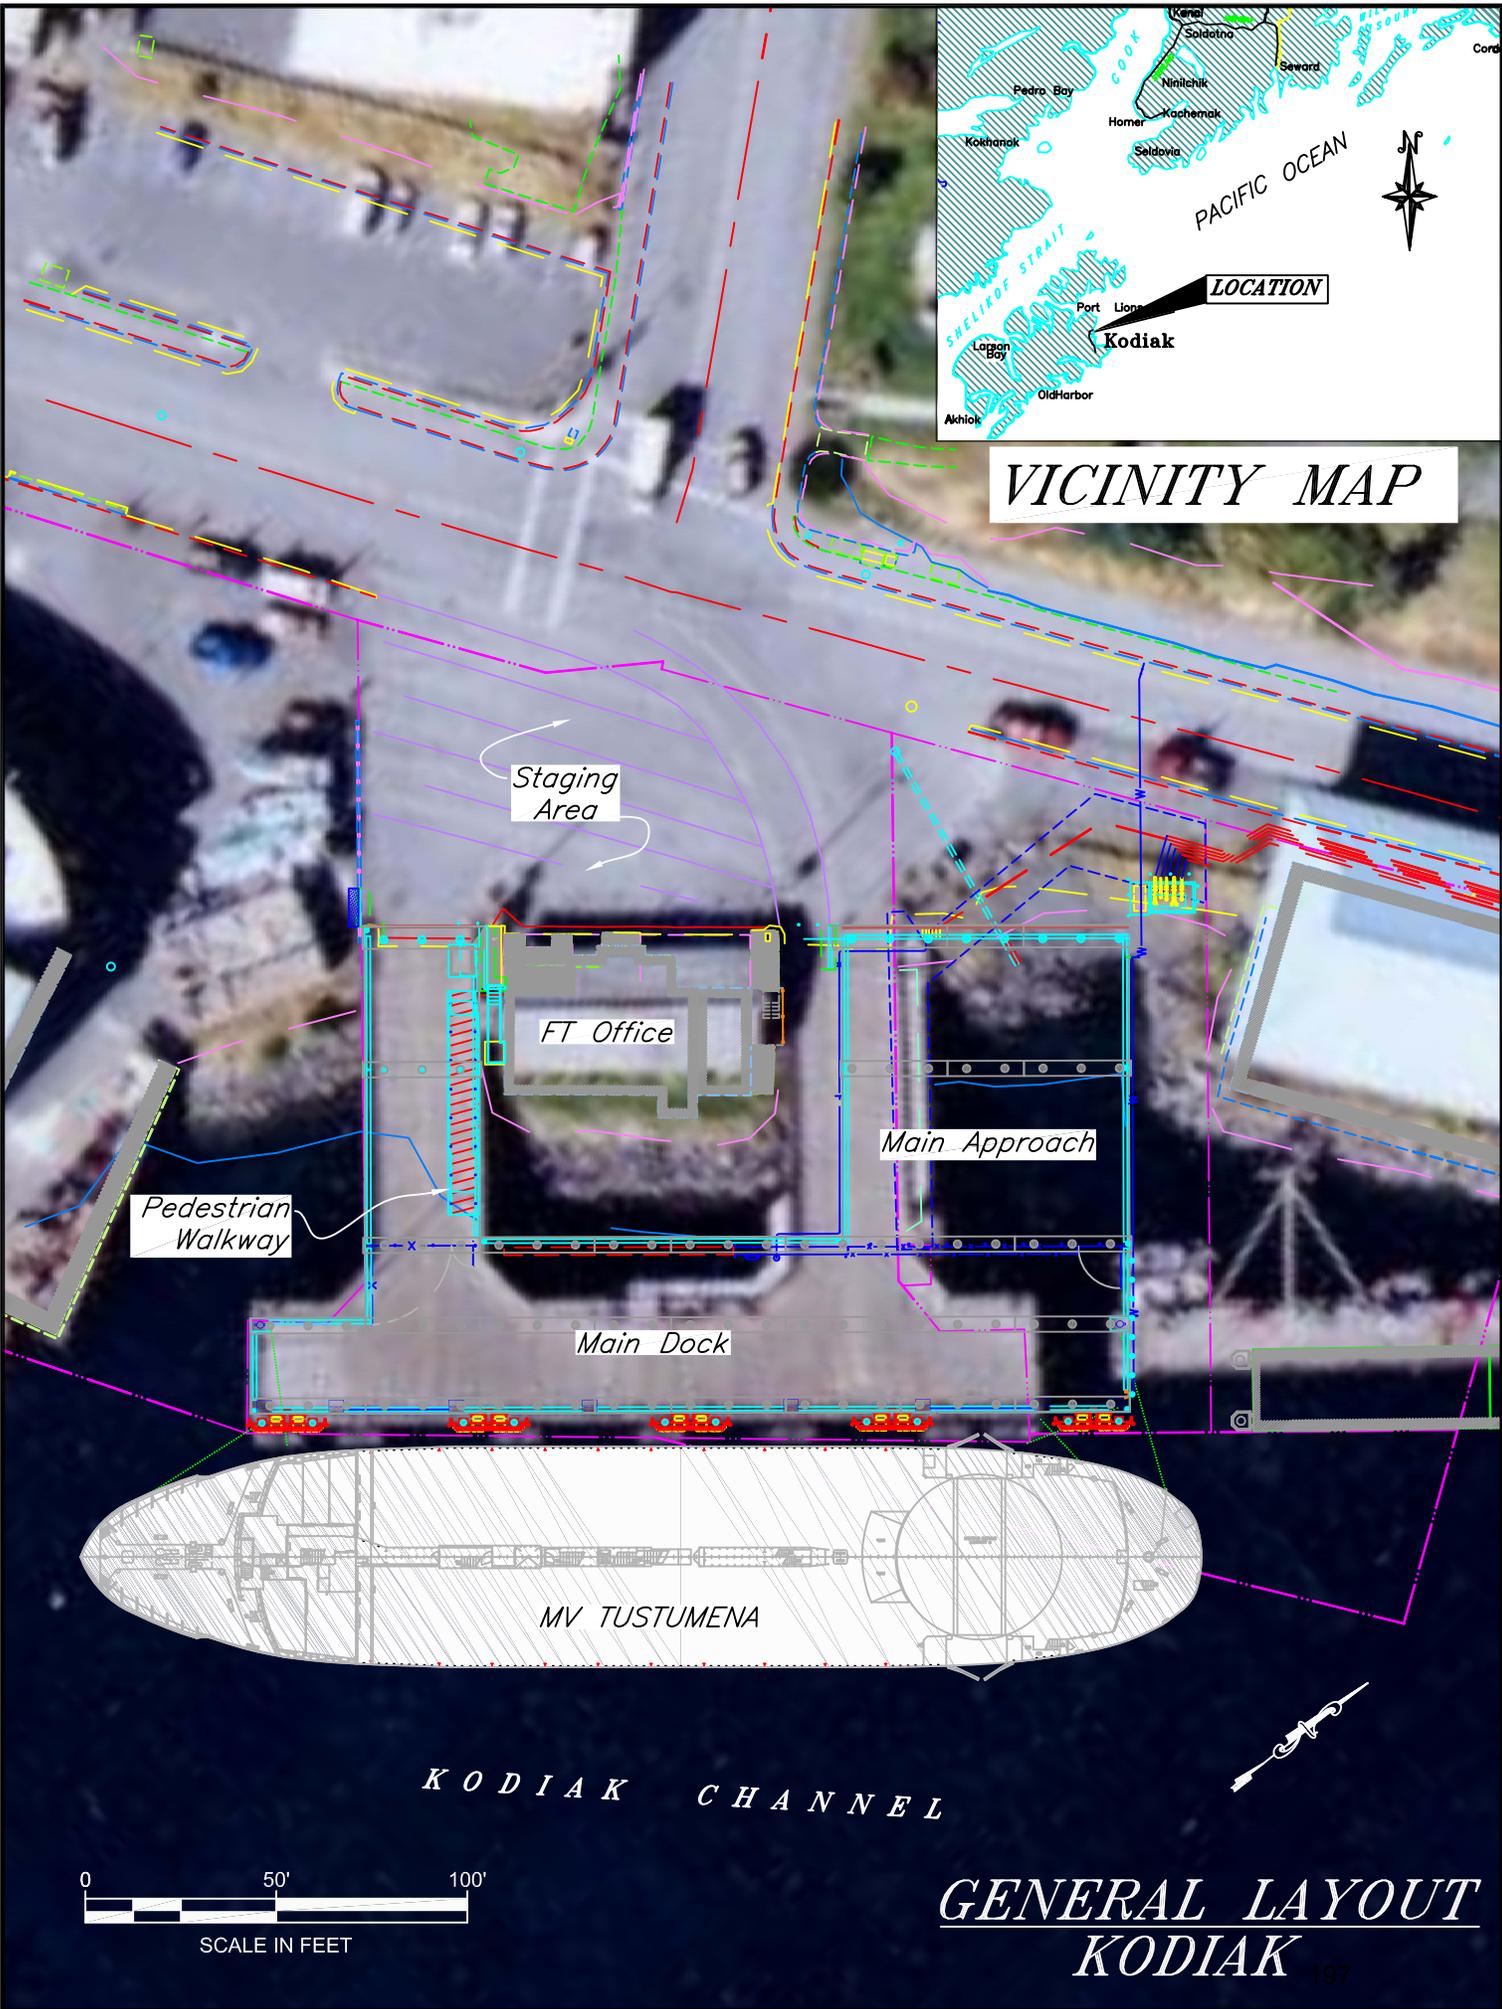
U-Shaped Dock - #1425	
Year Built:	2016
Dock Structure:	Steel pile supports, concrete pier caps, p/c concrete channel beams (approach), & p/c concrete haunched deck panels (main dock)
Fenders:	Five (5) pin pile supported fender panels
Mooring Bollards/Cleats:	Bollard mounted at both ends of dock; several cleats mounted to bullrail along the dock face.
Lighting:	Yes
Condition:	New
