**ST. MARY'S AIRPORT  
PLANNING AND RSA PRACTICABILITY STUDY**

**Project Number Z605630000**

**Condition and Needs Assessment Report**

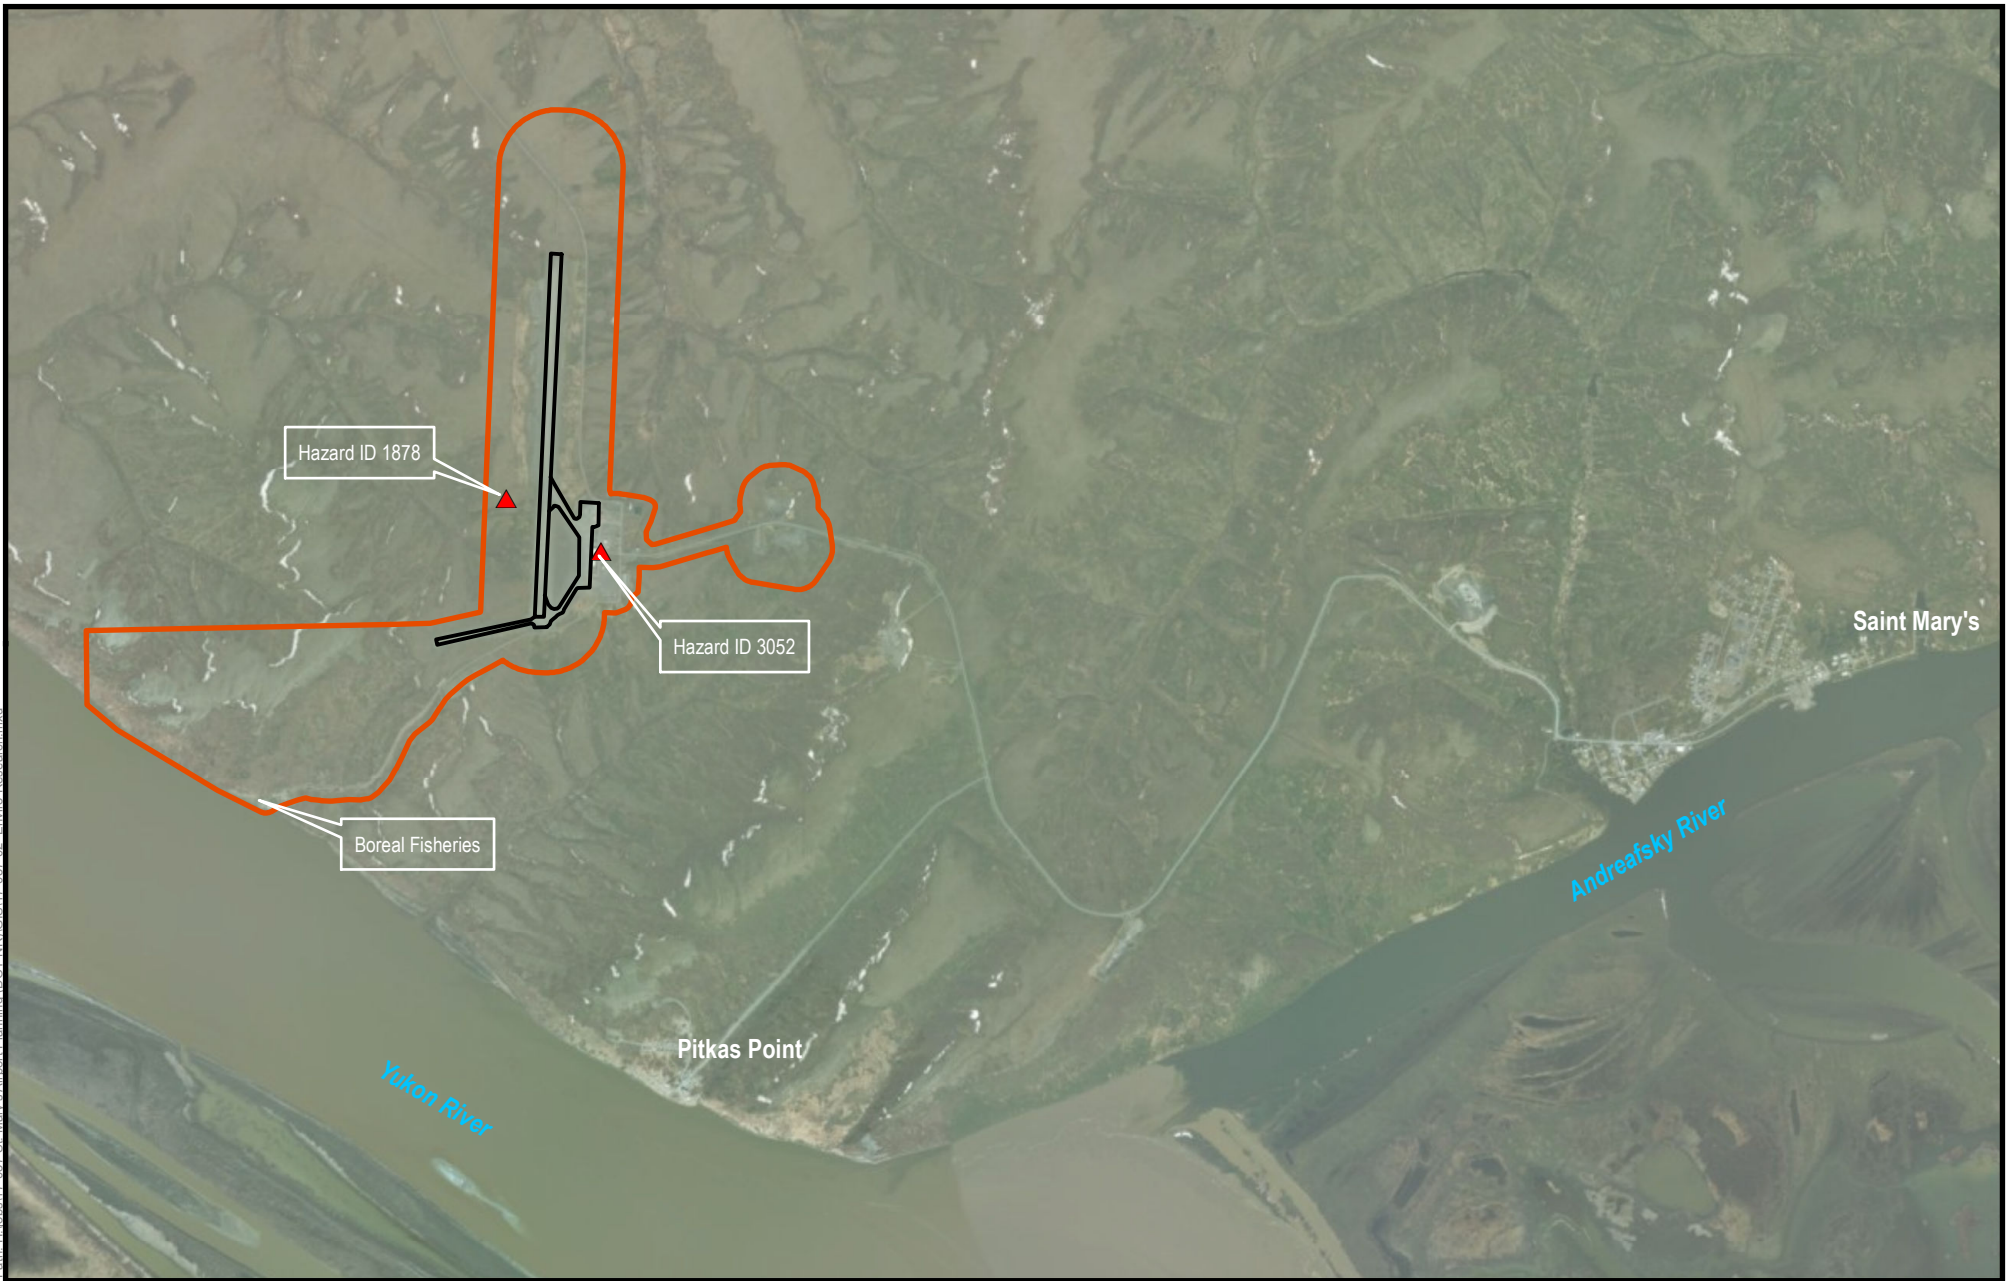
**Figure 1**

- Study Area
- St. Mary's Airport
- Contaminated Sites

Environmental resources were identified using Federal Aviation Administration's (FAA) Environmental Impacts: Policies and Procedures Order 1050.1F and FAA's National Environmental Policy Act Implementing Instructions for Airport Actions Order 5050.4b. Environmental resources within the project vicinity are identified on Figure 1.
