Appendix E: Vegetation and Wetlands

Addendum Katlian Bay Road

Staging Area - MP_0.0 (Upland w/ 5% wetland mosaic)

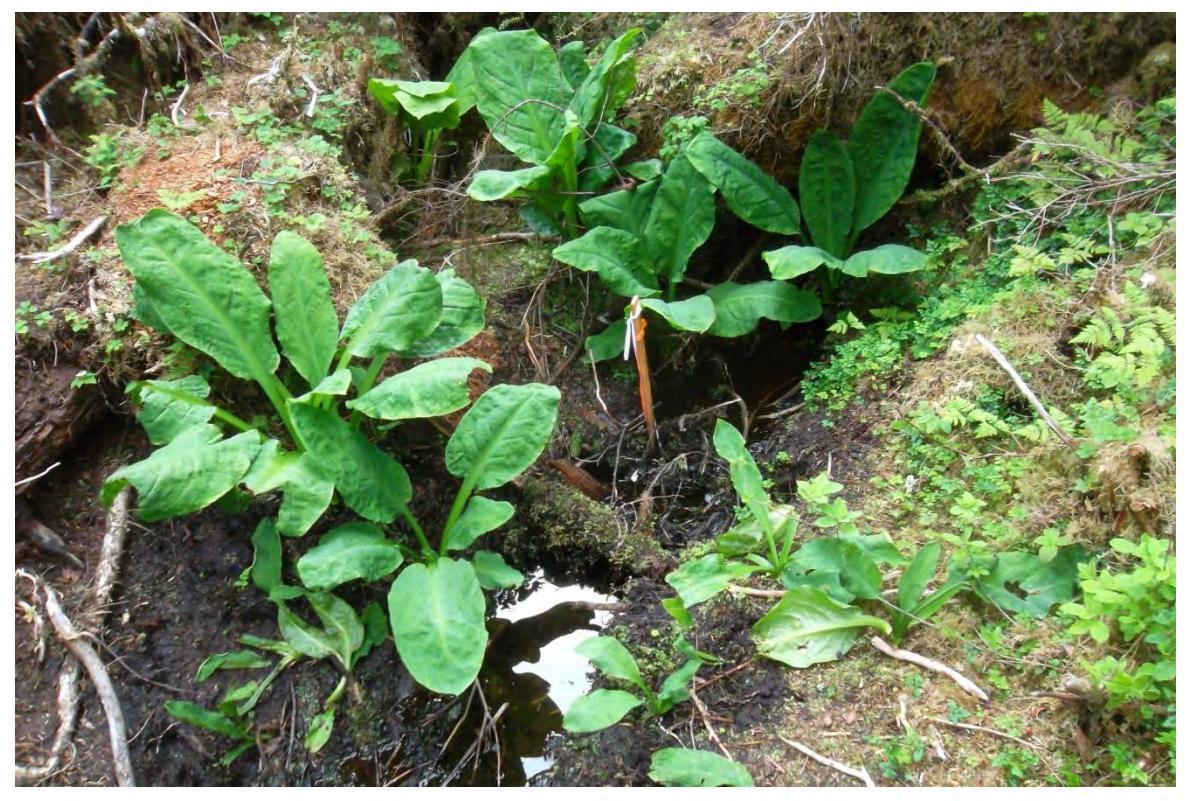
Photo 1. Photo of watercourse 1 within Wetland 1 near the Starrigavan Campground at Mile Post 0. Photo taken June 24, 2015.

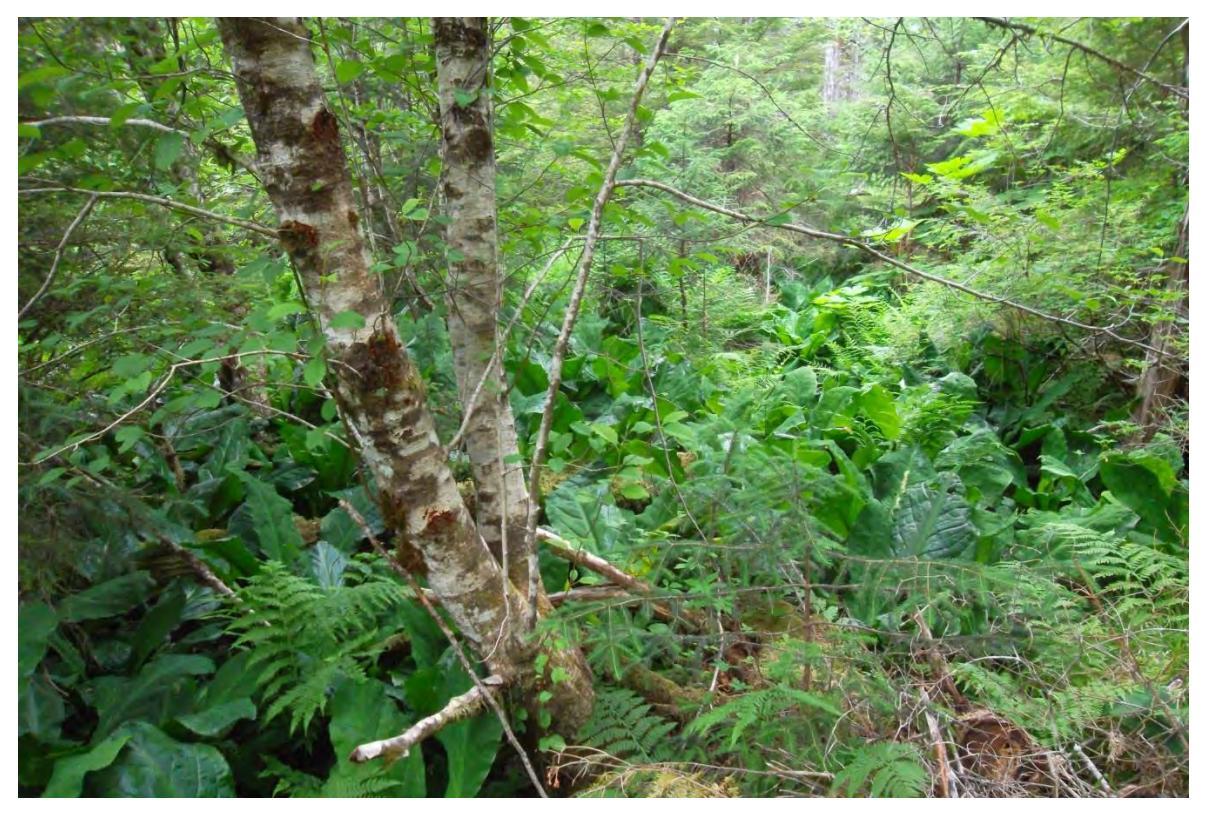
Photo 3. Photo of forested wetland habitat in Wetland 1 at Data Point 3; view south. Photo taken June 24, 2015.

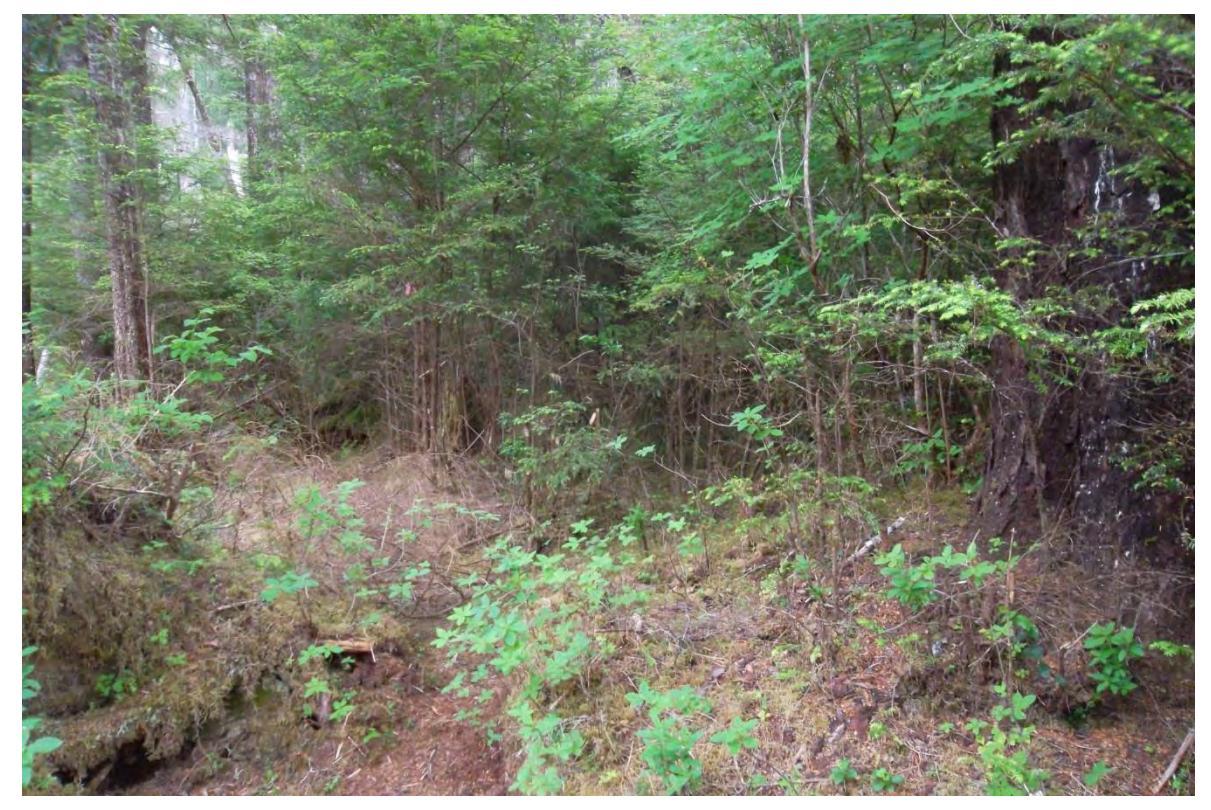
Photo 4. Photo of upland forest habitat at data point 4 near flag II2; view west. Photo taken June 24, 2015.

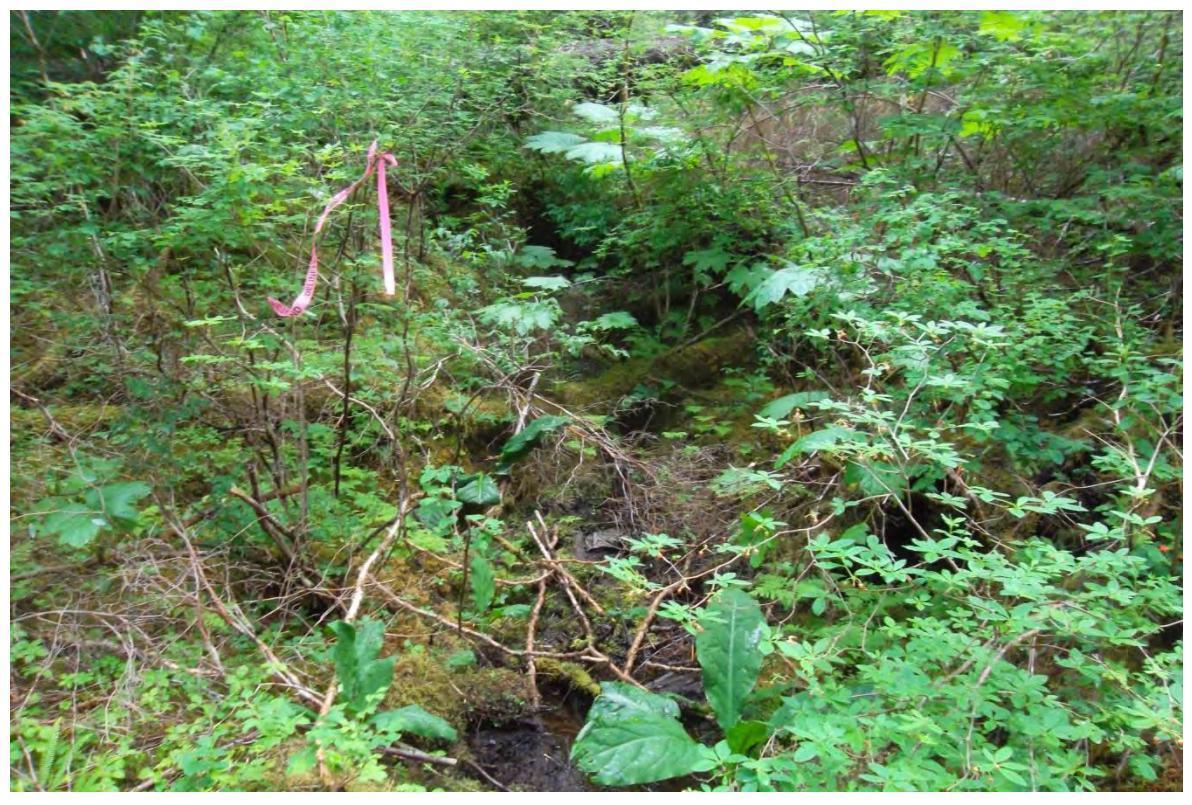
Photo 5. Photo of seep emanating from the hillside within Wetland 2; view east. Photo taken June 19, 2015.

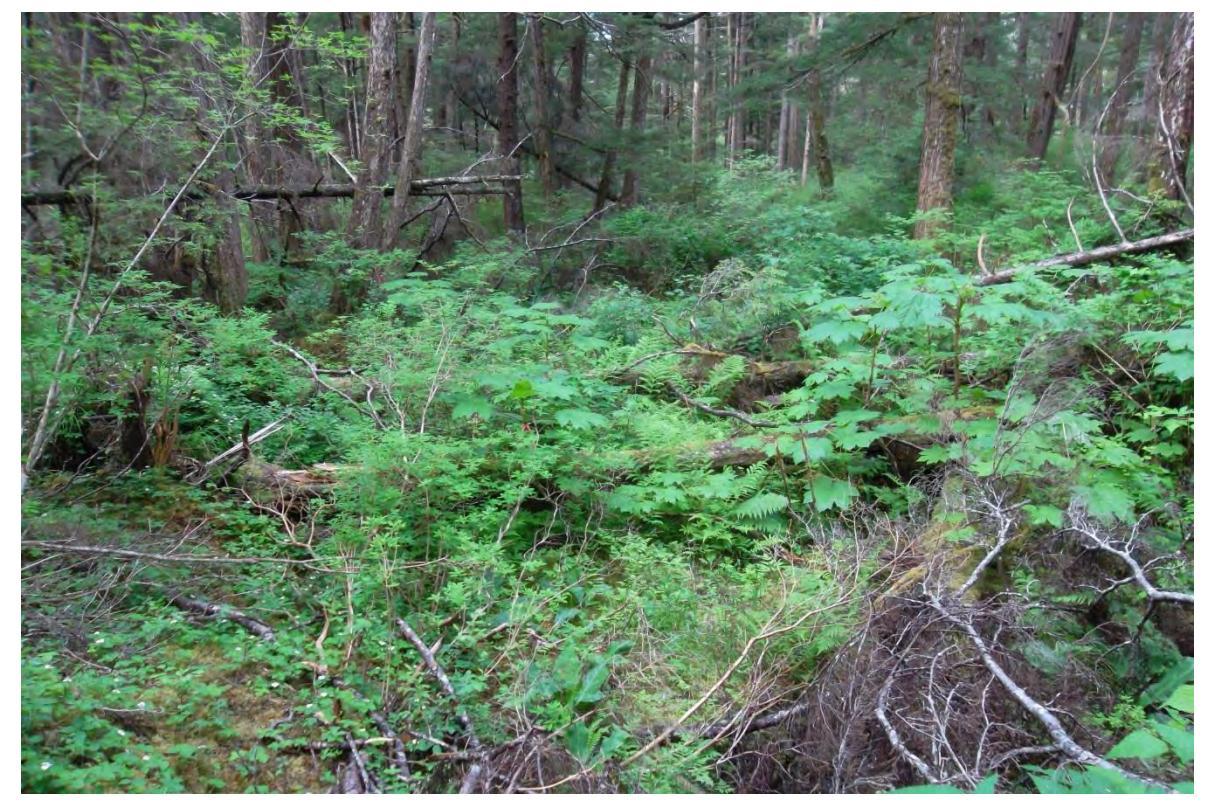
Photo 6. Photo of evergreen forest wetland habitat in Wetland 3; view west. Photo taken June 19, 2015.

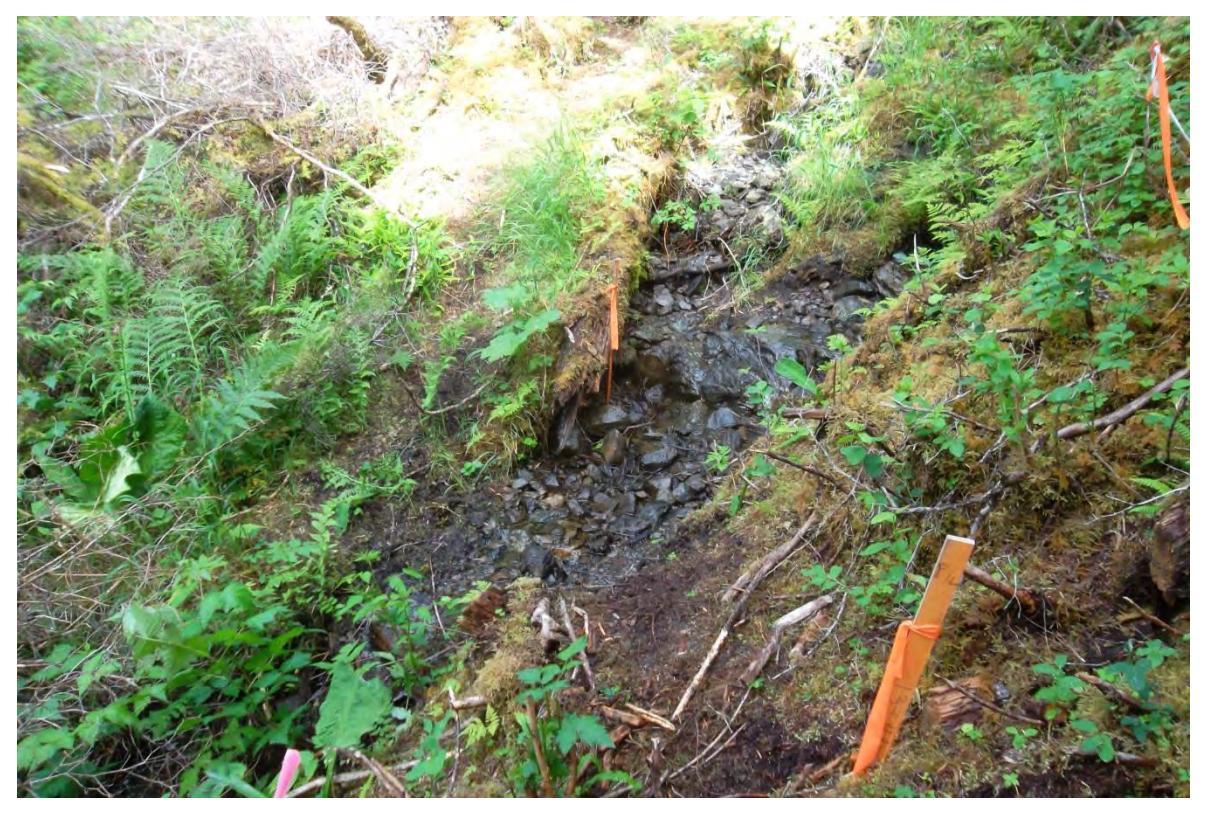
Photo 7. Photo of watercourse 4 flowing into Wetland 3; view north. Evergreen forest wetland habitat begins below the alignment (left side of photo). Photo taken on June 19, 2015.

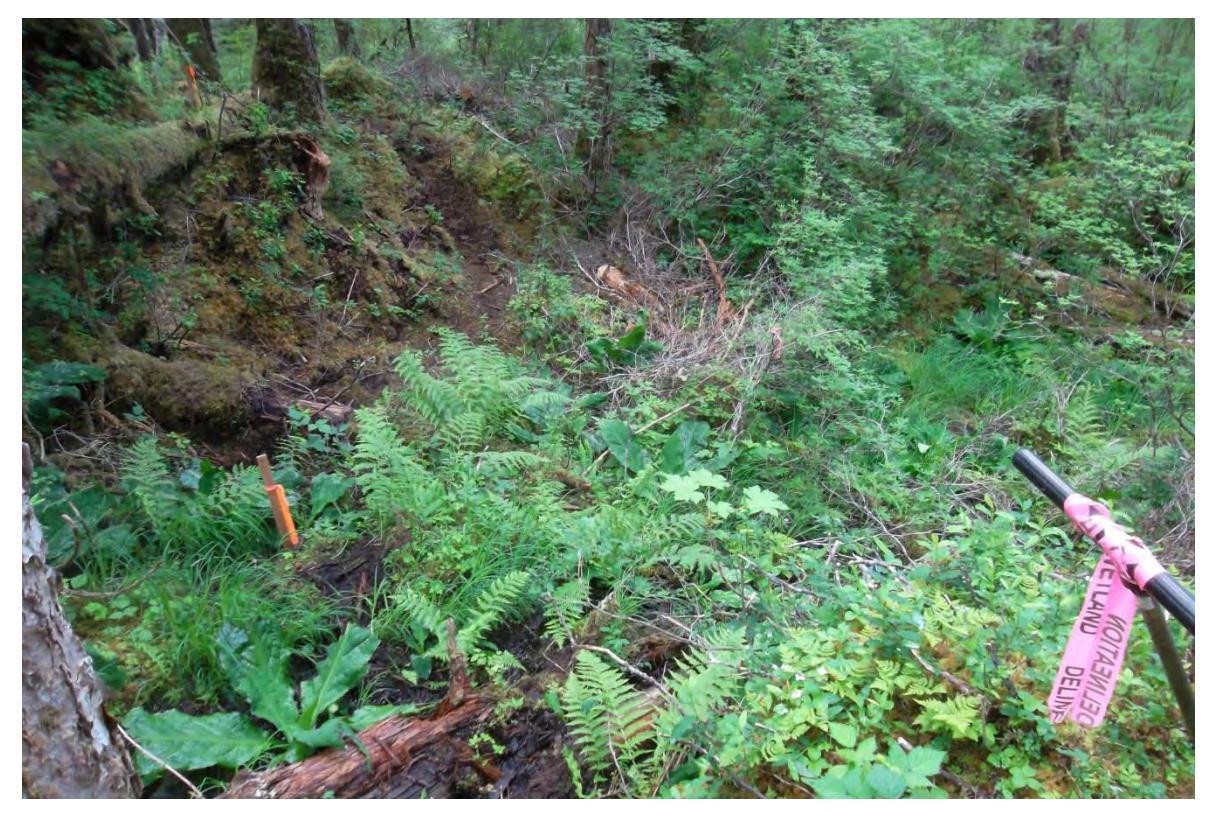
Photo 10. Photo of Wetland 5 with saturated soils and dense herbaceous groundcover; view southwest. Photo taken June 19, 2015.

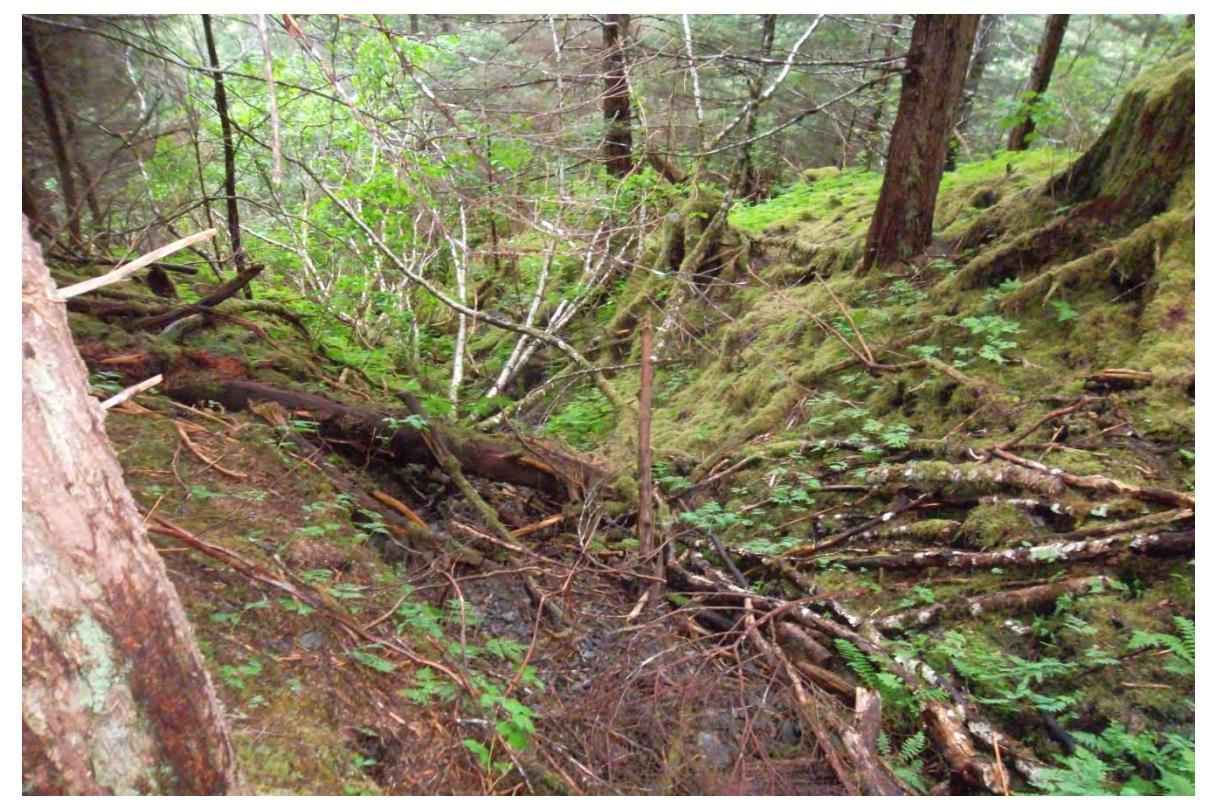
Photo 16. Photo of watercourse 23 confined by steep banks with dense Sitka alder (*Alnus viridus*) growth. Photo taken June 17, 2015.

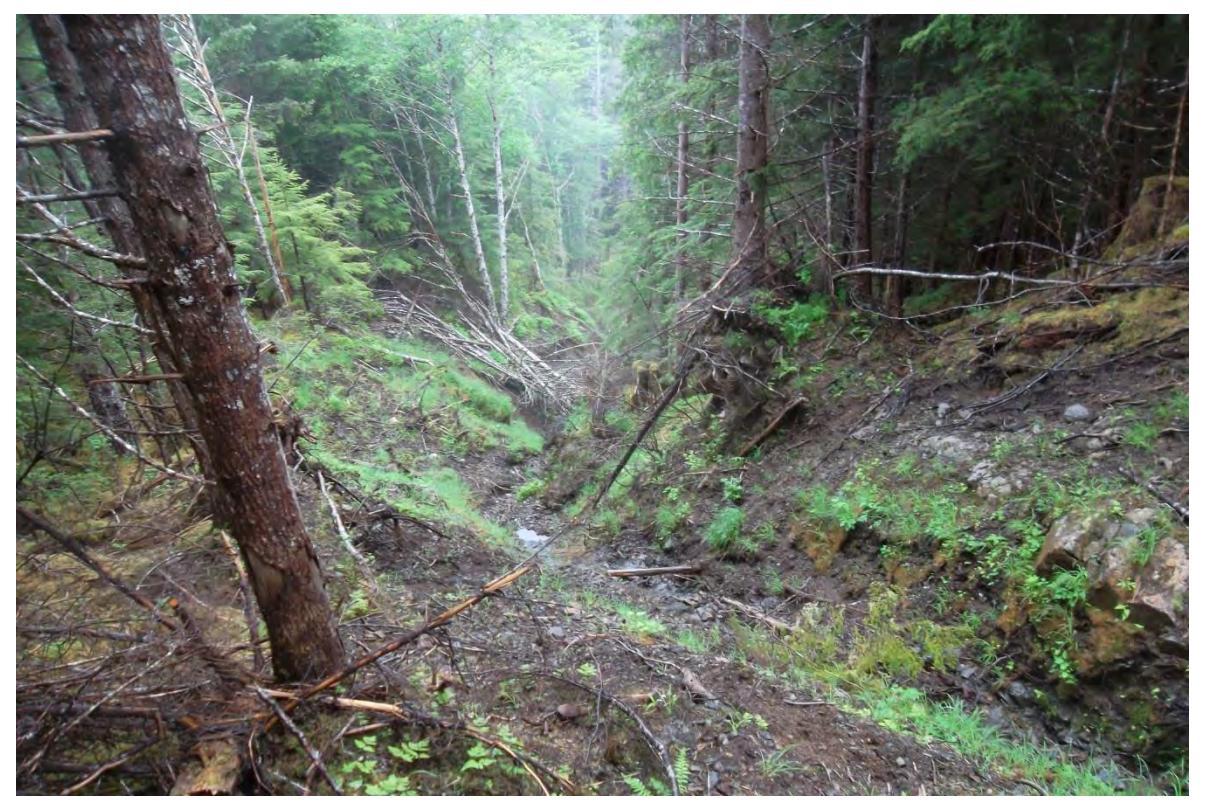
Photo 21. Photo of watercourse 33 and debris flow within an incised drainage. Photo taken June 18, 2015.

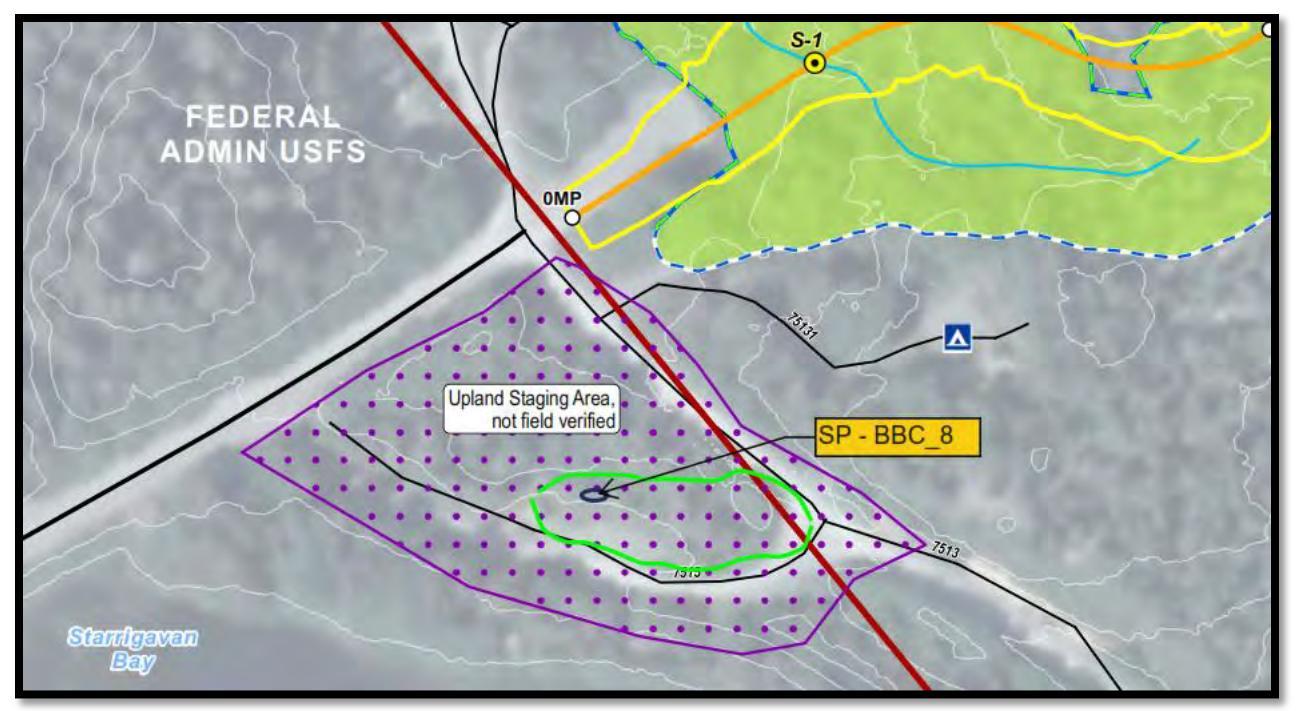
This proposed staging area is a 1.5 acre triangular, forested piece at the end of Halibut Pt. Rd., next to the Starrigavan Hikers Campground. The piece is bedrock-cored, hilly and completely forested. The western and broader half of the triangle is an upland forest dominated by Sitka spruce (FACU), western hemlock (FAC), rusty menziesia (FACU) and dwarf dogwood (FACU). The northern half of the triangle is an upland/wetland mosaic of 15- 20% wetland. The wetlands are small narrow (3-4 ft) stringers in the depressions between the small bedrock-cored hills. The wetland stringers have an overstory of Sitka spruce and western hemlock and understory of blueberry (FAC) and skunk cabbage (OBL). The soil in the wet areas is a mucky peat over bedrock.

Figure 1 - Potential staging area at the end of Halibut Point Rd. at Starrigavan campground. Green line shows approximate location of wetland mosaic area. Oval with label is BBC sample point #8.

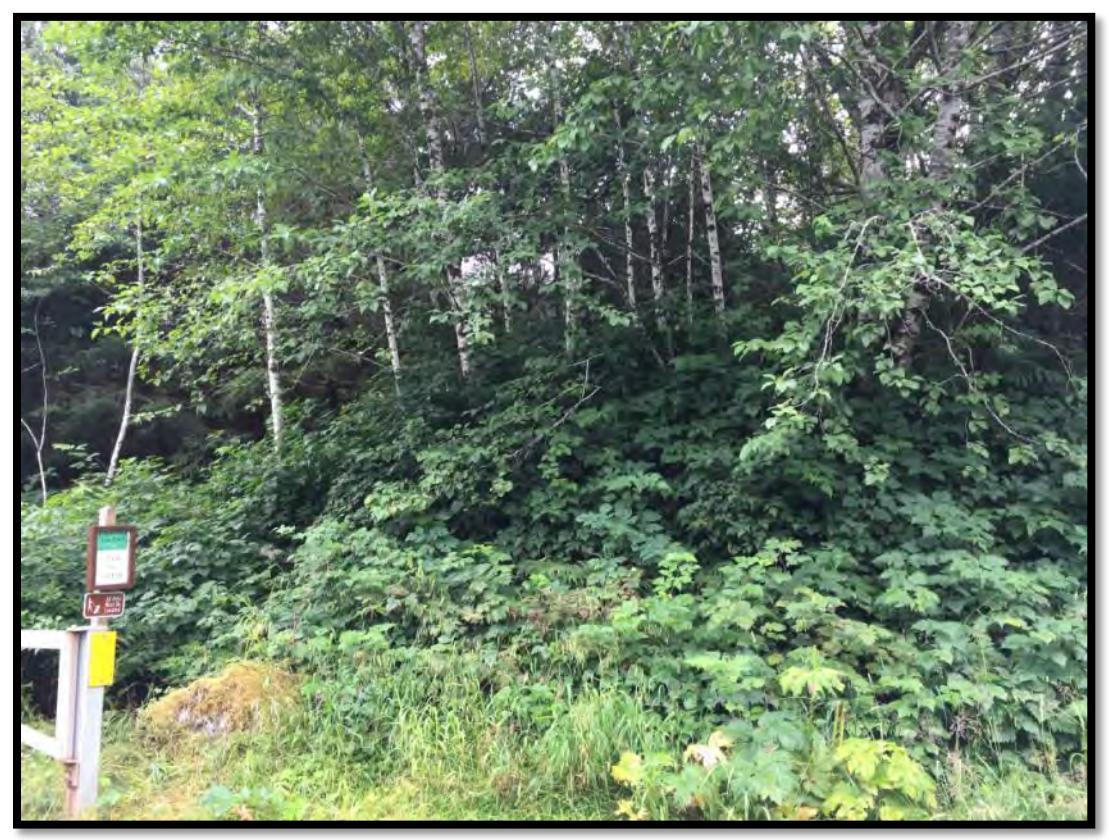
Figure 2 - View looking SE into the upland part of the triangle.

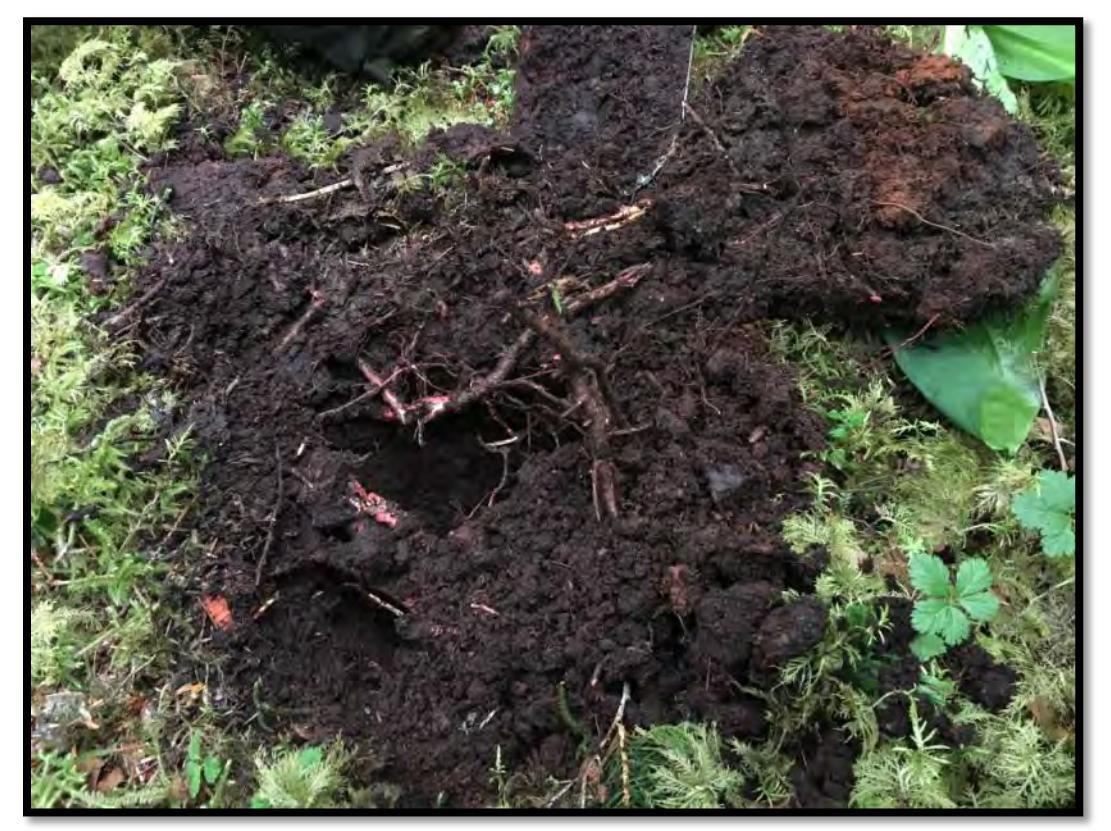
Figure 4 - Rooty, unsaturated peat in upland section of "triangle".

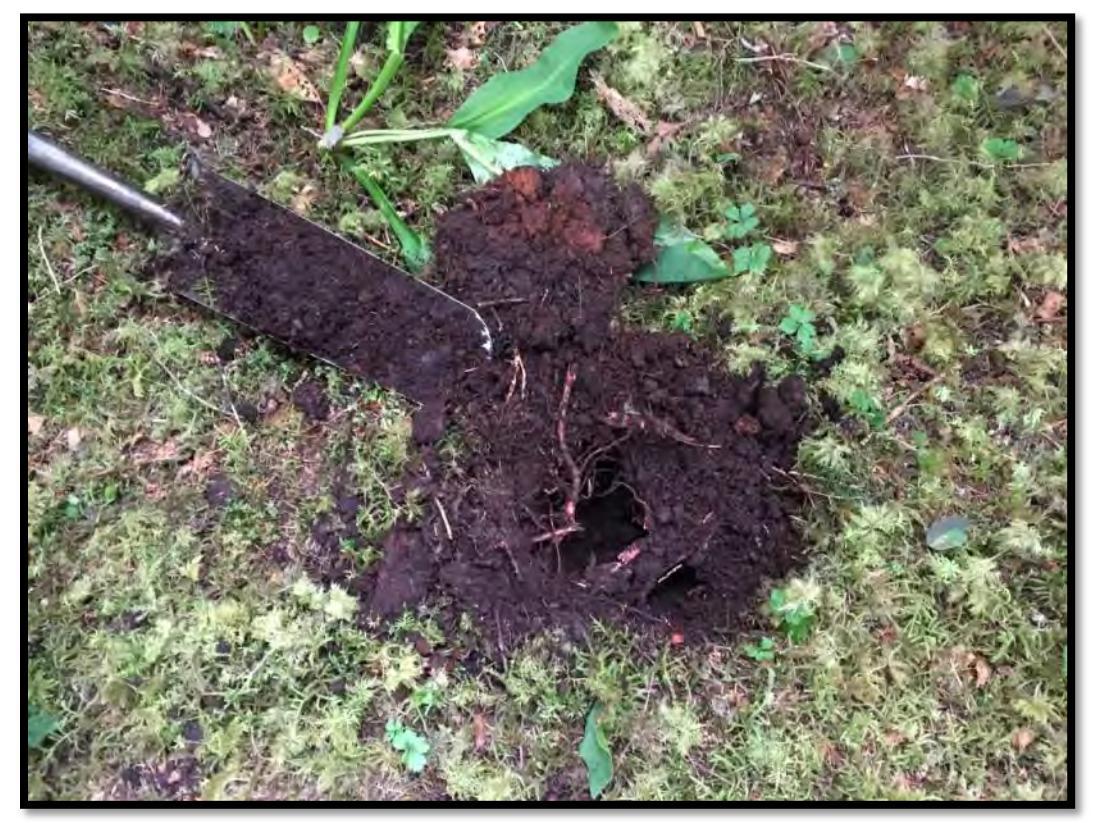
Figure 6 - Rooty, saturated peat in a wetland stringer in the wetland mosaic in the eastern section of the "triangle.

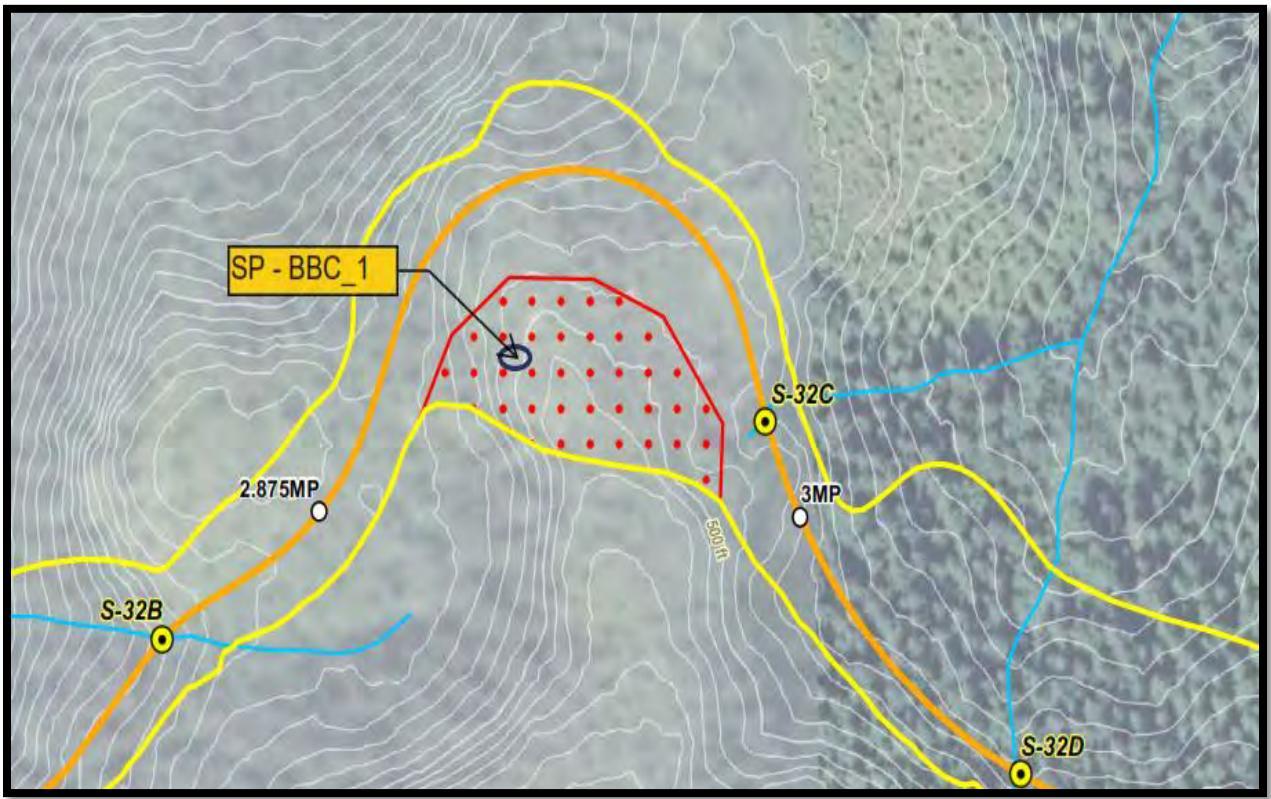
Figure 7 - Oval with label is BBC sample point #1.

This proposed waste site on a ridgeline with no drainages. The vegetation is young secondgrowth dominated by mountain and western hemlock (FAC), Sitka spruce (FACU), rusty menziesia (FACU), blueberries (3 species) (FAC), devils club (FACU) and dwarf dogwood (FACU). The soils are unsaturated peats down to at least 12 inches.

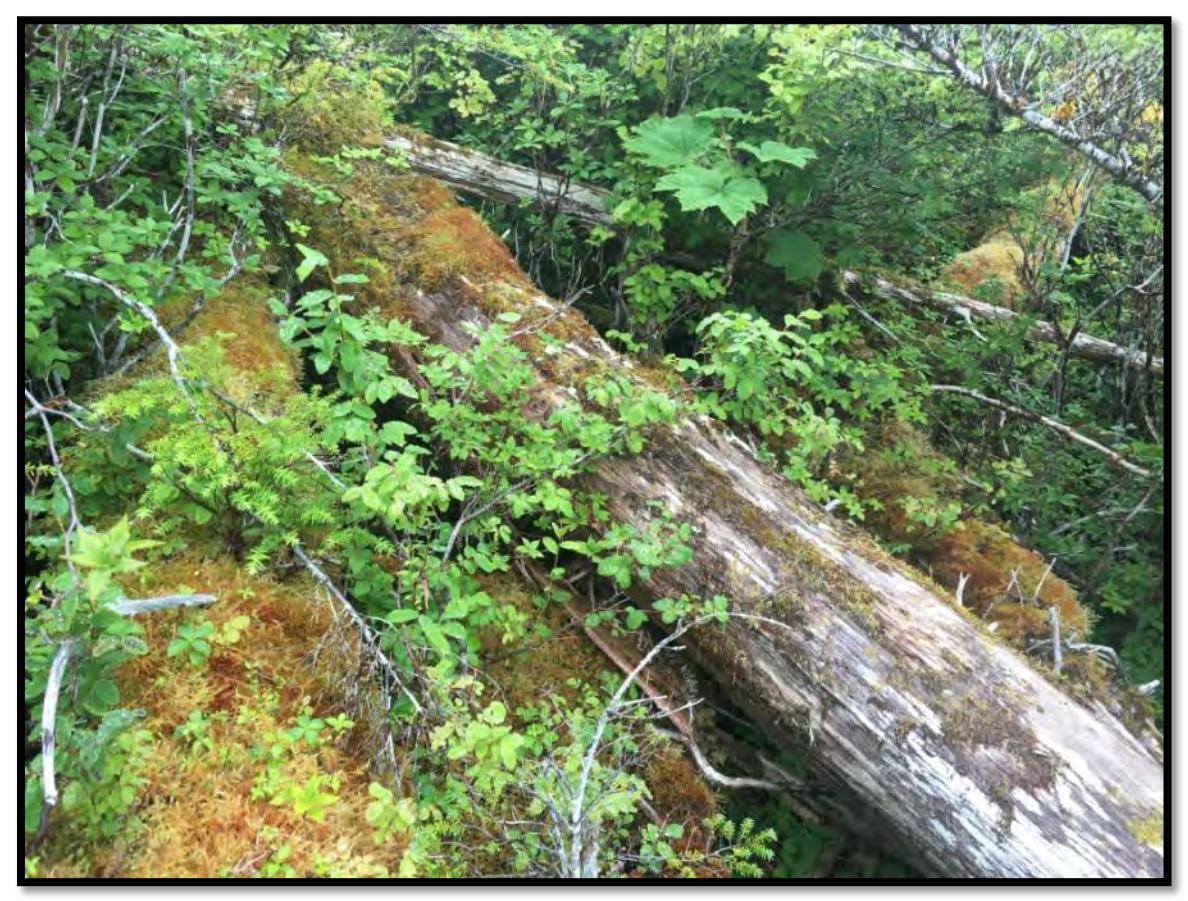
Figure 9 - Detail view of proposed waste site at mile point 2.9.

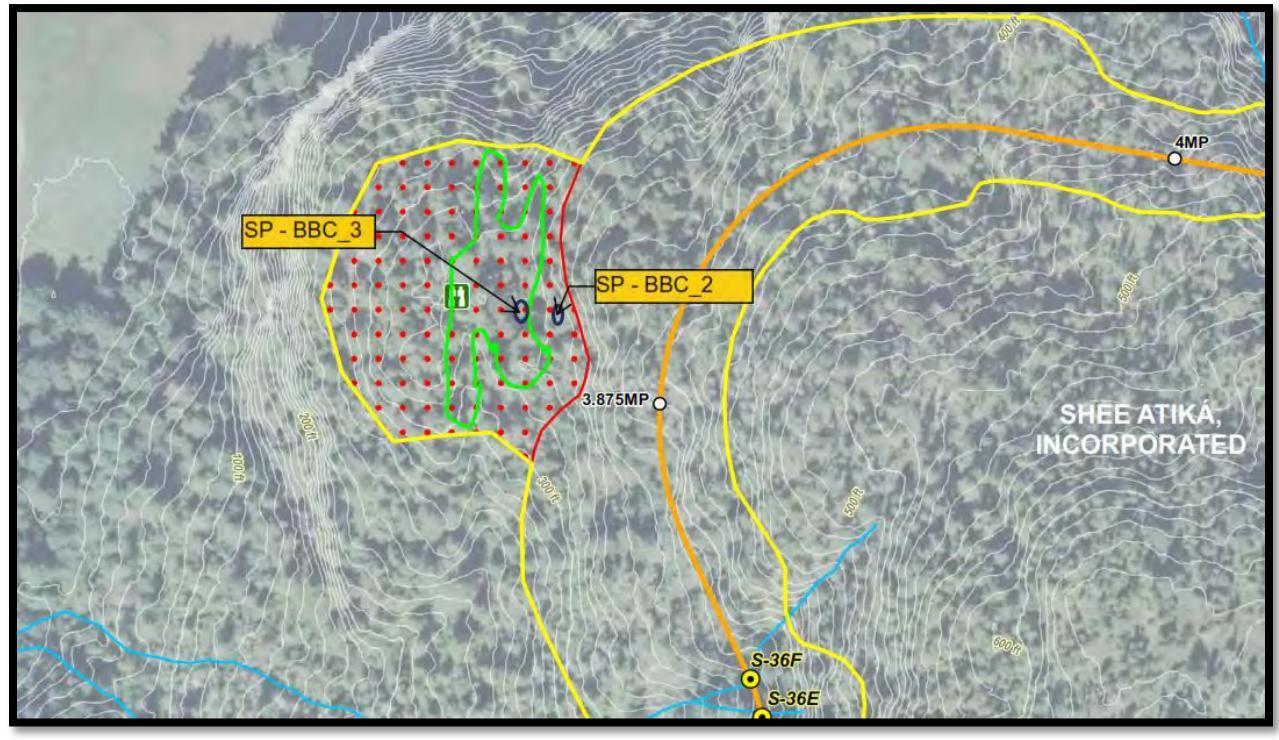
There is a small wetland in a depression between a steep cliff and a bedrock knob at this proposed waste site. The wetland boundaries were flagged and LEI said they would survey it in. There is a small drainage out of the wetland to the north and a larger one out of the wetland to the south. This one drains down to a large stream just below the knob that then drains west into Katlian Bay. The wetland is dominated by yellow cedar (FAC), mountain and western hemlock (FAC), rusty menziesia (FACU), evergreen *Coptis* (FAC) and skunk cabbage (OBL). The soils are a deep, saturated peat.

Figure 10 - The green is the approximate wetland location at mile point 3. 875. The ovals with labels are BBC sample points #2 and #3.

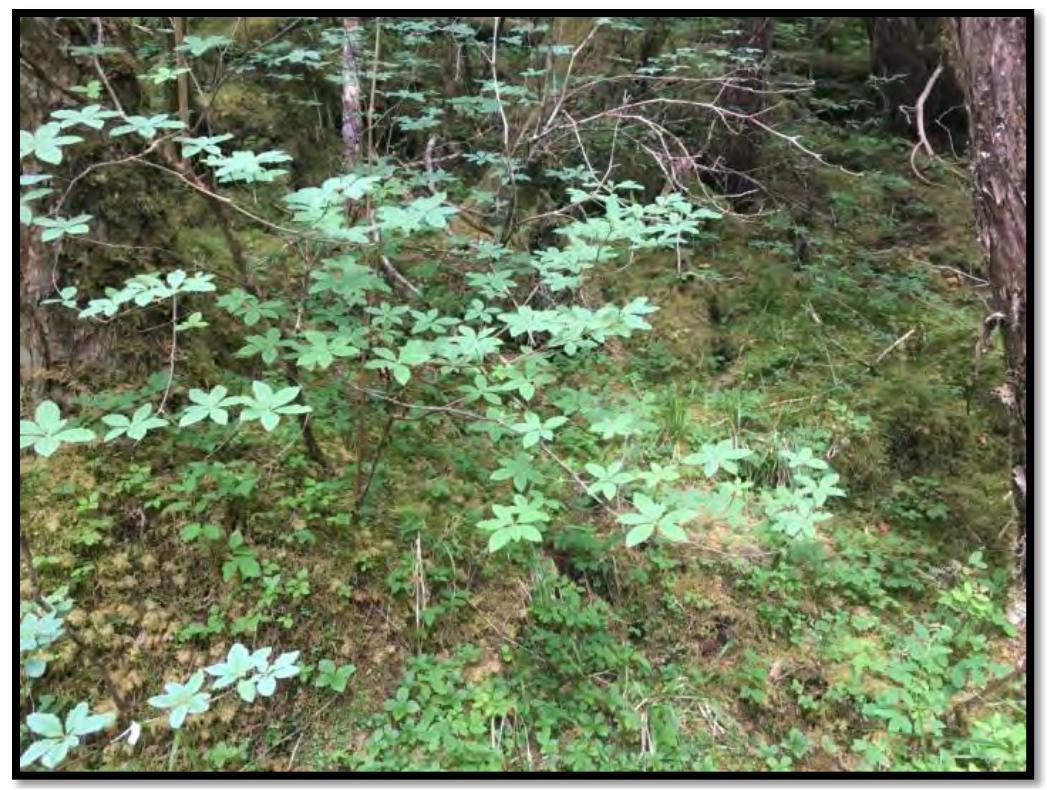
Figure 11 - Upland vegetation at sample point #2. Western hemlock, Sitka spruce rusty menziesia and dwarf dogwood dominate.

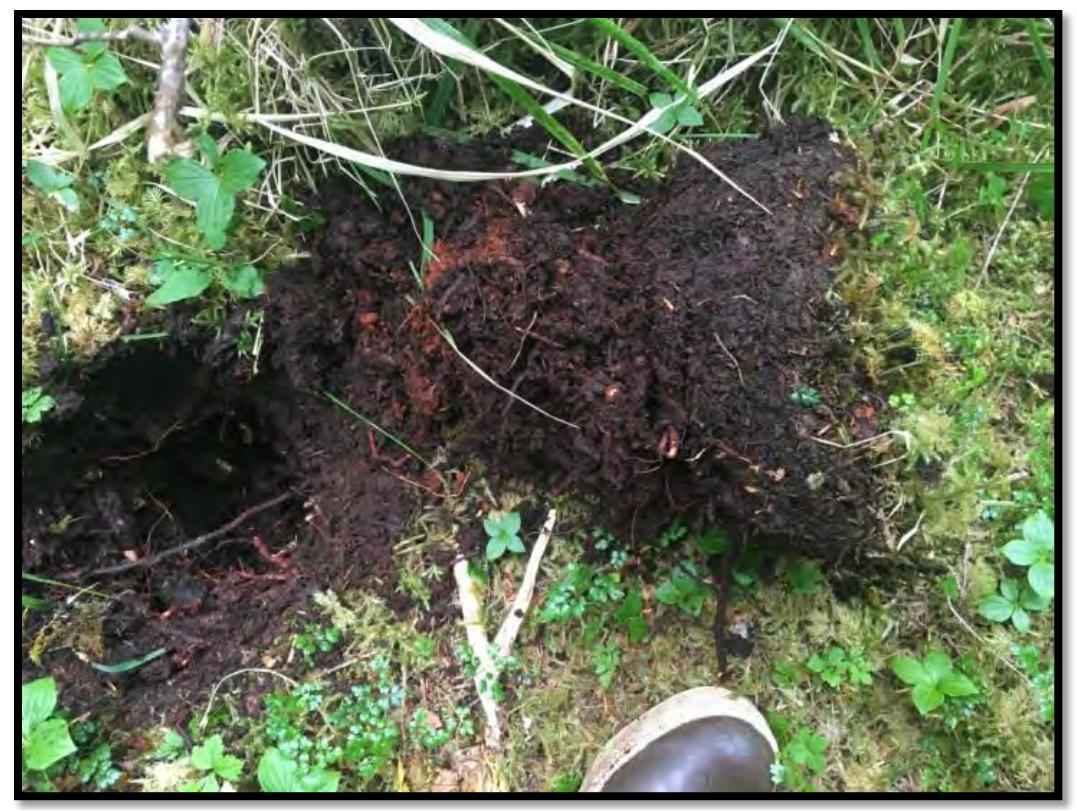
Figure 12 - Unsaturated peat at sample point #2.

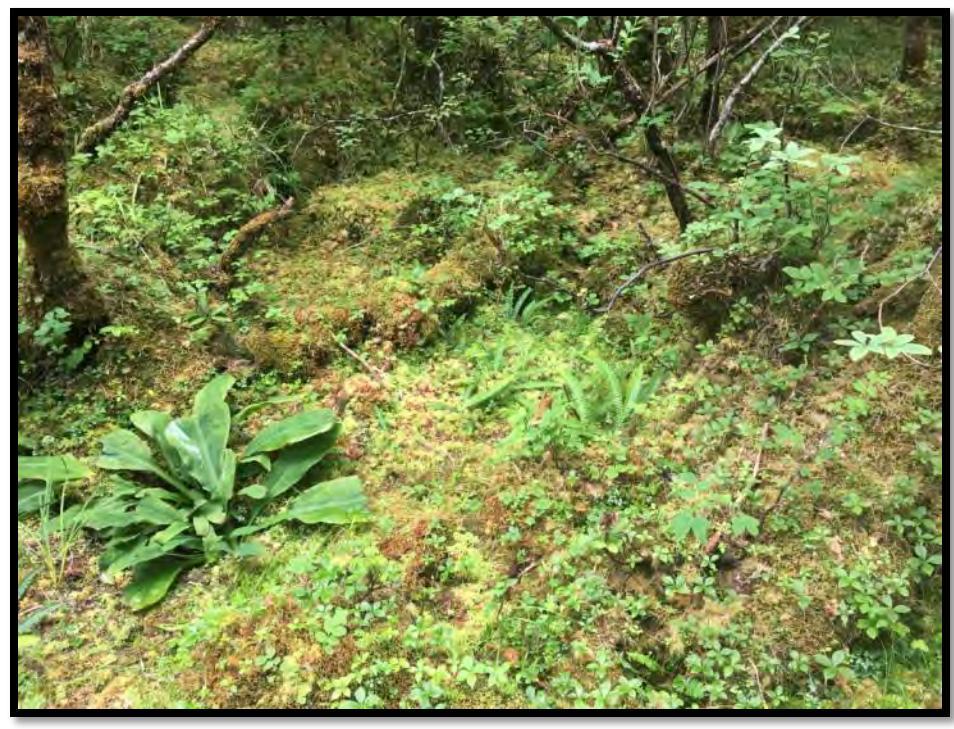
Figure 13 - Forested wetland at sample point #3 - dominated by yellow cedar, rusty menziesia, evergreen *Coptis* and skunk cabbage.

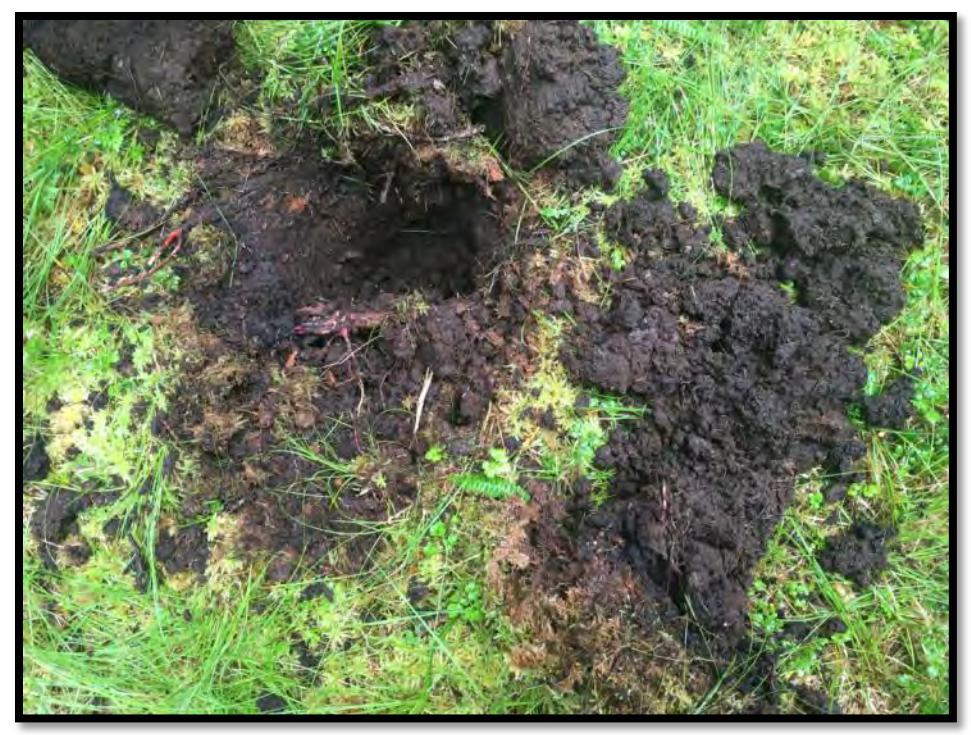
Figure 14 - Deep saturated peat at wetland sample point #3.

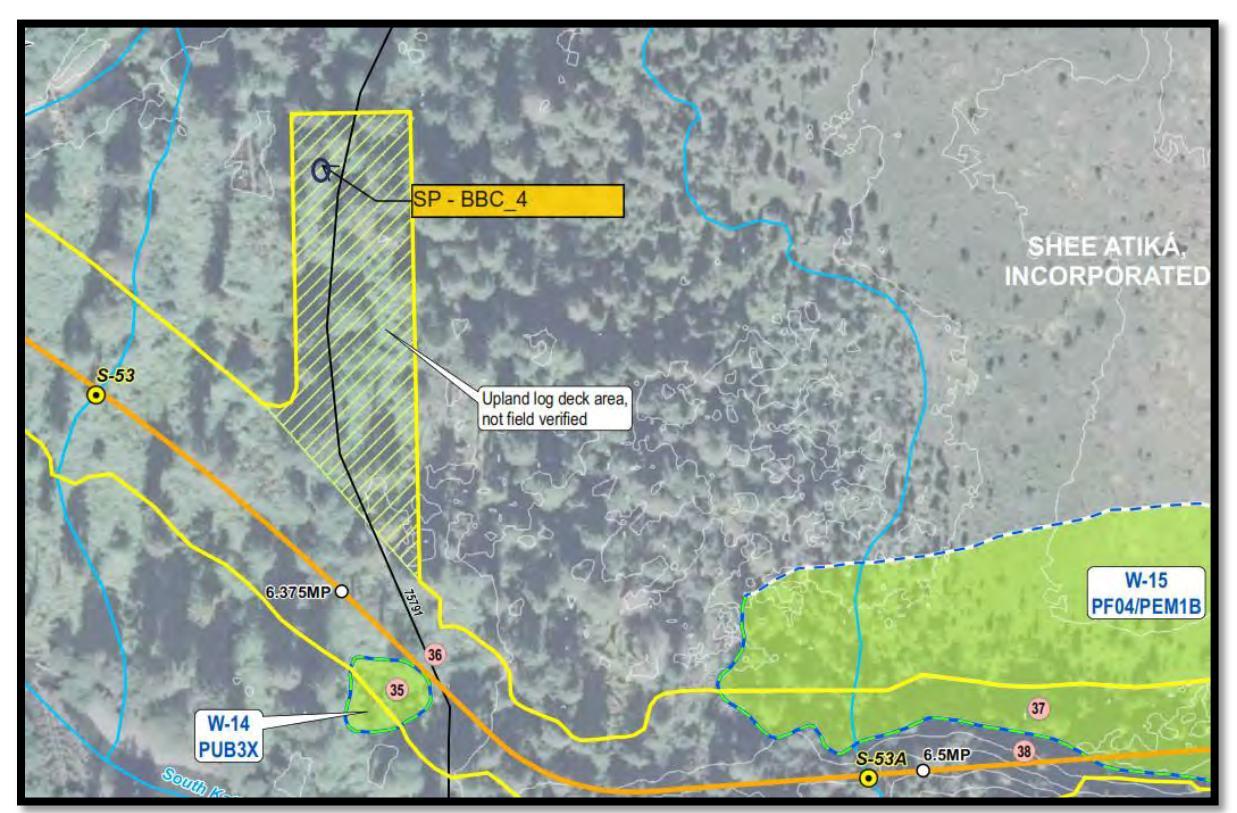
This proposed log deck is found over and around the old logging road 7591. The area around the road is second-growth red alder (FAC) forest with a scattering of Sitka spruce and an understory of devils club (FACU), skunk currant (FACU), and salmonberry (FACU) and a forb layer of enchanters nightshade (FAC) and lady fern (FAC). The soil is a well-drained silt-loam.

Figure 15 - Proposed log deck at mile post 6.375. The oval with label is BBC sample point #4.

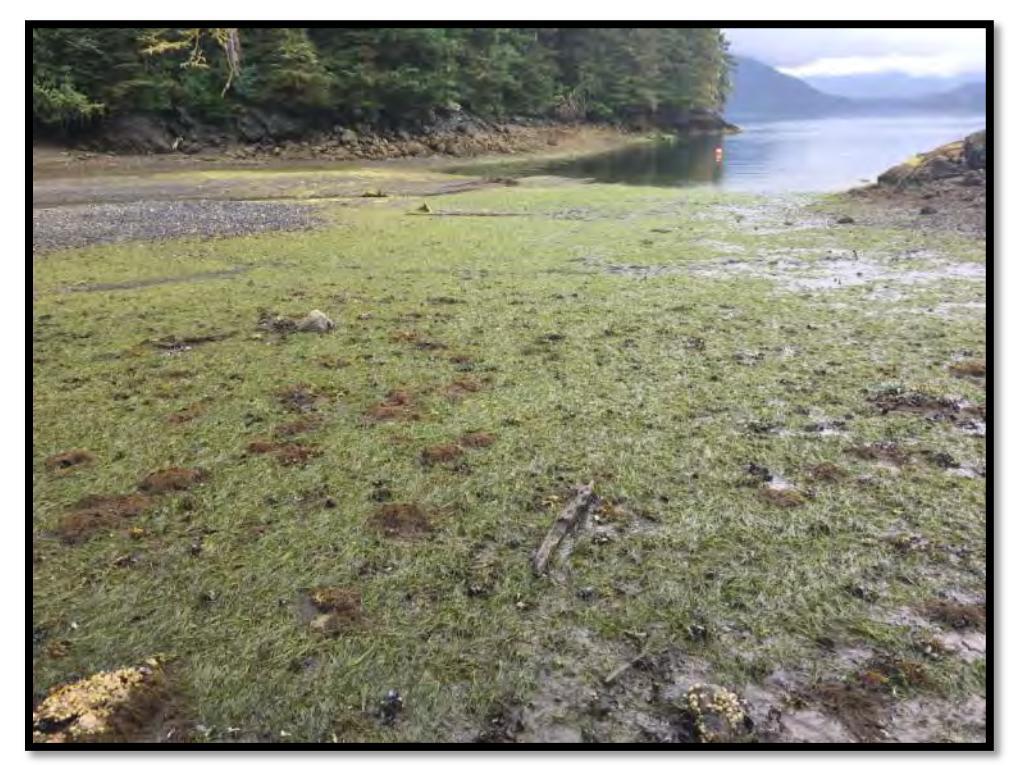
Figure 27 - The eastern most of the southern sites, the largest, and the only one visited that was found in rooted in silt rather than on the rocks.
